# 2022 California Battery Energy Storage System Disturbances

California Events: March 9 and April 6, 2022  
Joint NERC and WECC Staff Report

September 2023

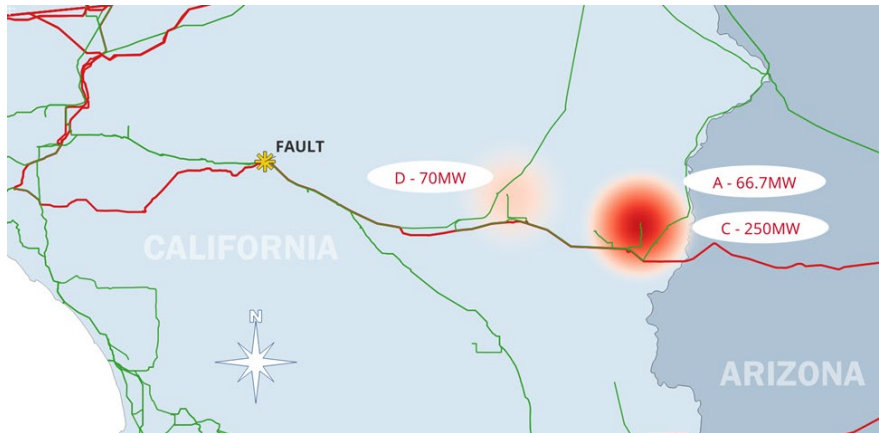
- **March 9, 2022:** At 18:03:20 Pacific time, a generator bus was faulted when a generator circuit breaker had an internal failure at a natural-gas-fired, simple-cycle facility in Riverside County, California, causing a C-phase-to-ground fault on the 220 kV system. Generator units relayed, disconnecting the natural gas generators that were carrying 694 MW. The fault was cleared in approximately 4.5 cycles. In addition, inverter-based resources from many different facilities also unexpectedly reduced 408 MW, 124 MW of which is attributed to BESS. The fault therefore resulted in a total loss of 1,102 MW of generation, and system frequency dropped

**Figure 1.1: Map of the Fault Location and Affected IBR Facilities—March 9, 2022**

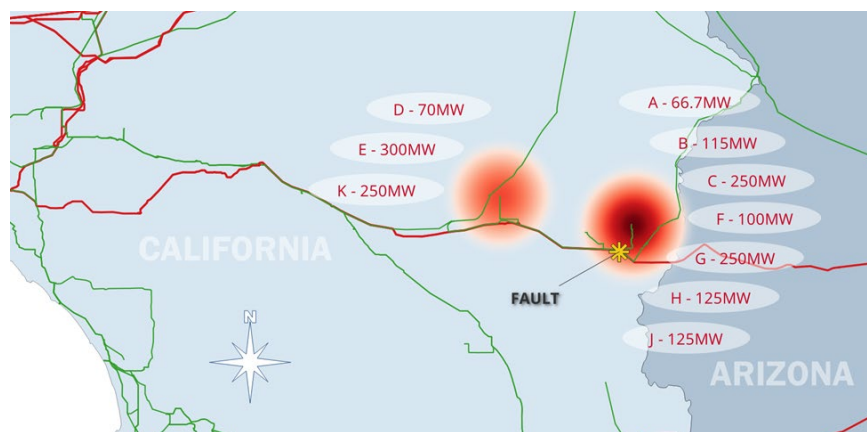
- April 6, 2022:** At 15:06:05 Pacific time, a B-phase-to-ground fault occurred on a 220 kV bus at a new BESS plant that was undergoing testing. The fault was cleared in approximately four cycles. The normally cleared fault resulted in an unexpected reduction of 498 MW from multiple inverter-based resources. The loss of generation caused the system frequency to fall from around 60.014 Hz to 59.924 Hz. The time from the event start to the frequency nadir was around seven seconds. The CAISO Balancing Authority raised regulating unit output to assist in recovery of the frequency and ACE. System frequency returned to normal in one and half minutes.

**Figure 1.2: Map of the Fault Location and Affected IBR Facilities—April 6, 2022**

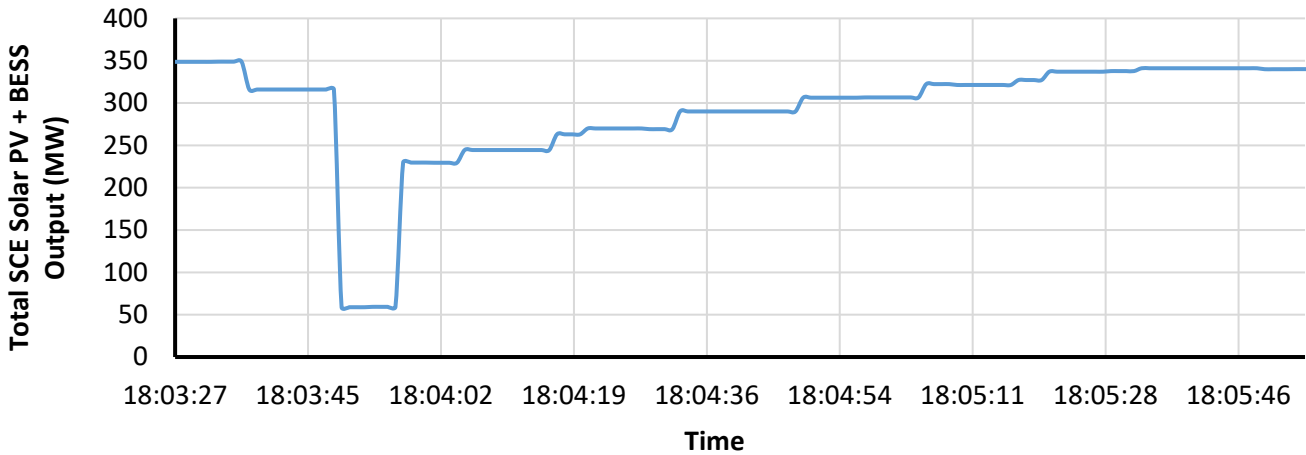
**Figure 1.3: SCE BPS-Connected Solar PV + BESS during March 9 Disturbance [Source: SCE]**

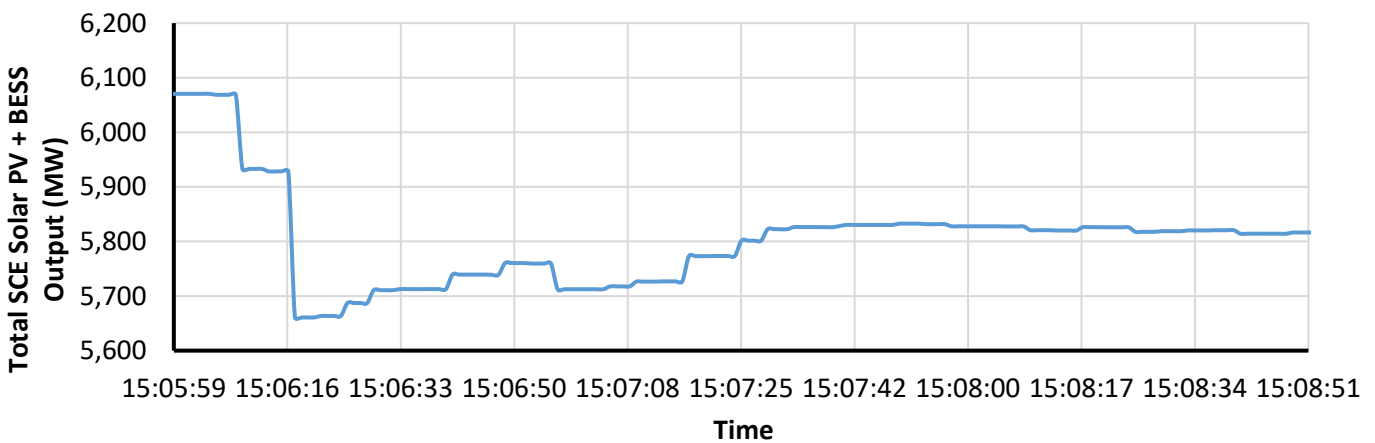
**Figure 1.4: SCE BPS-Connected Solar PV + BESS during Disturbance on April 6 [Source: SCE]**

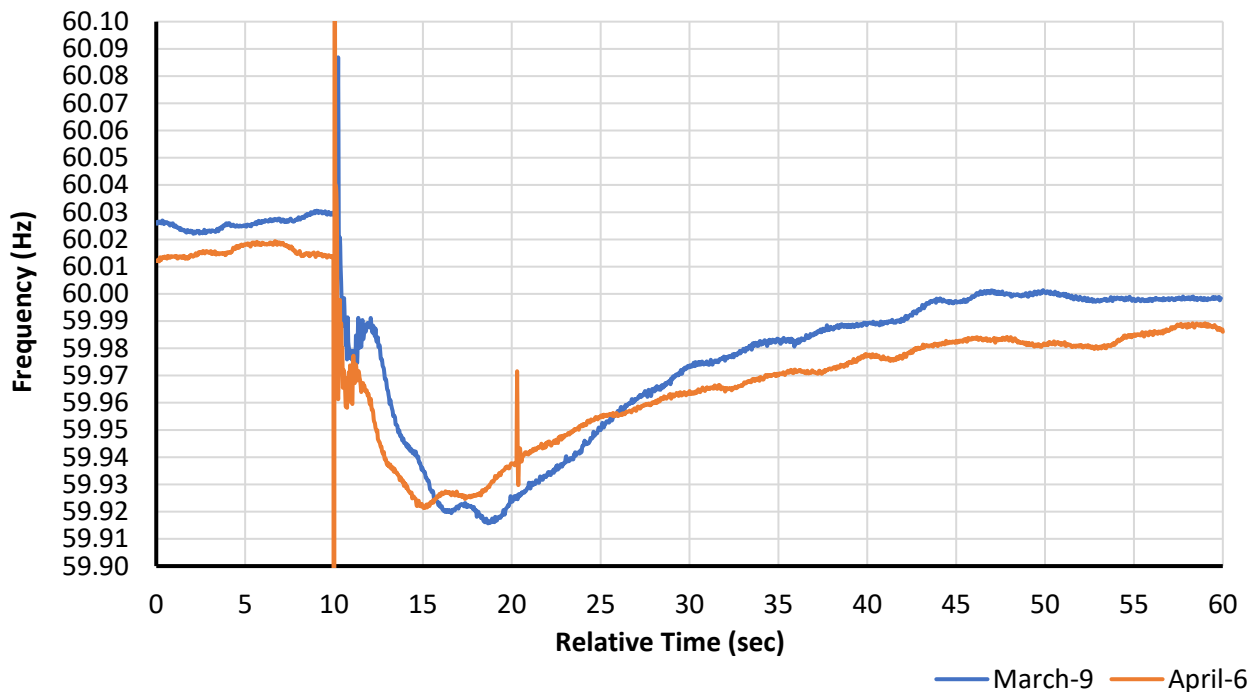
to 59.916 Hz. CAISO, the Balancing Authority, raised regulating unit output to assist in the recovery of the frequency and ACE. The time from the event start to the frequency nadir was measured at around 12 seconds. System frequency returned to normal in three minutes.

**Figure 1.5: WECC System Frequency for Each Disturbance [CAISO]**

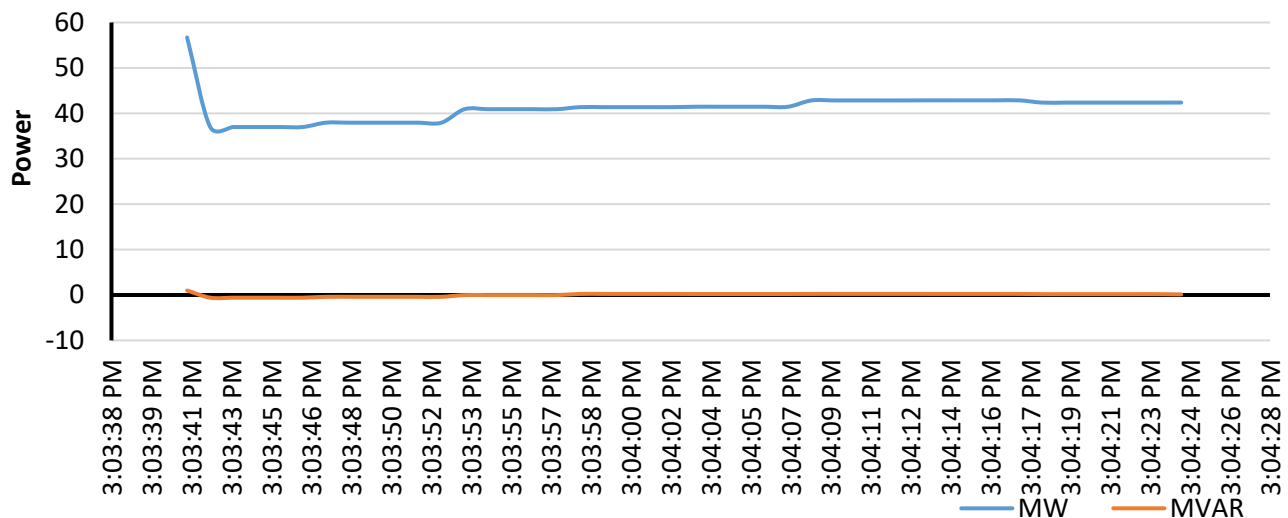
Plant A is a 66 MW facility connected to the 230 kV network that went into commercial operation in June 2021. The plant reduced output from 57 MW to 37 MW during the event (see [Figure A.1](#)). The plant consists of a total of 29 inverters; 15 inverters experienced instantaneous ac overcurrent tripping, and 12 inverters experienced unbalanced ac current tripping.

**Figure A.1: Plant A Active and Reactive Power at POI on March 9**

To mitigate these issues, the GO worked with the inverter original equipment manufacturer to perform software and configuration updates not only at this facility but proactively at other facilities that use the same inverter make and model.

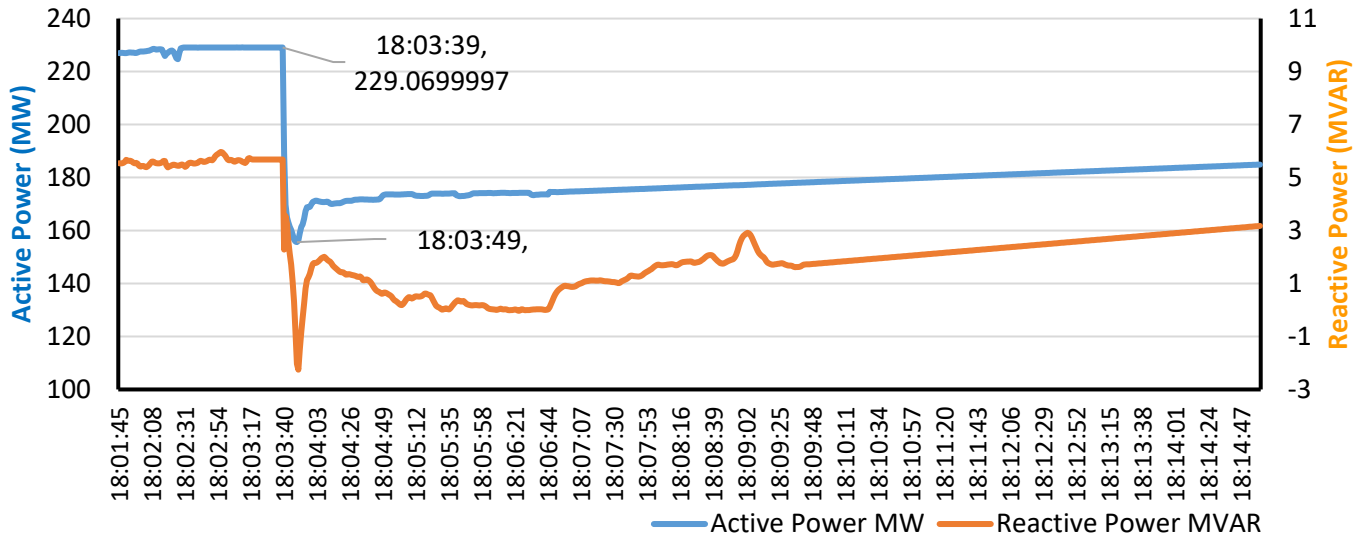
Plant C is a 250 MW facility connected to the 230 kV network that went into commercial operation in June 2021. The plant reduced output by 73 MW during the event (see [Figure A.2](#)). The plant consists of a total of 88 inverters. Of these, 27 inverters experienced instantaneous ac overcurrent tripping, and 35 inverters experienced unbalanced ac current tripping. GO was unable to provide any useful information regarding the cause of tripping from 12 additional inverters that reduced power.

**Figure A.2: Plant C Active and Reactive Power at POI on March 9**

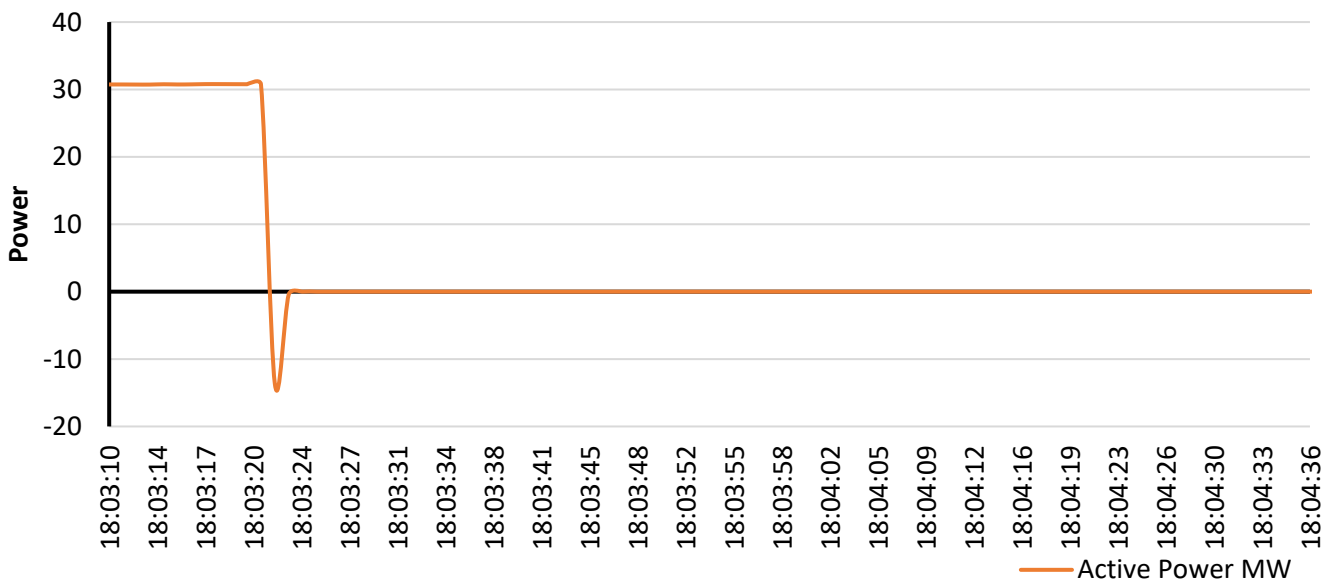
Plant D is a 70 MW hybrid PV + BESS facility connected to the 230 kV network. It went into commercial operation in June 2021. The plant consists of 13 BESS inverters that are rated for 35 MW total. The plant reduced output from 30.7 MW to 0 MW during the event (see [Figure A.3](#)). Inverter logs show 12 inverters tripped and 1 inverter was already off-line before the event. Two inverters tripped on high dc voltage protection four seconds before another 11 inverters tripped for an unknown reason as their fault code merely indicated that all internal modules were off-line. The plant partially recovered after 48 minutes.

**Figure A.3: Plant D Active Power at POI on March 9**

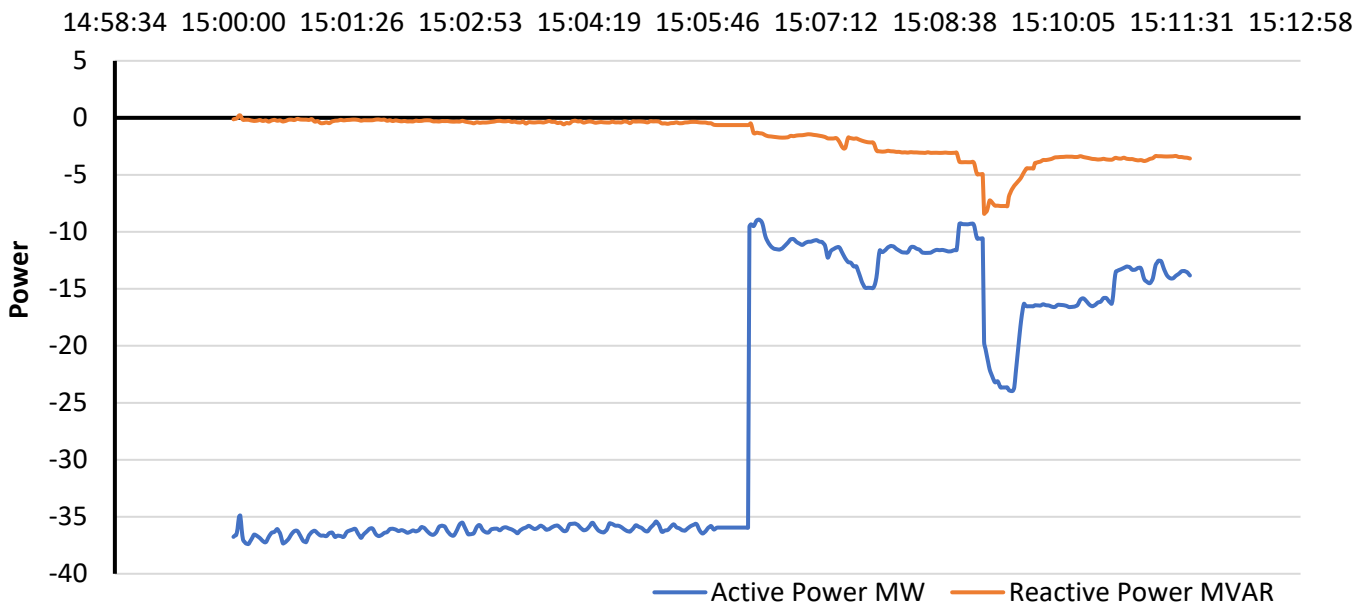
Plant B is a 115 MW facility connected to the 230 kV network that went into commercial operation in April 2021. The plant output dropped by 26 MW during the event from the pre-disturbance level of 36 MW (see [Figure A.4](#)). The plant consists of a total of 45 inverters. GO reported that five inverters tripped (three tripped on unbalanced ac current protection; cause of trip unknown for the rest). However, the loss of five inverters does not add up to the total 26 MW lost, suggesting that there is a data quality issue.

**Figure A.4: Plant B Active and Reactive Power at POI on April 6**

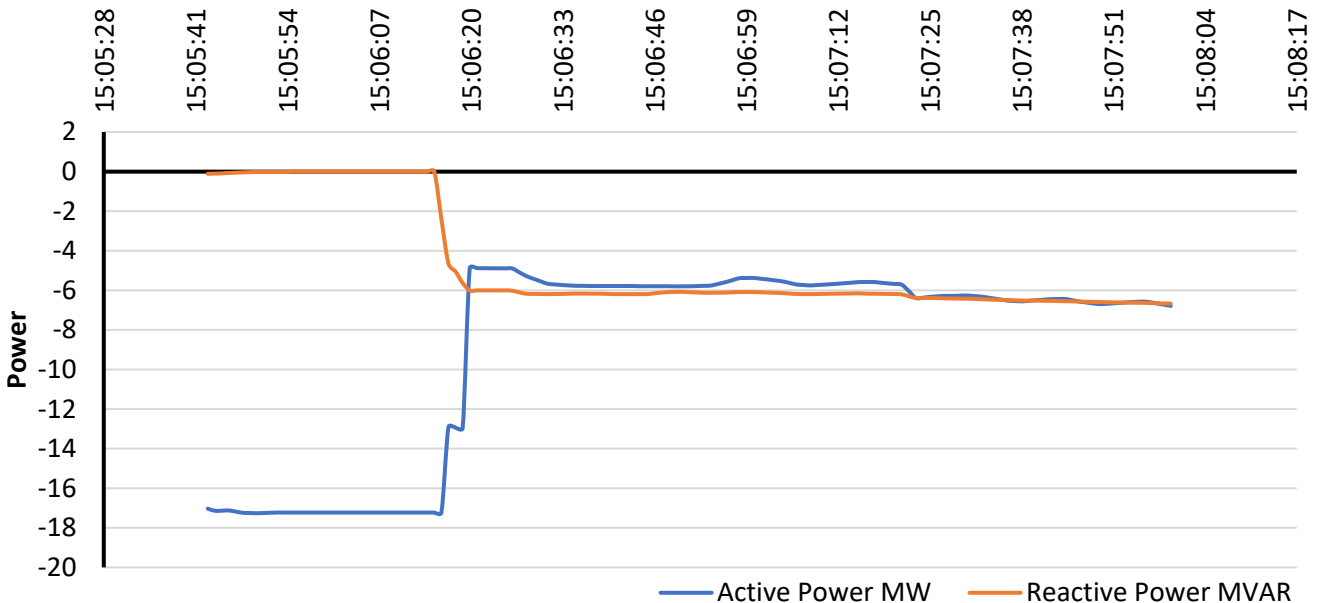
The GO reported there was no inverter fault and attributed the abnormal power response to the facility charging at a lower power level than the set point to manage the battery nearing its full state of charge. However, data from GO (Figure A.5) indicated that the facility metering was interrupted right around the disturbance due to the log recording the same value for a few seconds. When the recording resumed, the plant charging power level dropped, and the reactive power consumption increased simultaneously, suggesting that a few inverters were lost. The results are inconclusive.

**Figure A.5: Plant C Active and Reactive Power at POI on April 6**

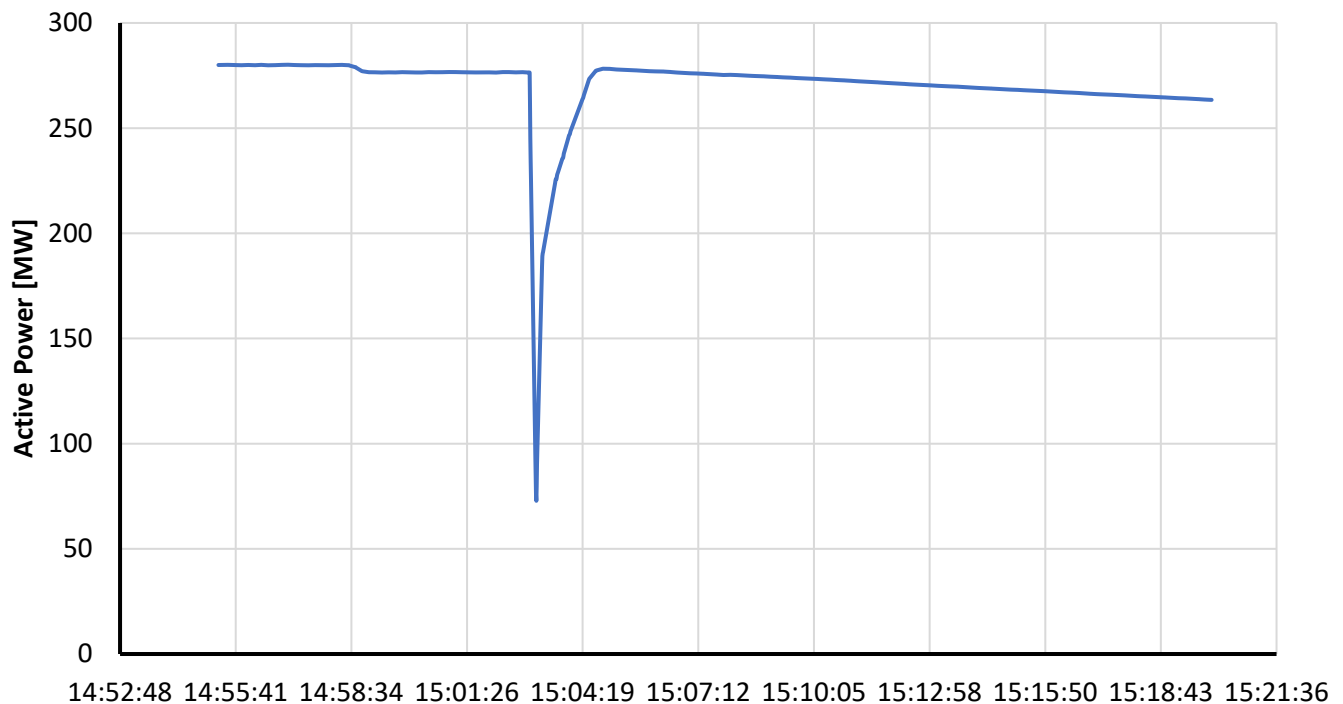
Plant E is a 300 MW facility connected to the 230 kV network that went into commercial operation in 2014. The plant experienced a 104 MW power reduction due to momentary cessation. It is an older facility where momentary cessation could not be disabled. Its power recovery has improved since the last event it was involved in. One inverter tripped on dc overcurrent. See [Figure B.1](#).

**Figure B.1: Plant E Active Power at POI on April 6**

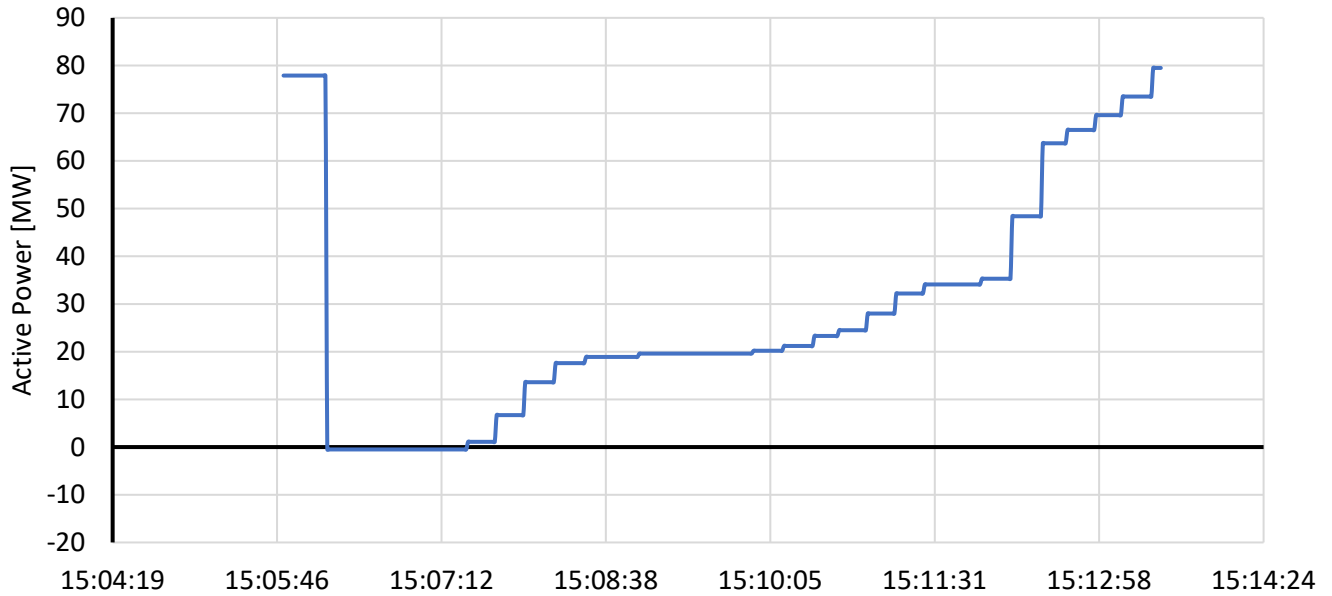
Plant F is a 100 MW facility connected to the 230 kV network that went into commercial operation in 2022. During the event, the plant output dropped from 78 MW to 0 due to 26 inverters tripping on ac overcurrent. See [Figure B.2](#).

**Figure B.2: Plant F Active Power at POI on April 6**

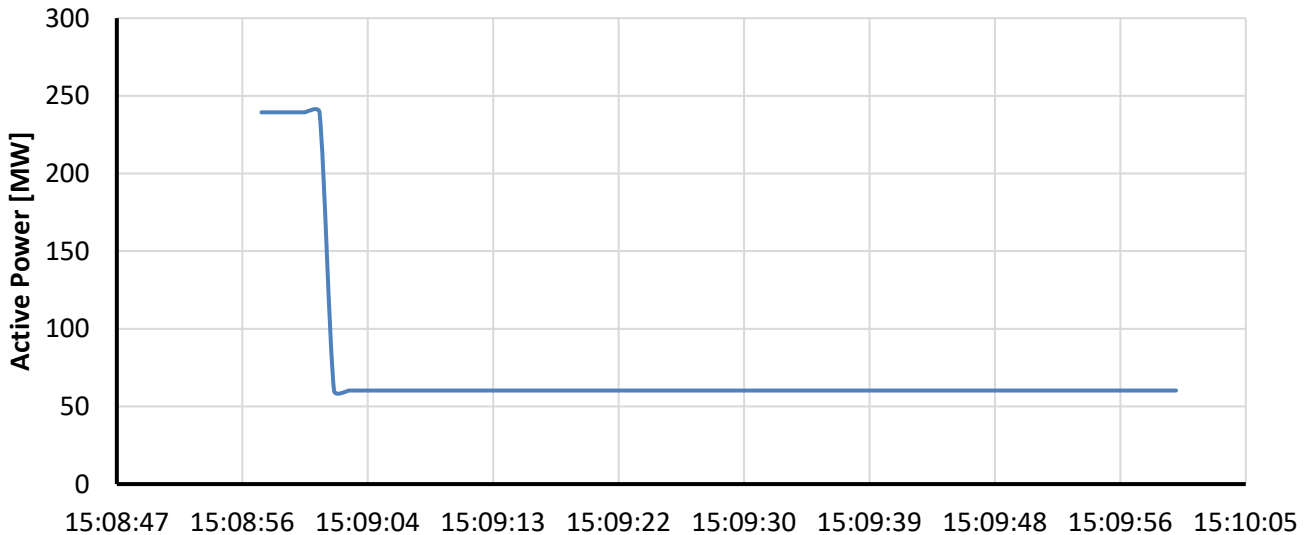
Plant G is a 250 MW facility connected to the 230kV network that went into commercial operation in 2016. During the event, the plant output dropped from 239 MW to 60 MW due to 192 inverters tripping on low line-to-line voltage and 2 inverters of a different manufacturer tripping for unknown reasons as the inverters did not record fault codes. A few months prior to the event, the inverter trip settings had been revised from being set directly on PRC-024 no-trip boundaries, but the inverter still tripped. See [Figure B.3](#).

**Figure B.3: Plant G Active Power at POI on April 6**

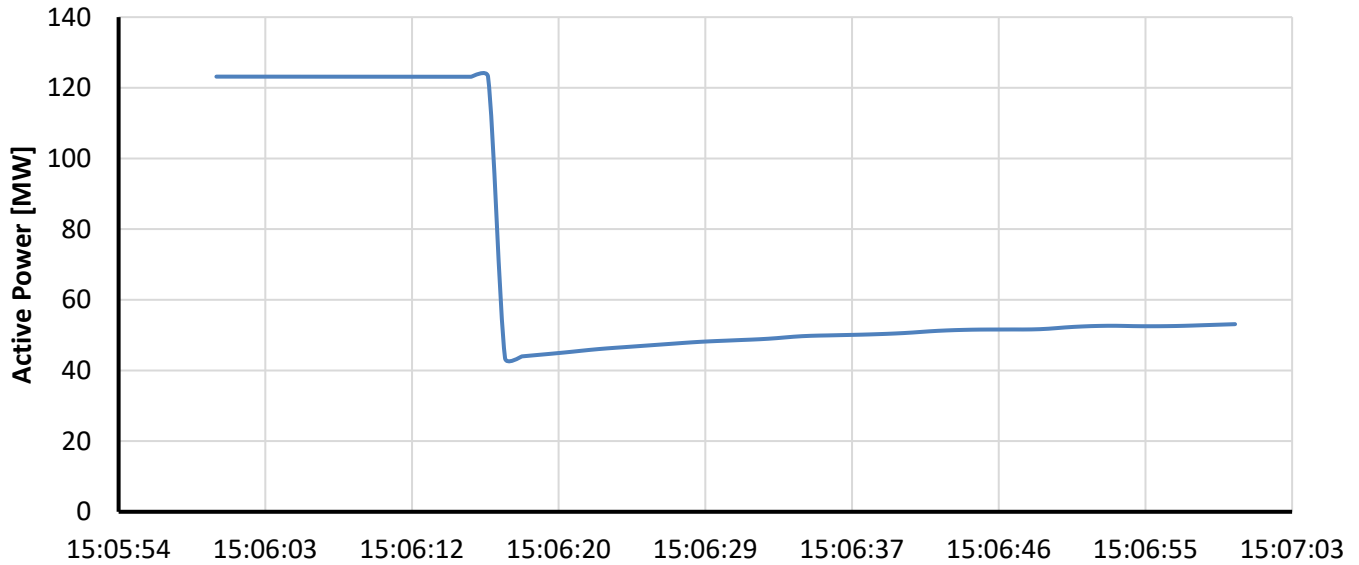
Plant H is a 125 MW facility connected to the 230 kV network that went into commercial operation in 2020. During the event, the plant output dropped from 123 MW to 43 MW due to 23 inverters tripping and 3 inverters experiencing partial loss of modules. The causes of tripping included high voltage ac, unbalanced dc bus, and ac overcurrent. See [Figure B.4](#).

**Figure B.4: Plant H Active Power at POI on April 6**

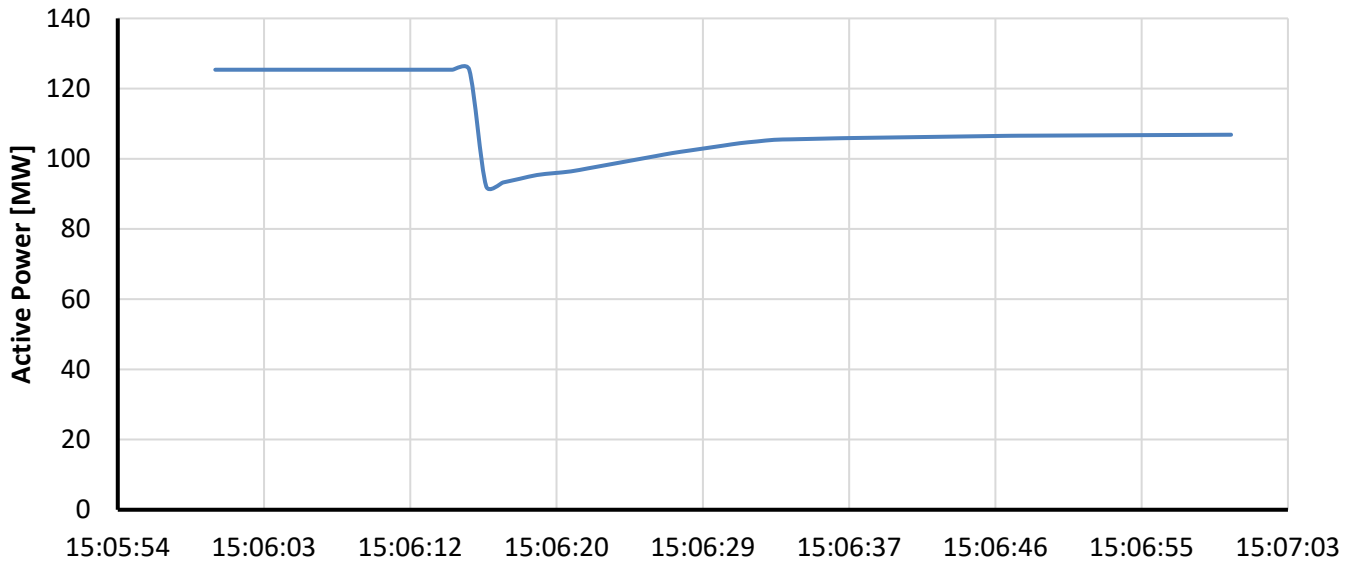
Plant J is a 125 MW facility connected to the 230 kV network that went into commercial operation in 2020. During the event, the plant output dropped from 125 MW to 92 MW due to 26 inverters experiencing partial module loss and 1 inverter tripping completely. The causes of tripping included unbalanced dc bus and unknown. See [Figure B.5](#).

**Figure B.5: Plant J Active Power at POI**

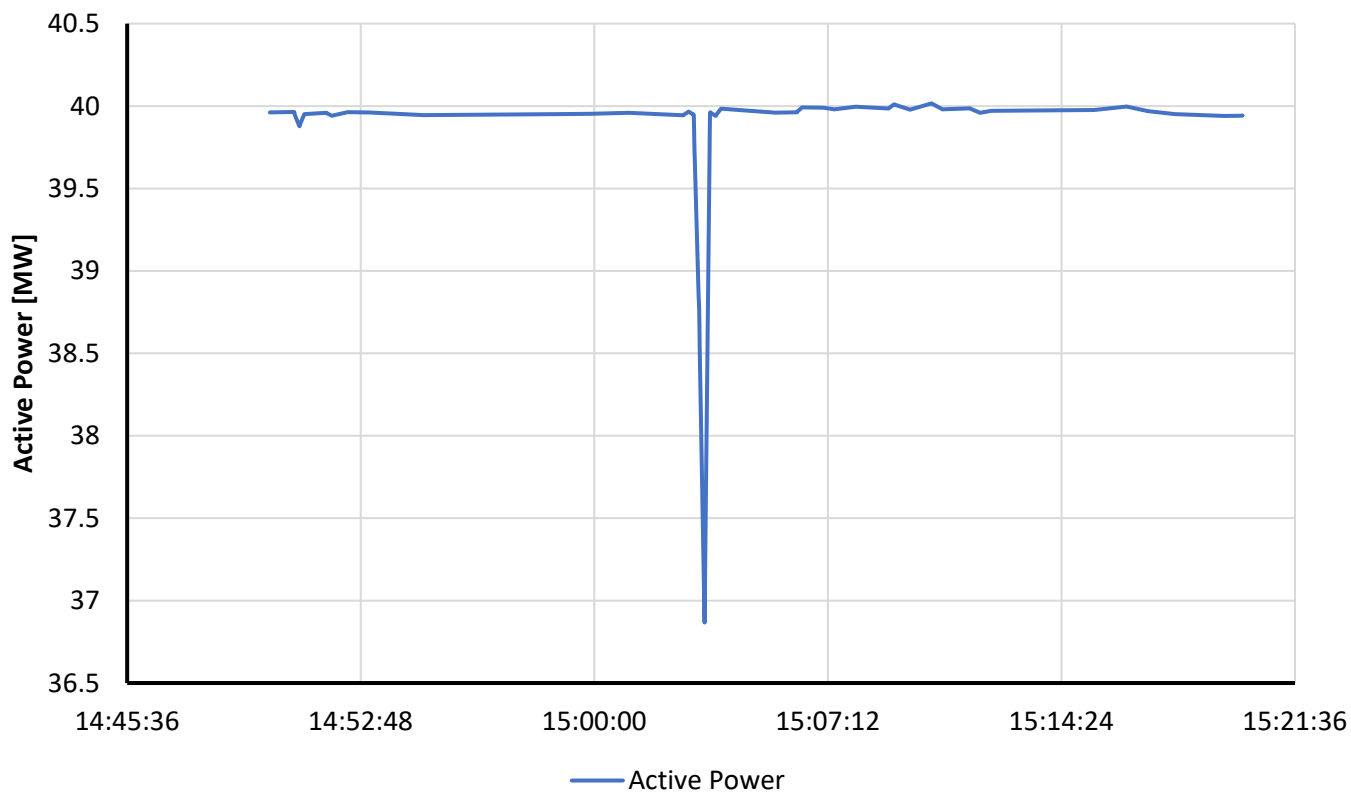
Plant K is a 250 MW facility connected to the 230 kV network that went into commercial operation in 2014. During the event, the plant output dropped from 40 MW to 37 MW due to momentary cessation. No inverter tripping was reported. See [Figure B.6](#).

**Figure B.6: Plant K Active Power at POI on April 6**
