2022 Odessa Disturbance

Texas Event: June 4, 2022
Joint NERC and Texas RE Staff Report

December 2022

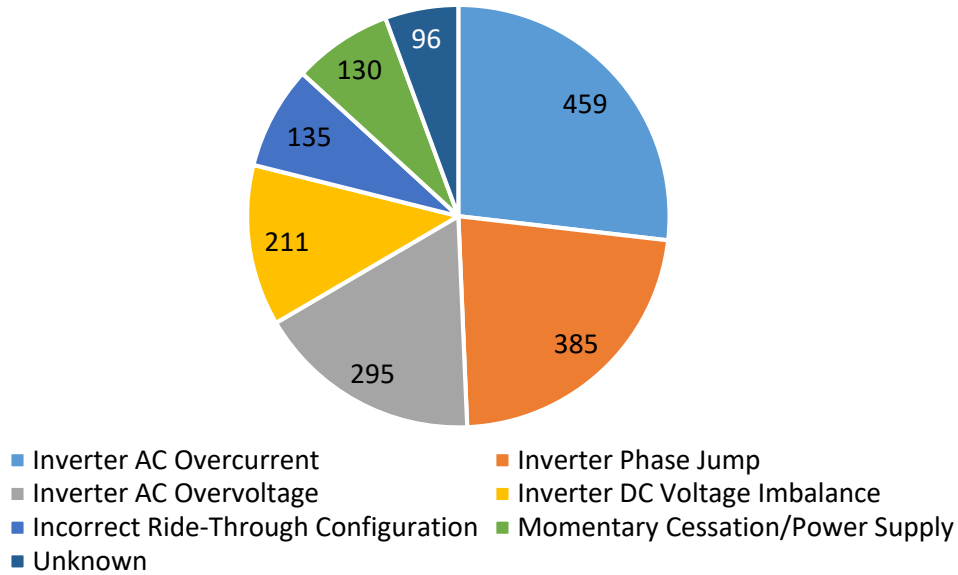
Figure 1.1: Causes of Solar PV Reduction

Cause of Reduction	Odessa 2021 Reduction [MW]	Odessa 2022 Reduction [MW]
Inverter Instantaneous AC Overcurrent	–	459
Passive Anti-Islanding (Phase Jump)	–	385
Inverter Instantaneous AC Overvoltage	269	295
Inverter DC Bus Voltage Unbalance	–	211
Feeder Underfrequency	21	148*
Unknown/Misc.	51	96
Incorrect Ride-Through Configuration	–	135
Plant Controller Interactions	–	146
Momentary Cessation	153	130**
Inverter Overfrequency	–	–
PLL Loss of Synchronism	389	–
Feeder AC Overvoltage	147	–
Inverter Underfrequency	48	–
Not Analyzed	34	–

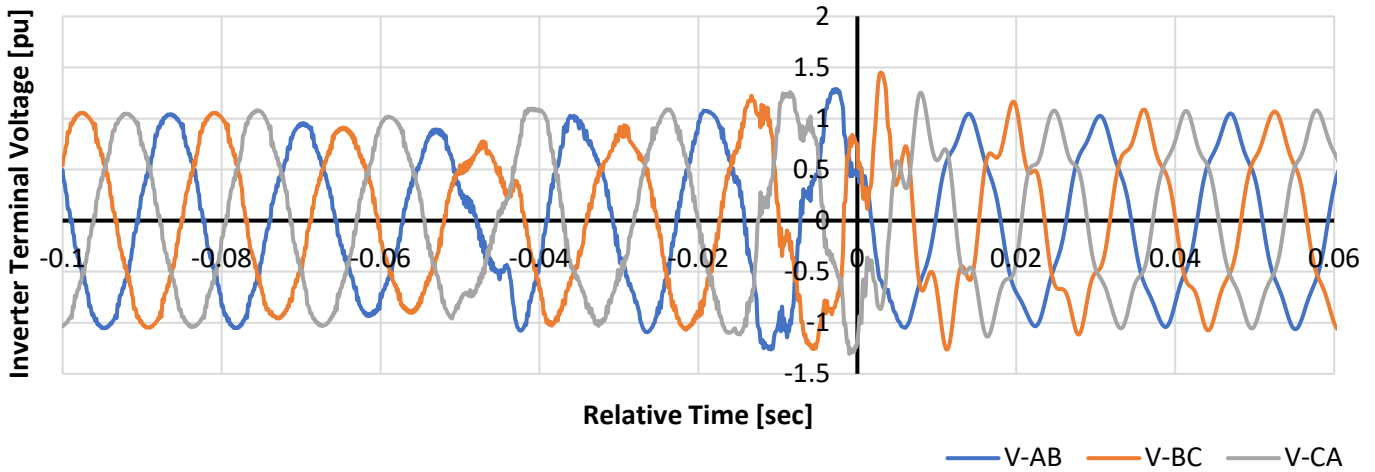
Figure 1.5: Inverter-Level High Speed Oscillography Voltage Data

Inverter instantaneous ac overvoltage tripping is a persistent and recurring cause of unexpected tripping of BPS-connected inverter-based resources. NERC has documented the cause of this tripping in detail in the *2021 Odessa Disturbance Report* and has issued strong recommendations that inverters used on the BPS be designed, constructed, and tested rigorously to ensure they can withstand expected instantaneous spikes in voltage that occur during normally cleared BPS faults. NERC also highlighted inadequacies in PRC-024-3 since the standard allows for instantaneous tripping at fairly low overvoltage levels.¹⁹ The PRC-024-3 curves are intended as point of interconnection (POI) voltage measurements, not inverter terminal voltage measurements; however, industry has not developed standardized methods to ensure inverter-level protections are sufficient for various dynamic (sub-cycle) POI voltage levels during faults. This would require extensive EMT modeling and studies for each interconnecting facility; NERC has strongly recommended that these types of studies be conducted for future interconnections to avoid systemic inverter tripping concerns that should be identified during interconnection studies.

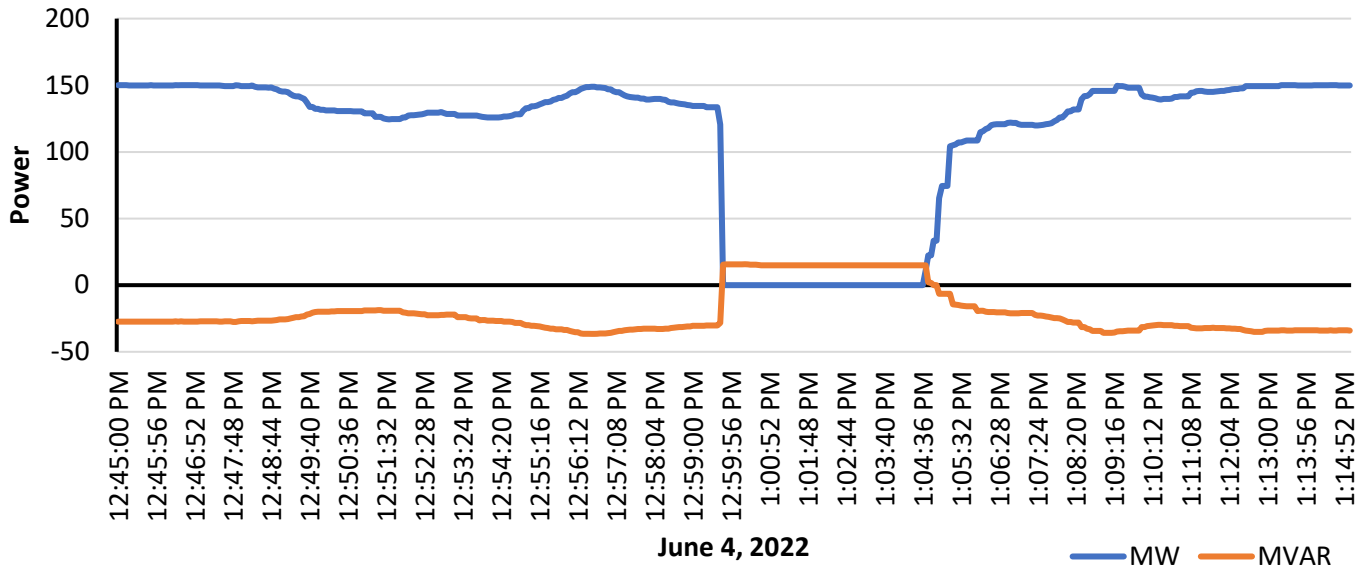
Figure A.1: Plant Active and Reactive Power at POI

Plant B is a 152 MW facility connected to the 138 kV network that went into commercial operation in June 2020. The plant reduced output by 133 MW during the event (see [Figure A.1](#)). All inverters in the plant tripped on voltage phase jump protection that acts as passive anti-islanding protection for this specific inverter manufacturer. The inverters tripped and automatically returned to service with a preprogrammed time delay of five minutes.

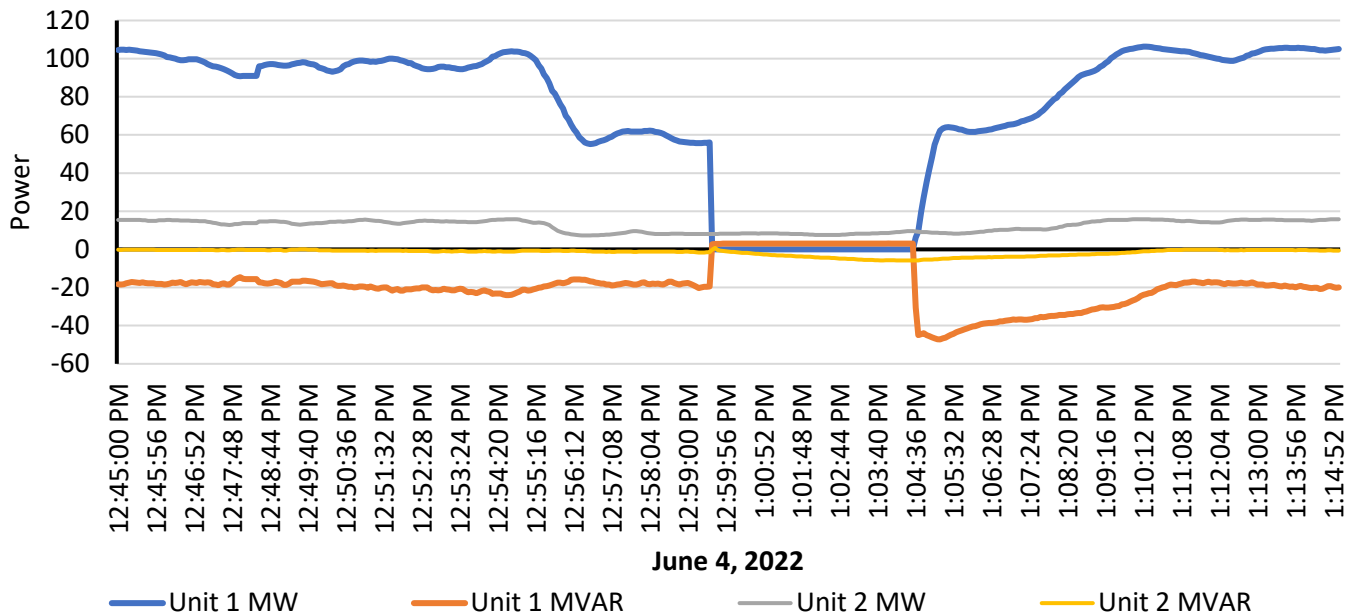
Figure A.2: Plant Active and Reactive Power at POI

Plant C is a 258.5 MW facility connected to the 345 kV network that went into commercial operation in November 2020. The plant reduced output by 56 MW during the event (see [Figure A.2](#)). All inverters in the plant tripped on voltage phase jump protection that acts as passive anti-islanding protection for this specific inverter manufacturer. The inverters tripped and automatically returned to service with a pre-programmed time delay of five minutes.

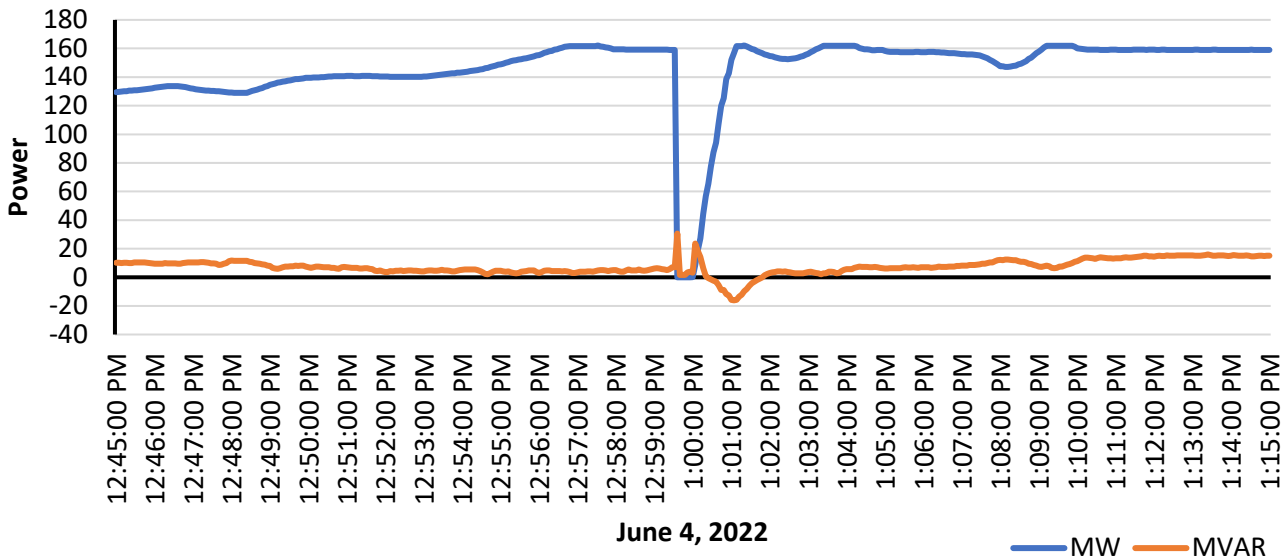
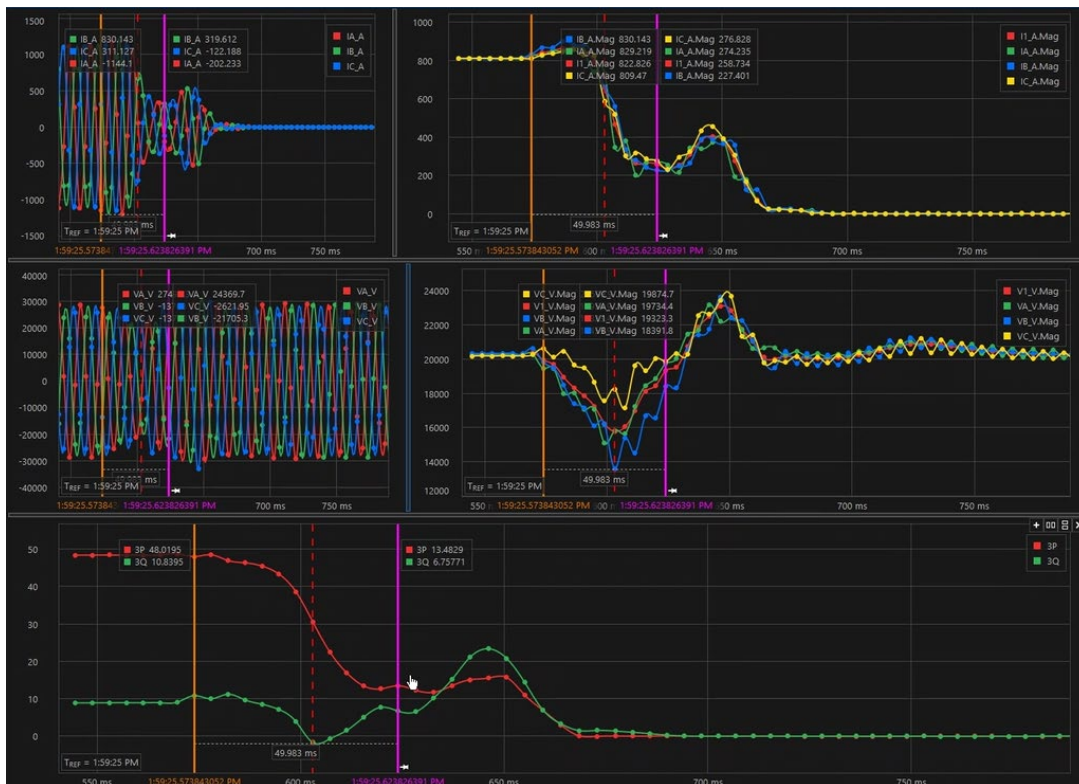
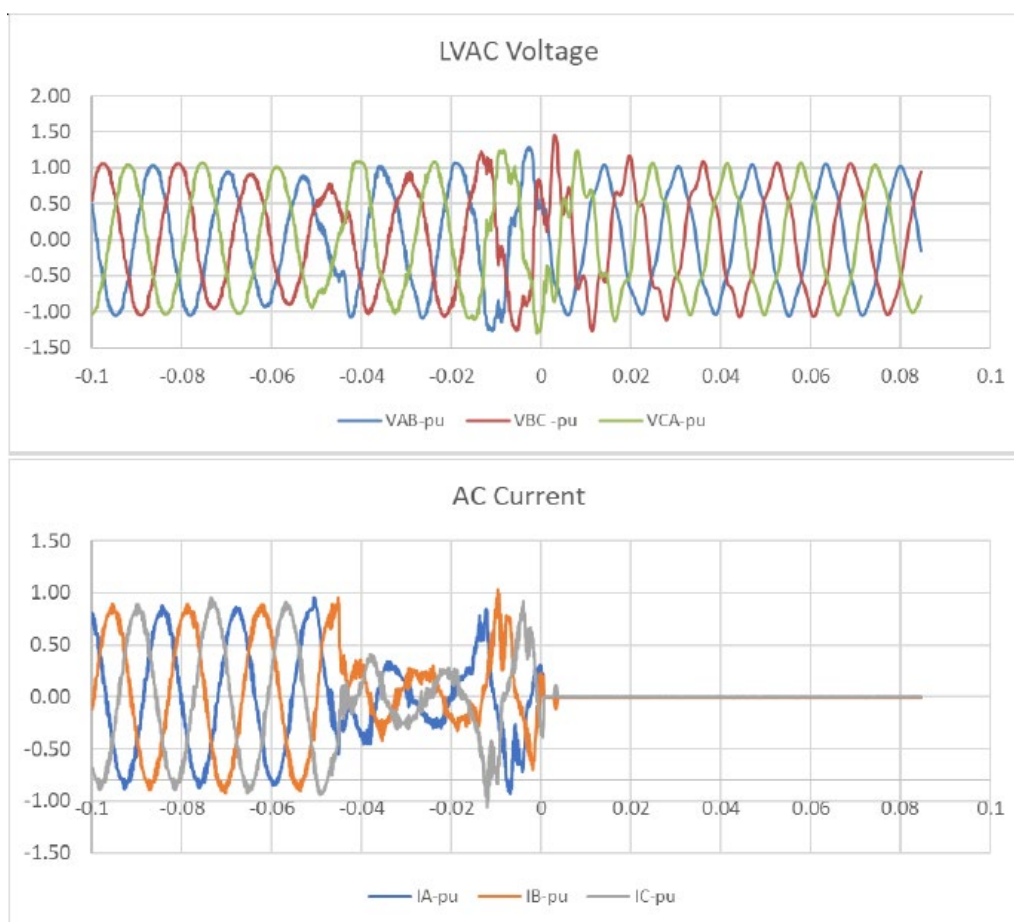
Plant E is a 162 MW facility connected to the 138 kV network that went into commercial operation in May 2021. Plant E reduced power output from 159 MW to 0 MW when the fault occurred (see [Figure A.3](#)). All inverters tripped on instantaneous ac overvoltage protection set at 1.25 pu. This is considered a “minor” fault by the manufacturer so the inverters initiated an automatic restart about 25 seconds after the fault. The inverters returned to predisturbance output 1.5 minutes after the fault. The oscillography data at the POI (see [Figure A.4](#)) and the inverter-level oscillography data (see [Figure A.5](#)) show that the inverters were injecting reactive current upon fault clearing, which very likely lead to overvoltage conditions.

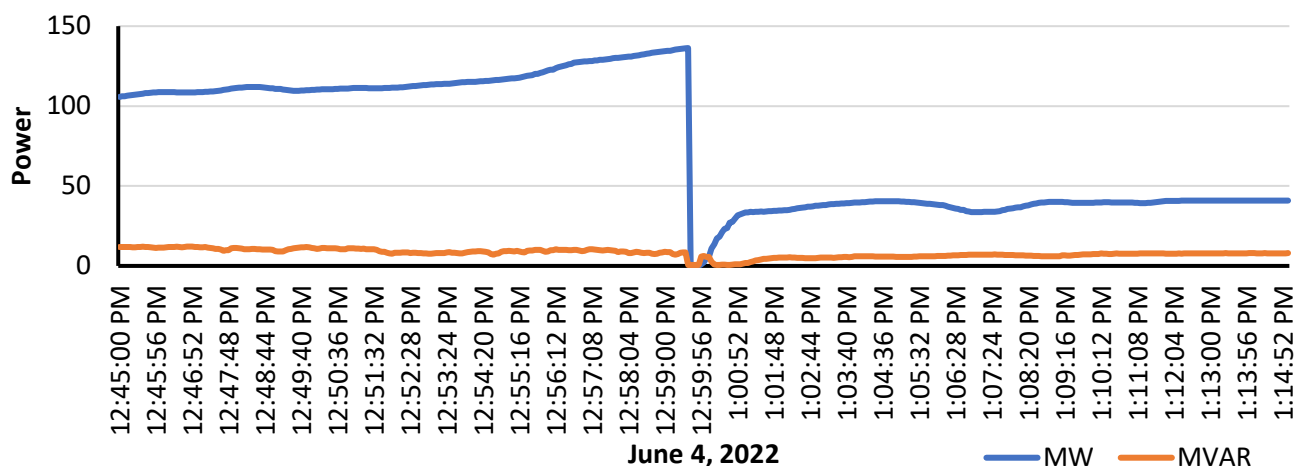
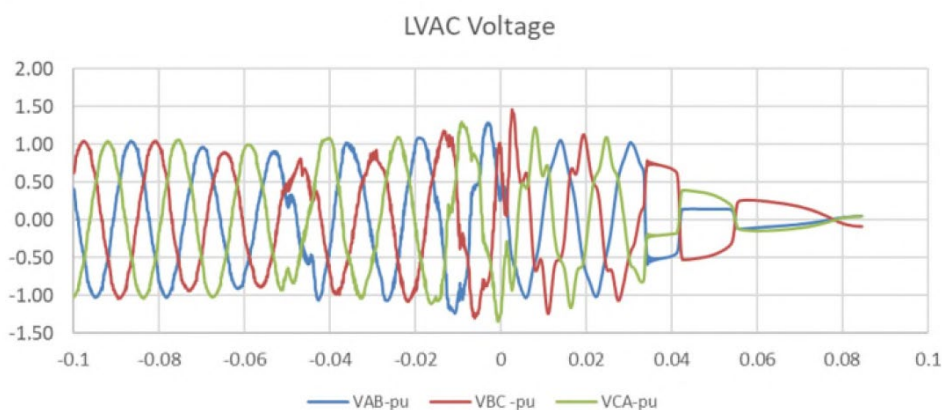
Plant U is a 143.5 MW facility connected to the 138 kV network that went into commercial operation in August 2021. Plant U reduced power output from 136 MW to 0 MW when the fault occurred (see Figure A.6). Inverters tripping at this facility is attributed to the following:

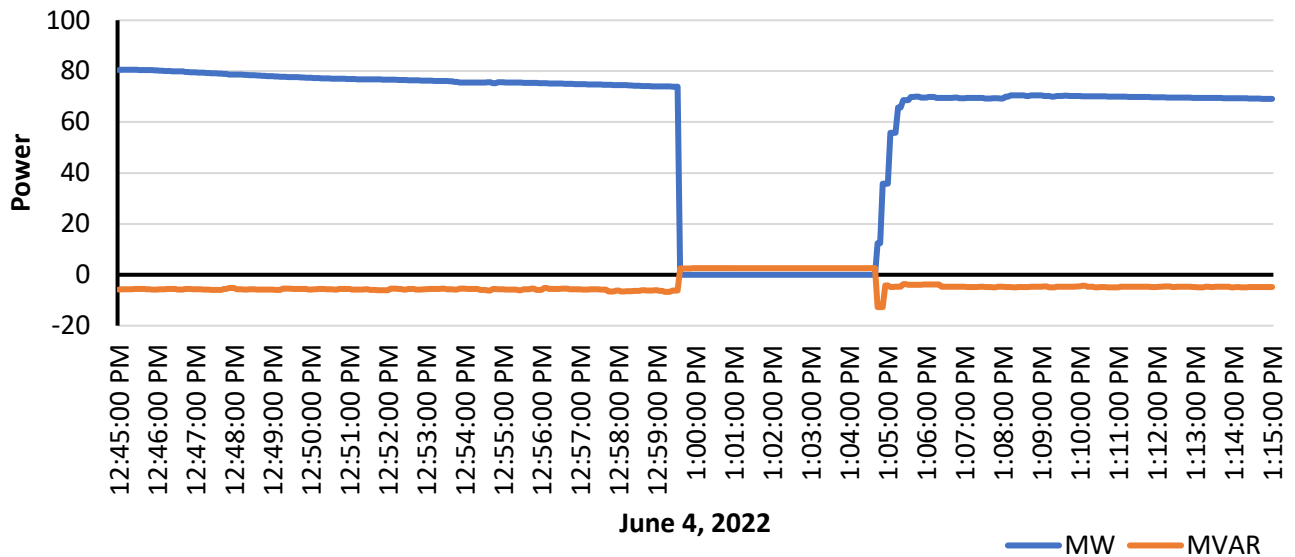
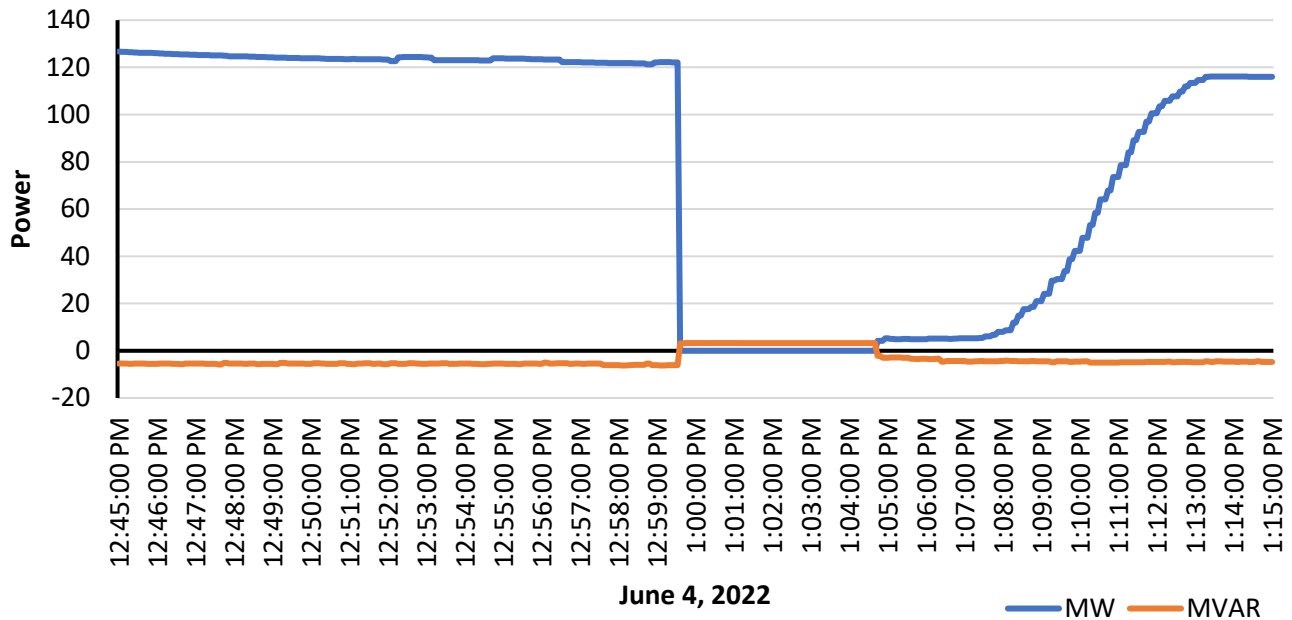
Plant I and Plant J Unit #1 and Unit #2 are 154 MW and 150 MW resources, respectively, connected to the 345 kV network that went into commercial operation in June 2020. Unit #1 reduced active power by 74 MW and recovered 5 minutes later. Unit #2 reduced power output by 122 MW and recovered about 14 minutes later. The combined reduction of active power for the facility is 196 MW (see Figure A.9 and Figure A.10). Both units at the facility have the same inverter make and model and are connected to the same POI bus. All inverters tripped on voltage phase jump protection used as a passive anti-islanding protection for this specific inverter manufacturer. The GO and inverter manufacturer were unable to determine why the units recovered over different time scales.

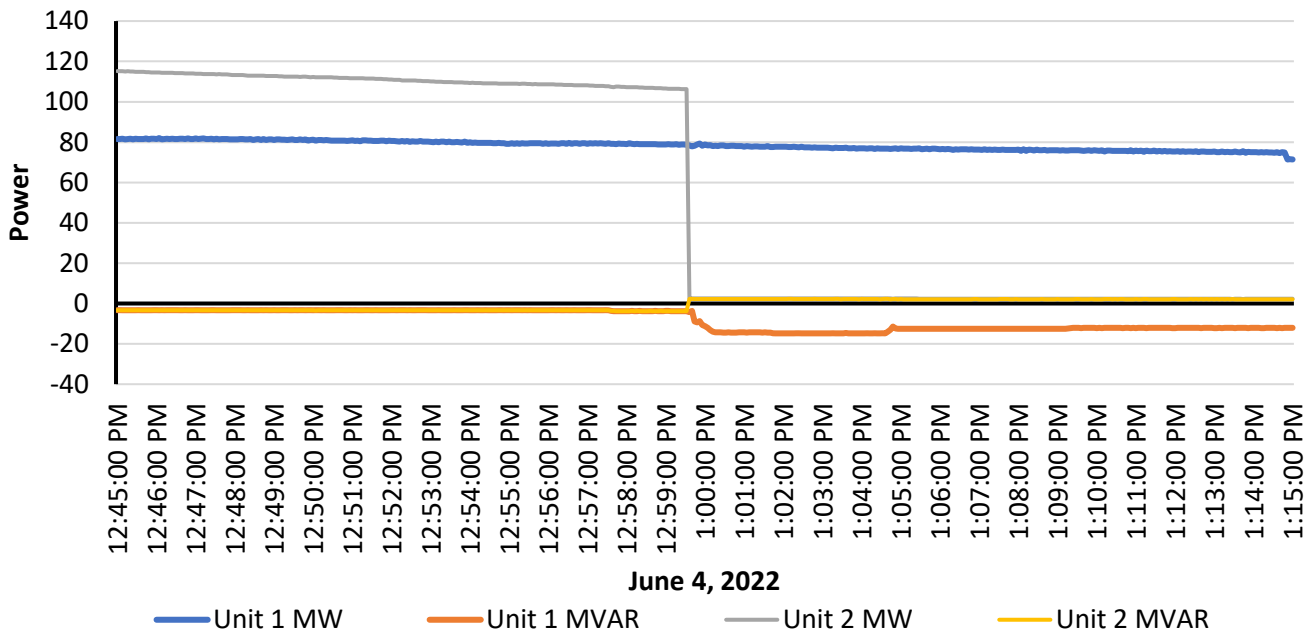
Figure A.11: Plant Active and Reactive Power at POI

Plant J Unit #1 and Unit #2 are 126.5 MW and 126.4 MW resources, respectively, connected to the 345 kV network that went into commercial operation in July 2021. Unit #1 rode through the disturbance³⁶ and Unit #2 reduced power output by 106 MW and remained off-line until the following day (see [Figure A.11](#)). All affected inverters tripped on dc voltage imbalance caused by ac-side voltage phase angle changes that the inverter control could not regulate fast enough to control dc bus voltages.

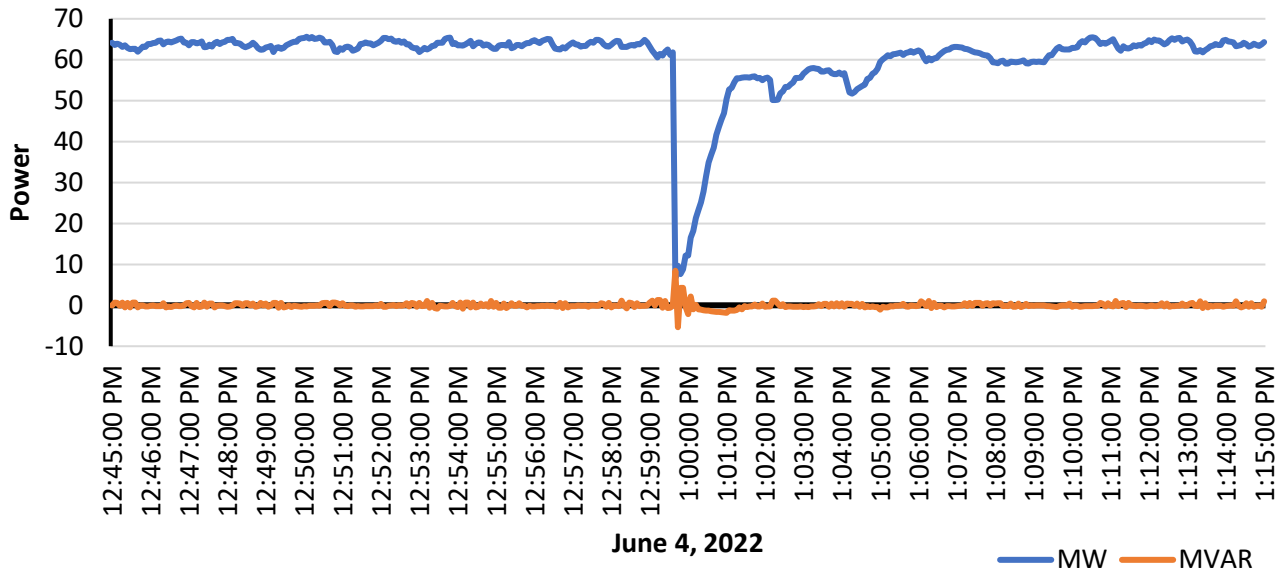
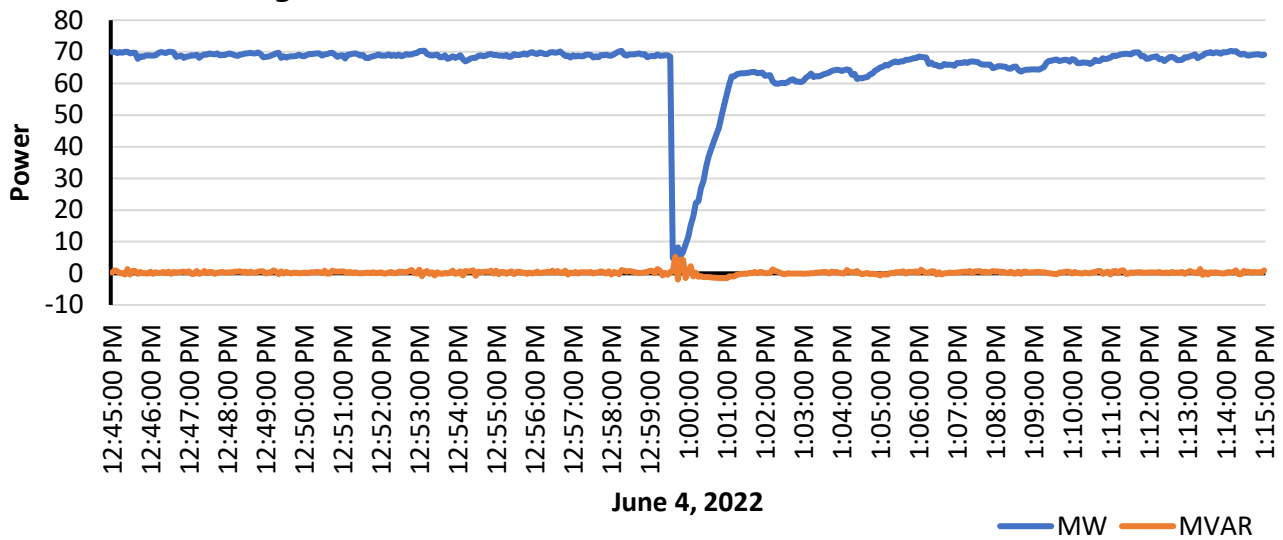
Plant K and Plant L are a combined 157.5 MW facility connected to the 138 kV network that went into commercial operation in September 2016. Plant K reduced active power by 62 MW (see [Figure A.12](#)), and Plant L reduced output by 68 MW (see [Figure A.13](#)), totaling a 130 MW reduction. Both plants recovered in about 1.5 minutes.

These plants were also involved in the 2021 Odessa Disturbance and entered momentary cessation with plant-level controller interactions that precluded the inverters from returning to predisturbance output in a suitable time.³⁷ In follow-up discussions, the GO stated that the facility had actually turned off momentary cessation in 2019 following the NERC alerts; however, the inverter manufacturer informed the team that at low voltages, these inverters can have inverter power supplies fail (i.e., there are no uninterruptible power supplies). So the options are to perform either of the following:

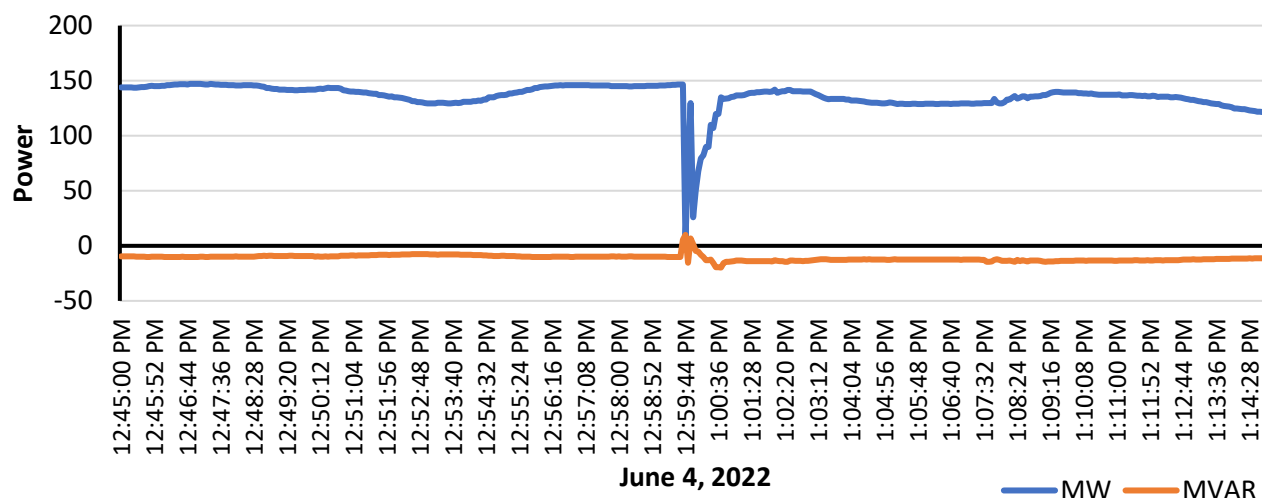
Figure A.14: Plant Active and Reactive Power at POI

- **Inverter DC Voltage Unbalance Tripping (11 MW)**
Three inverters tripped on dc voltage unbalance and remained off-line for 30 seconds.
- **Incorrect Ride-Through Configuration (135 MW)**
All inverters at the facility had low voltage ride-through disabled. Inverters were programmed to provide zero active power during low voltage ride through events (configured to occur below 0.9 pu voltage).
- **Plant-Level Controller Interactions (146 MW)³⁸**
Given that inverter low voltage ride-through was disabled, the plant controller interacted with the inverter response and resulted in abnormal plant response after fault clearing (see Figure A.15). The plant has since corrected the inverter and plant controller settings to mitigate this issue.

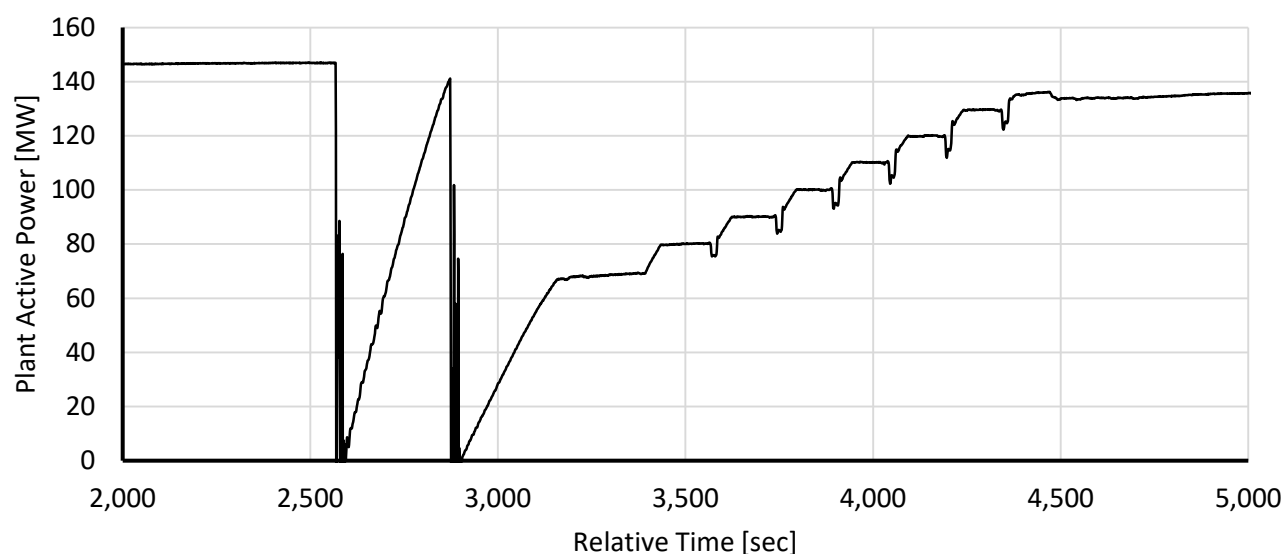
Figure A.15: Plant-Level Controller Interactions

The GO disabled feeder-level overvoltage protection after the *2021 Odessa Disturbance Report* findings were disseminated, which eliminated this risk of tripping. Inverter low voltage ride-through operating modes have been changed from zero active current support to a mode that provides both active and reactive current during faults that is proportional to voltage, which is more aligned with expected performance. Inverter overvoltage protection settings have also been expanded to 1.35 pu with a time duration of 0.5 seconds. The GO enabled low voltage ride-through settings and expects the plant to recover to predisturbance output with no interactions and within 1 second of a fault occurring.

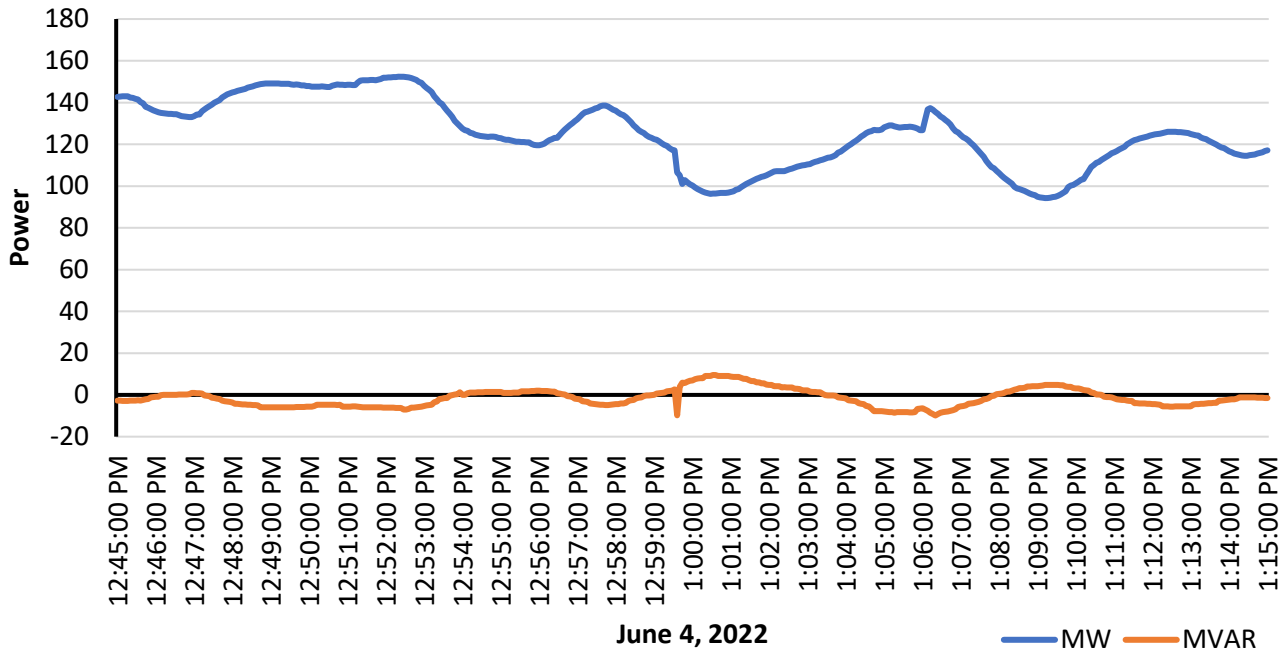
Figure A.18: Plant Active and Reactive Power at POI

Plant P is a 157.5 MW facility connected to the 138 kV network that went into commercial operation in August 2017. Seven inverters tripped due to ac overcurrent protection for a 10 MW reduction (see [Figure A.18](#)). The GO was unable to determine the settings for ac overcurrent since the equipment manufacturer that is now out of business.

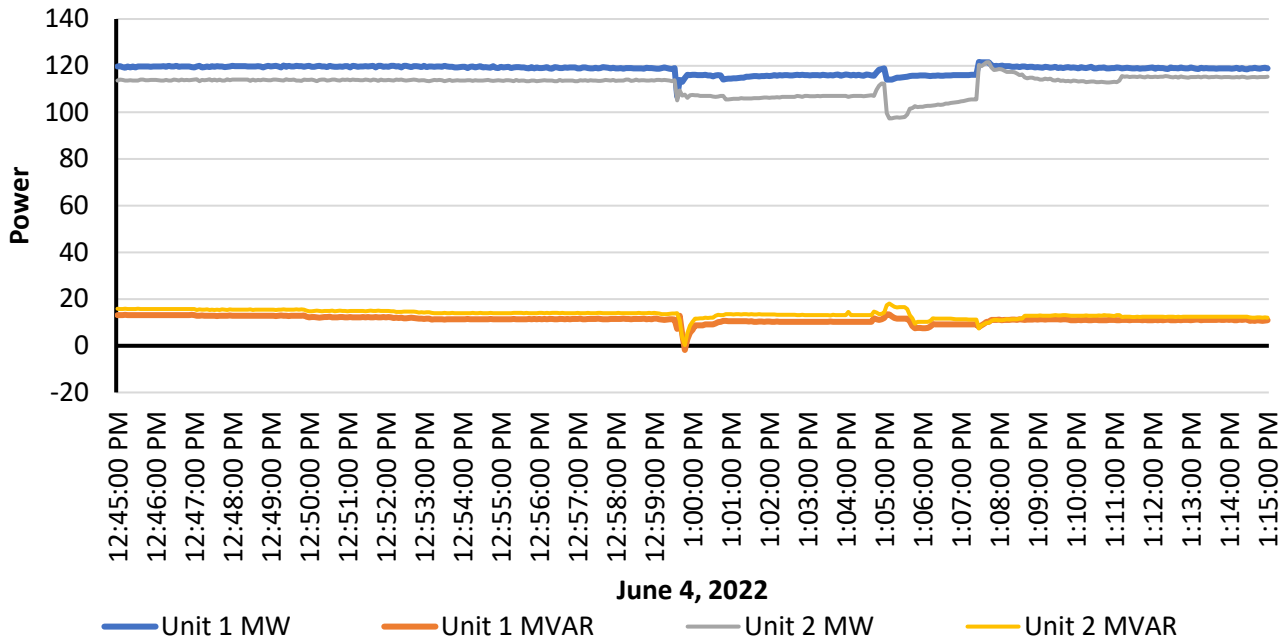
Figure A.19: Plant Active and Reactive Power at POI

Plant Q is a 255 MW facility connected to the 138 kV network that went into commercial operation in December 2020. The plant reduced output by 12 MW (see [Figure A.19](#)), likely attributed to some inverters tripping on ac overcurrent protection; however, information provided by the GO was not comprehensive.

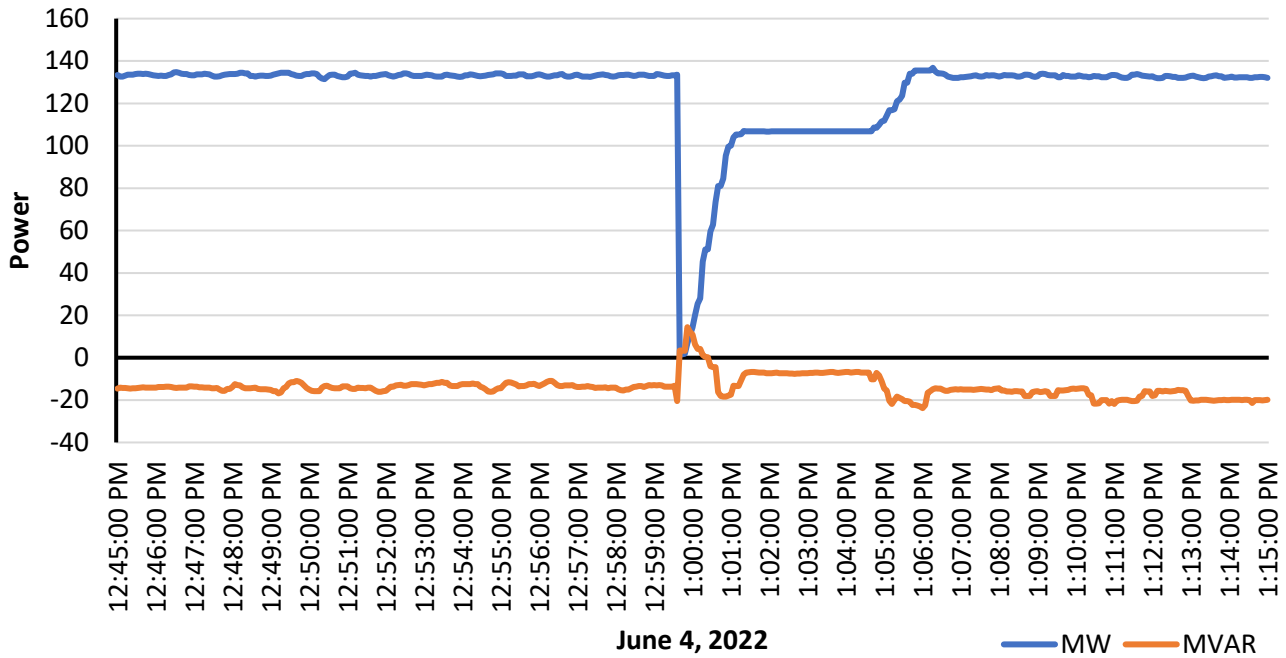
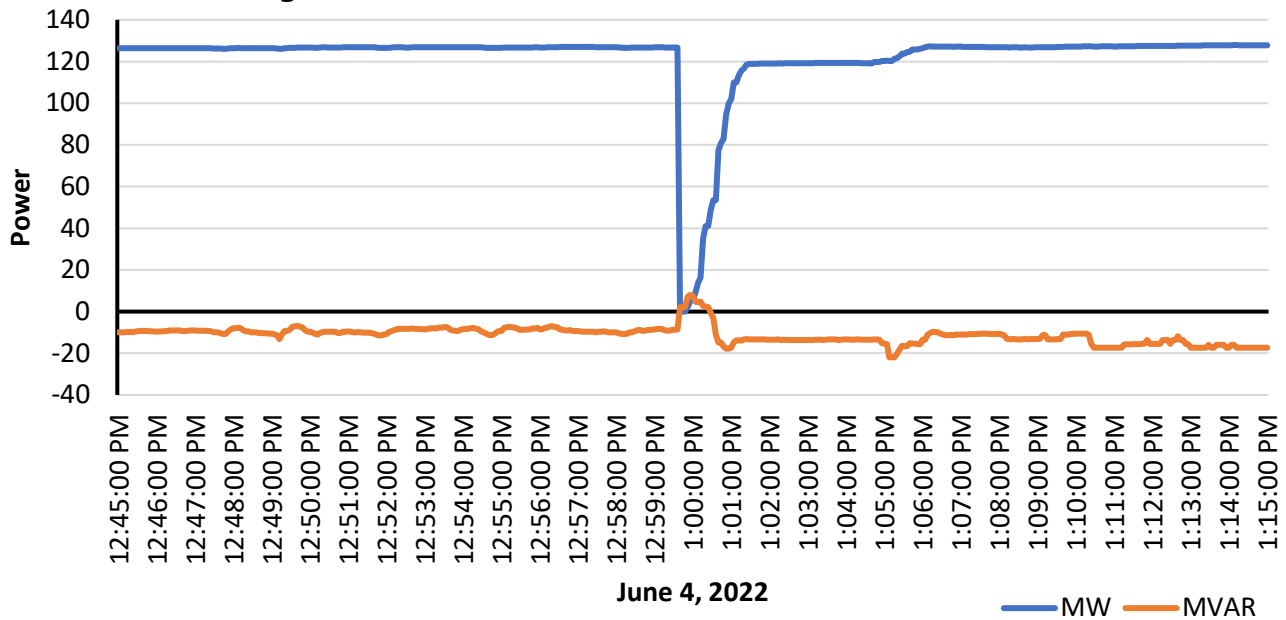
current. Inverters that tripped on the minor fault code began restarting in about 10 seconds and recovered in 1.5 minutes. Inverters that tripped on the major fault code about 5 minutes after the fault and recovered in 6.5 minutes.

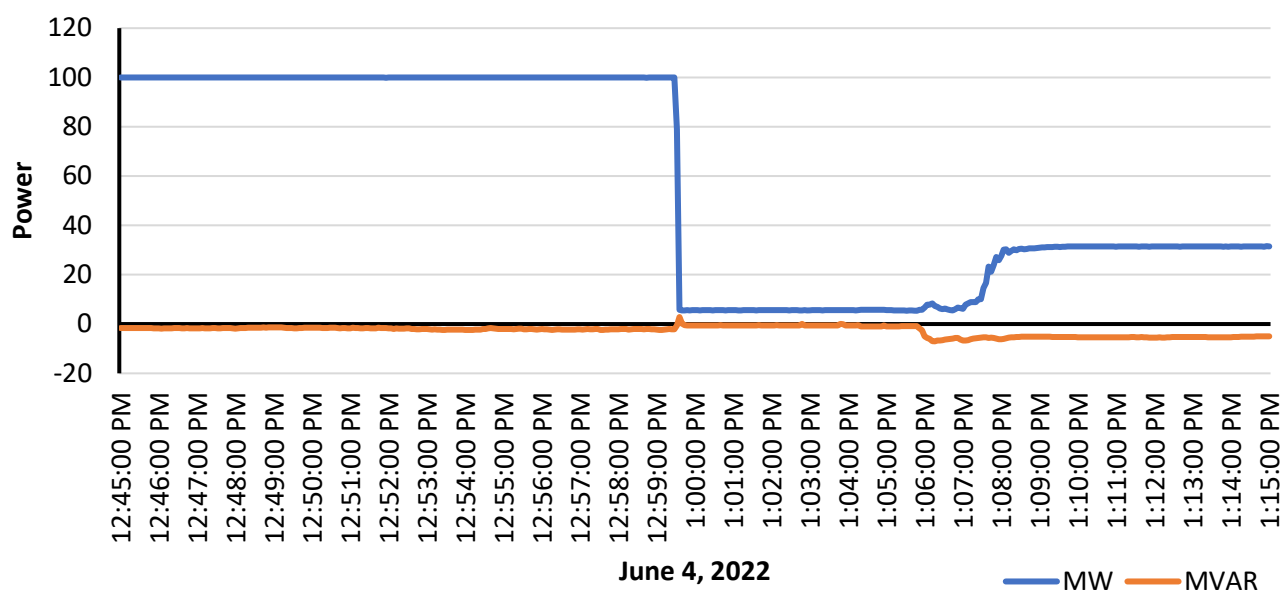
Figure A.22: Plant Active and Reactive Power at POI

Plant S is a 100 MW facility connected to the 138 kV network that went into commercial operation in December 2019. The plant reduced power output by 94 MW when the fault occurred (see [Figure A.22](#)). Tripping was attributed to dc voltage unbalance tripping. Some inverter (68 MW) tripped and remained off-line for an extended period of time due to a major fault code; some inverters tripped on a minor fault code (26 MW) and recovered in about 7 minutes.
