April and May 2018 Fault Induced Solar Photovoltaic Resource Interruption Disturbances Report

Southern California Events: April 20, 2018 and
May 11, 2018

Joint NERC and WECC Staff Report

January 2019

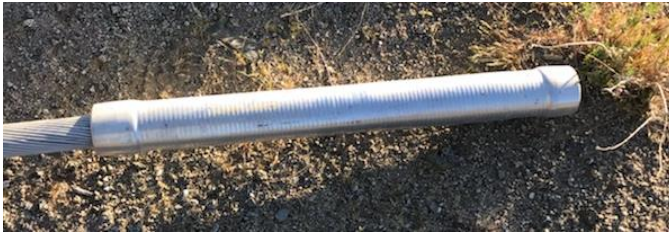
On April 20, 2018, at 17:11:06 Pacific Daylight Time (PDT), a splice failed on a 500 kV transmission line in the SCE footprint, causing the top conductor to fall into the middle phase of a vertically arranged tower structure (see [Figures 1.1](#) and [1.2](#)). The disturbance was coined the “Angeles Forest” disturbance since the fault occurred in the vicinity of the Angeles National Forest but was unrelated to any forest fires. The B-C phase fault was cleared normally within 2.6 cycles. Since the fault involved direct conductor contact, the fault is assumed to be a low impedance line-line fault.

Figure 1.1: Photo of Failed Splice
[Source: SCE]

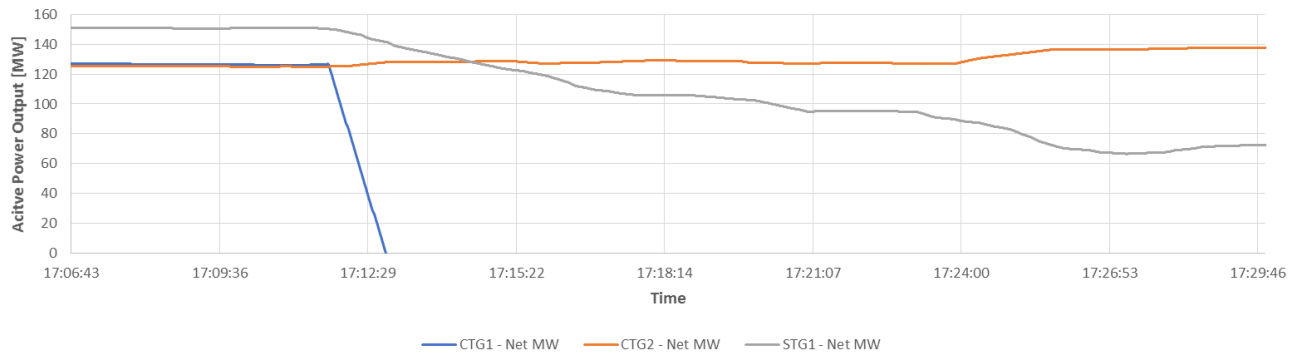
Figure 1.9: Combined-Cycle Power Plant Response to Angeles Forest Disturbance

In addition to the BPS-connected solar PV resource tripping, one natural gas turbine at a 2-on-1 (two natural gas turbines and a steam turbine) combined-cycle power plant located in Kern County in the PG&E footprint tripped off-line due to the fault event. The plant tripped on low fuel gas pressure, causing one natural gas turbine loaded at 125 MW to trip. This subsequently reduced the steam turbine output from 150 MW to 75 MW over the course

of 19 minutes. [Figure 1.9](#) shows the response of the two natural gas turbines and the steam turbine during the disturbance.

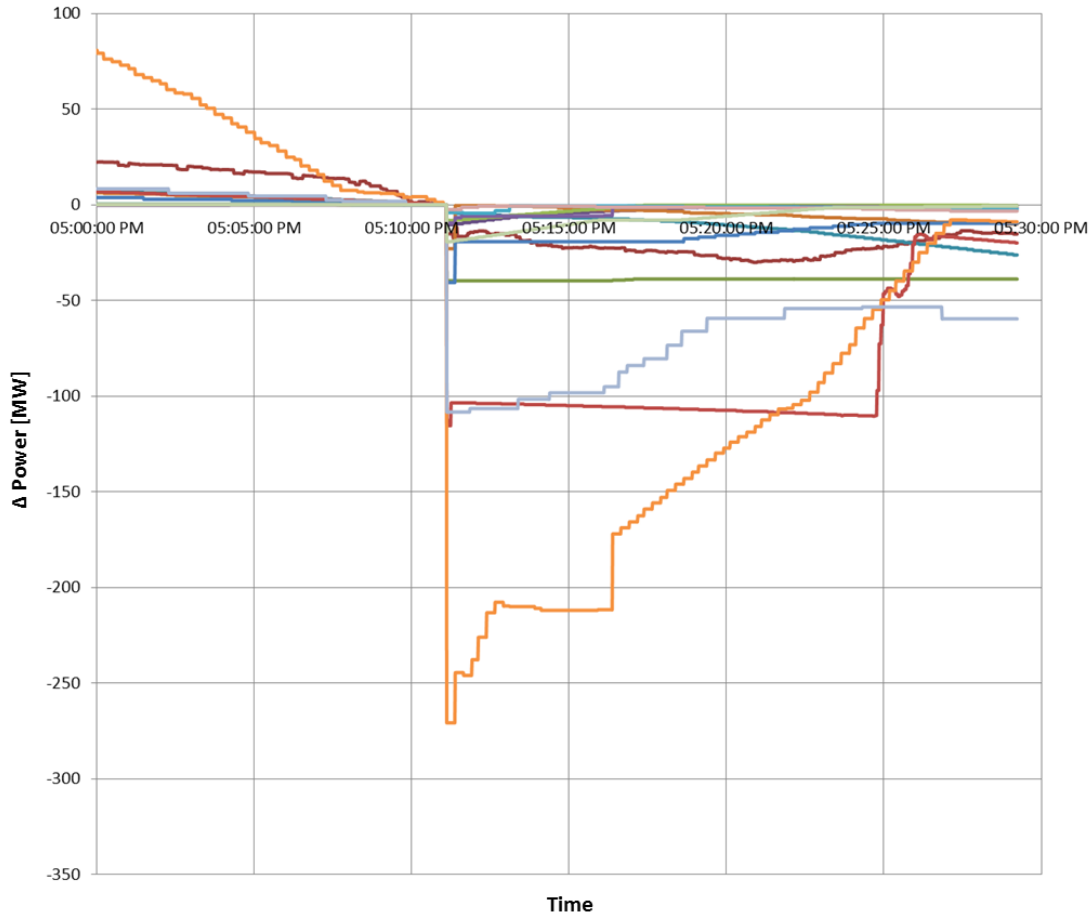
Figure 1.10: Affected Solar PV Facilities (SCADA Data) [Source: SCE]

[Figure 1.10](#) shows the change in active power output (normalized to 0 MW at the time of the disturbance) for individual BPS-connected solar PV resources in SCE that were affected by the disturbance, as an illustration of the varied plant responses. The plot covers 30 minutes of time using SCADA data from SCE. The plot shows that four inverter-based resources constituted the majority of BPS-connected solar PV reduction in the SCE area. Causes of tripping for plants in the SCE area and other areas are discussed in [Chapter 2](#).

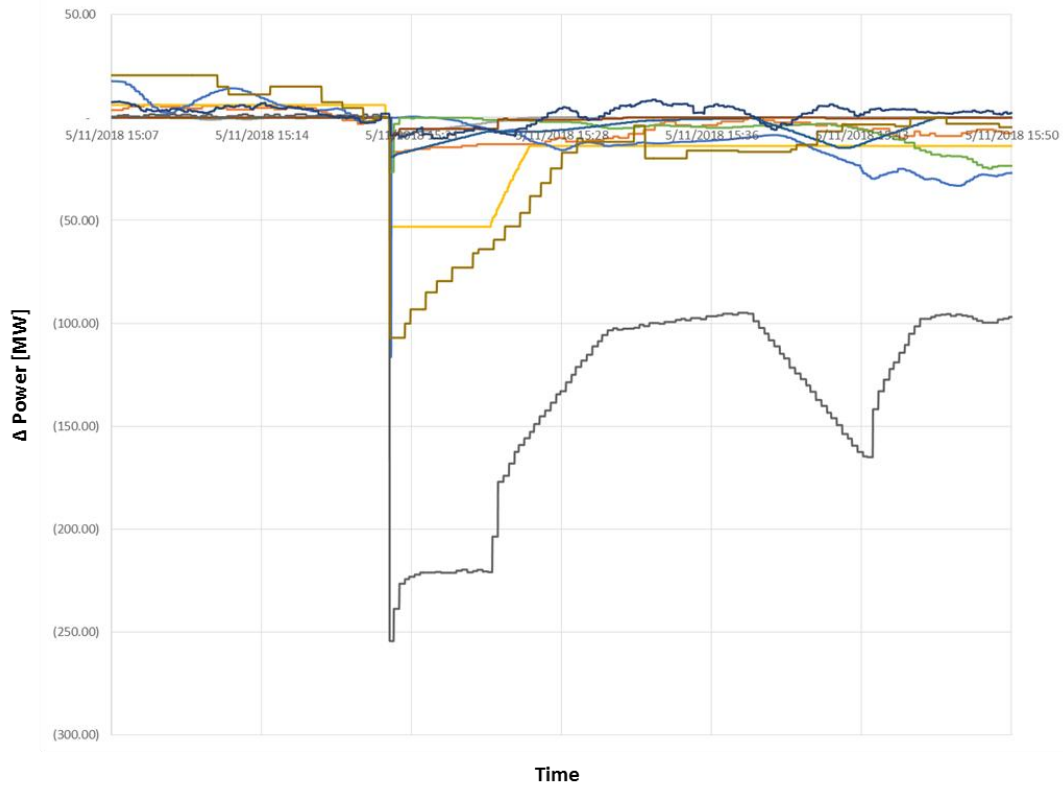
Figure 1.18: Affected Solar PV Facilities (SCADA Data) [Source: SCE]

Figure 1.18 shows individual BPS-connected solar PV resources that were affected by the disturbance, and their change in active power output from the time of the disturbance (normalized to 0 MW for unit prior to the disturbance). The plot covers 43 minutes of time by using SCADA data from SCE. The plot shows that three inverter-based resources constituted the majority of BPS-connected solar PV reduction in the SCE area. The causes of tripping are discussed in Chapter 2.

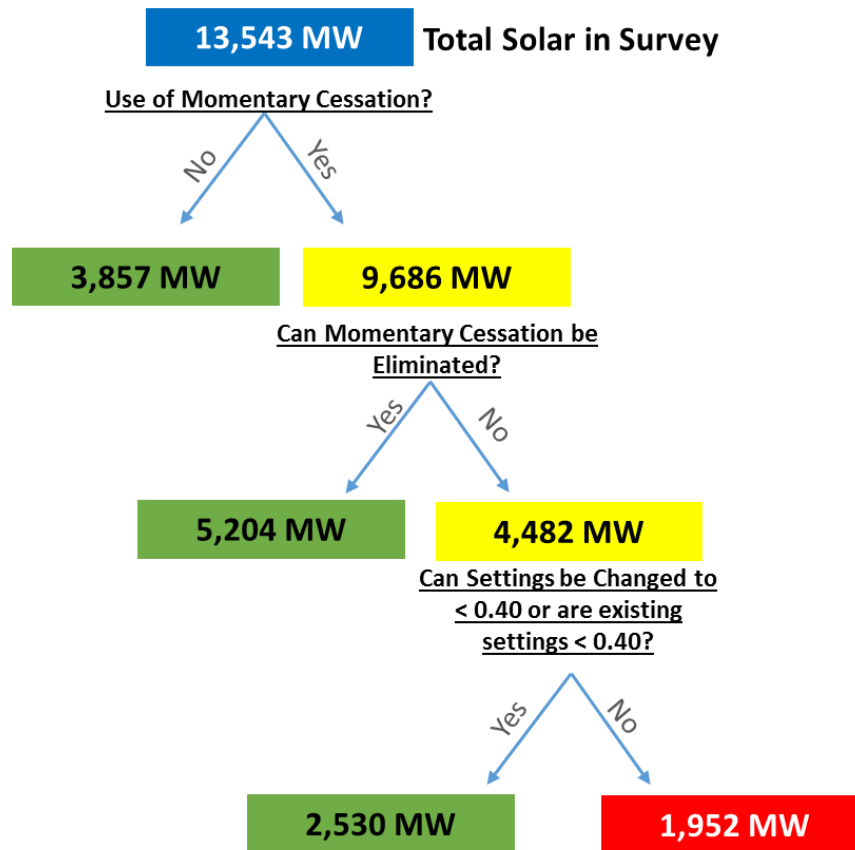
Figure 2.1: Data Collected Related to Momentary Cessation

Many plants involved in both the Angeles Forest and Palmdale Roost disturbances exhibited momentary cessation caused by inverter terminal voltage falling below specified low voltage threshold values for each facility. The NERC Alert¹³ following the Blue Cut Fire recommended that any recovery from momentary cessation should occur within five seconds, which was attributed to ensuring frequency stability for widespread loss of active power by solar PV resources. This recommendation was modified in the NERC Alert¹⁴ following the Canyon 2 Fire disturbance. That recommendation stated that GOs should work with their inverter manufacturer(s) to identify changes consistent with equipment capability that can be made to eliminate momentary cessation to the greatest possible extent. For inverters where momentary cessation cannot be eliminated entirely (i.e., by using another form of ride-through mode), GOs were recommended to identify changes that can be made to momentary cessation settings that result in the following:

Momentary cessation continues to be an issue during disturbances. Many momentary cessation settings have not been widened from above 1.1 per unit or below 0.9 per unit voltage. The NERC Alert issued on May 1, 2018, and the Canyon 2 Disturbance Report includes three recommendations that address momentary cessation—recommendations 1a, 1b, and 2.

GOs, in coordination with their inverter manufacturer(s), should implement the recommended changes to inverter settings and performance as outlined in the NERC Alert following the Canyon 2 Fire disturbance. TPs and PCs should be following up with applicable GOs to ensure that these changes are being made and that models are being updated accordingly to accurately reflect the dynamic behavior of solar PV resources connected to the BPS.

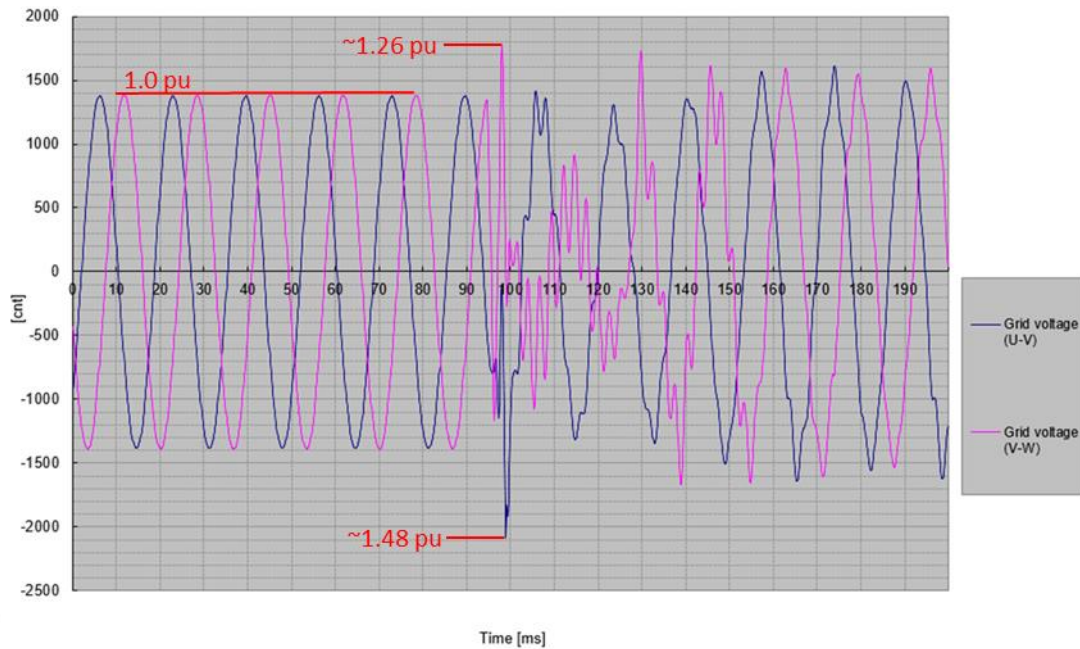
Figure 2.4: Transient Sub-Cycle AC Overvoltage at Inverter Terminals

Key Finding #3: Inverter tripping on transient sub-cycle ac overvoltage continues to be an issue. In some cases, this ac overvoltage causes dc reverse current in the inverter, and the inverters may exhibit a fatal error code that requires manual reset at the inverter.

A number of solar PV plants, particularly with one inverter manufacturer, exhibited tripping on transient sub-cycle ac overvoltage. [Figure 2.4](#) shows a high-speed recording from one of the inverters that tripped. The inverter experiences sub-cycle spikes in voltage, particularly during the on-fault conditions (fault inception and fault clearing). Immediately after the fault, the voltage waveform is still somewhat distorted and a slight root-mean-square overvoltage persists. It is unclear, due to lack of time synchronization and data logging resolution, what part of the waveform actually initiated the tripping. However, note that the ac overvoltage instigates the opening of the inverter ac circuit breaker. This does not occur until after the BPS fault is already cleared.

Transient ac overvoltage may also lead to inverter tripping on dc reverse current. Inverters have anti-parallel diodes across the insulated-gate bipolar transistors (IGBTs), or switches in the power electronics, to mitigate voltage spikes during switching. During normal operation, the inverter balances the ac voltage so as to keep the potential higher on the dc side. Normally, this is not a problem because the maximum ac voltage the inverter can generate is sufficiently lower than the field dc voltage; thus current can flow out to the grid. However, ac transient overvoltage may cause the ac voltage to be greater than the dc voltage. This can lead to current flowing into the dc bus and PV arrays. UL Std. 1741¹⁵ includes a testing requirement that any reverse current should not exceed the manufacturer’s specification for maximum reverse current. The maximum dc reverse current specification depends on the inverter and is specified by the manufacturer. However, it does not specify a maximum duration and provides sufficient design flexibility that it should be feasible for inverters to not trip due to reverse current during transient ac overvoltages.

Recommendation #3: GOs should work with their inverter manufacturers to set transient ac overvoltage protection as wide as possible while still protecting the integrity of the inverter and associated equipment. GOs should also coordinate with their inverter manufacturer to ensure that dc reverse current detection and protection are set to avoid tripping for dc reverse currents that could result during sub-cycle transient overvoltage conditions since these are not likely to damage any equipment in the plant.

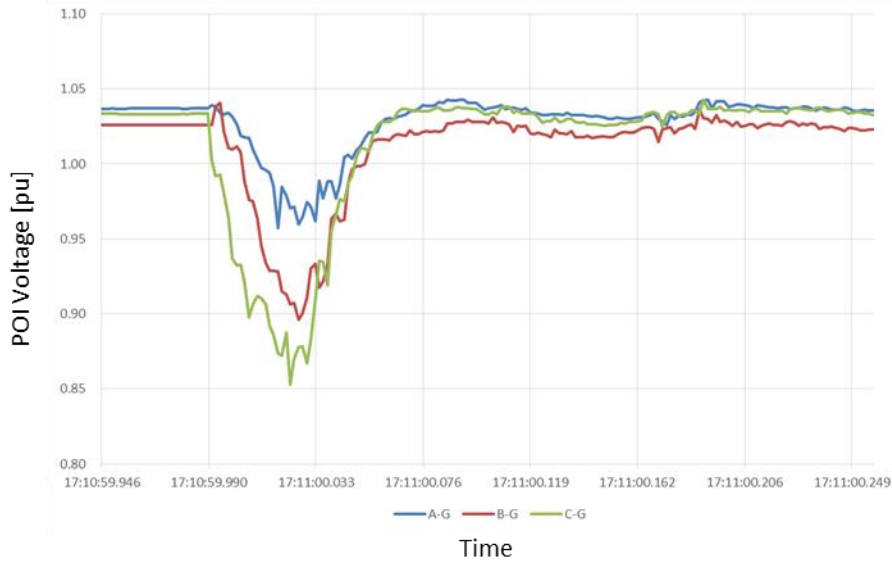
Figure 2.7: POI Voltage for Plant Reporting Low Voltage Tripping

There is a clear difference between observed voltage conditions at the individual inverter terminals and at the POI, yet insufficient data from local inverters continues to hinder comprehensive analysis to identify a root cause.

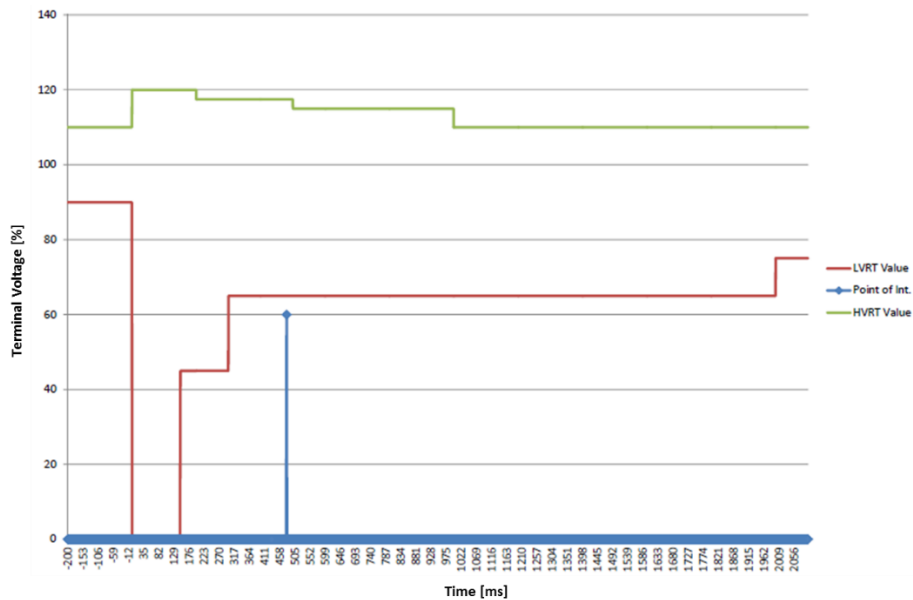
Figure 2.8: Illustration of Inverter Terminal Voltage versus PRC-024-2 Voltage Curve

Key Finding #5: Vastly different voltage conditions have been observed during grid disturbances between the individual inverter terminals and the point of interconnection (POI). Many existing inverters are programmed with the PRC-024-2 curve settings and do not account for differences between inverter terminal conditions and the POI. This leads to a susceptibility for inverter tripping and does not meet the intent of PRC-024-2.

The GO for the plant described in the preceding sub-section stated that the observed local inverter terminal voltage conditions fell outside the PRC-024-2 low voltage curve, and that was the reason for inverter tripping. The GO provided an illustration of these conditions (see [Figure 2.8](#)), showing the programmed inverter voltage protective settings and the cumulative voltage observed for inverters 5-8.

Recommendation #5: GOs should be performing analyses for each installation to correctly set inverter protective functions such that all inverters within a facility will not trip for any voltages seen at the POI within the “No Trip” zone of Attachment 2 of PRC-024-2. Setting the inverter protection settings to match the PRC-024-2 curve is not a recommended practice as it does not consider the vastly different voltage conditions that may be experienced at the inverter terminals relative to the POI voltage (as has been observed in multiple disturbances analyses).

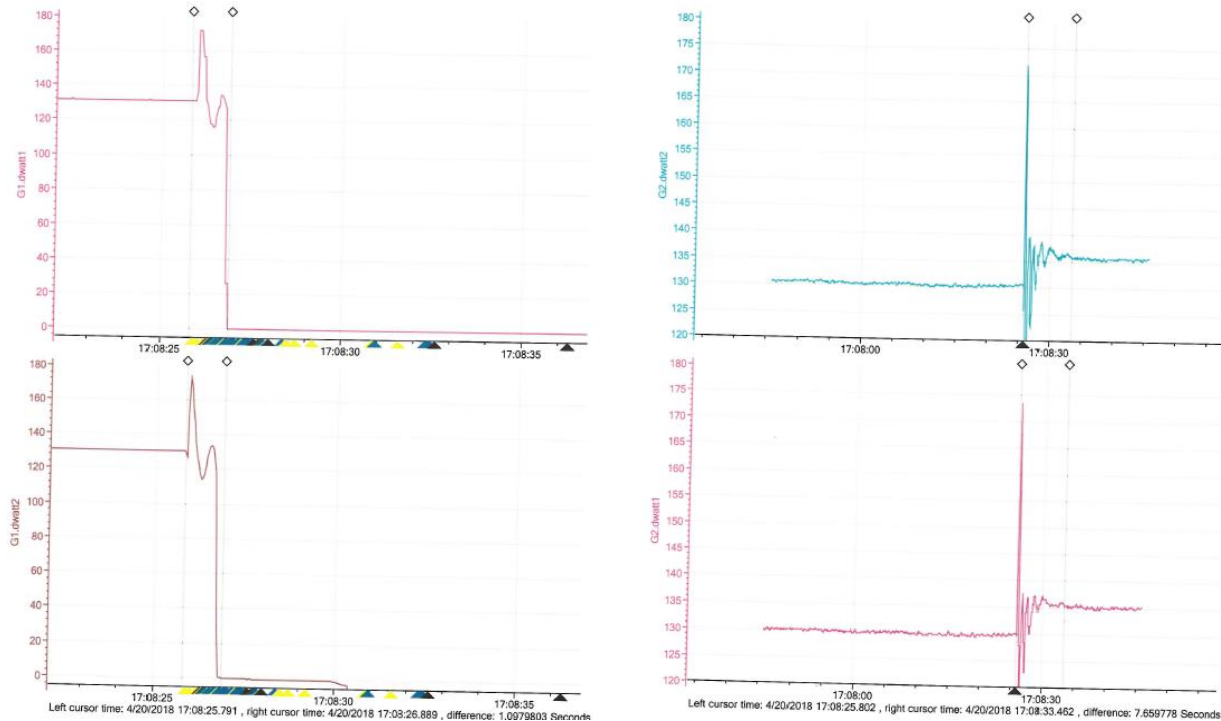
Figure 2.16: Gas Turbine Responses at Tripped Combined-Cycle Plant

Key Finding #9: The combined-cycle power plant tripped due to low fuel gas pressure as the turbine control system attempted to readjust the number of burners used as the plant initiated a runback of active power output. One CT tripped, causing the steam turbine to also reduce output over many minutes.

power output signals “failed.” When both power output signals are failed simultaneously, the turbine control system initiates runback to a safe operating level (16 MW, in this case). This reduced output results in the turbine control system decreasing the number of burners being utilized in the turbine combustor, which results in the burners actually being required to pass more fuel than when the unit is at full load. The turbine control system determined that the fuel pressure was too low to sustain the required natural gas flow through the reduced amount of burners being utilized at the lower output level. The turbine control system then initiated a low fuel pressure trip.

Recommendation #9: The GO for this facility should coordinate with the turbine manufacturer to ensure that the turbine controls are correctly tuned to be able to ride through BPS fault disturbances.
