Lesson Learned Transmission Relaying – Removing Unused Components

Lesson Learned #:

20110805

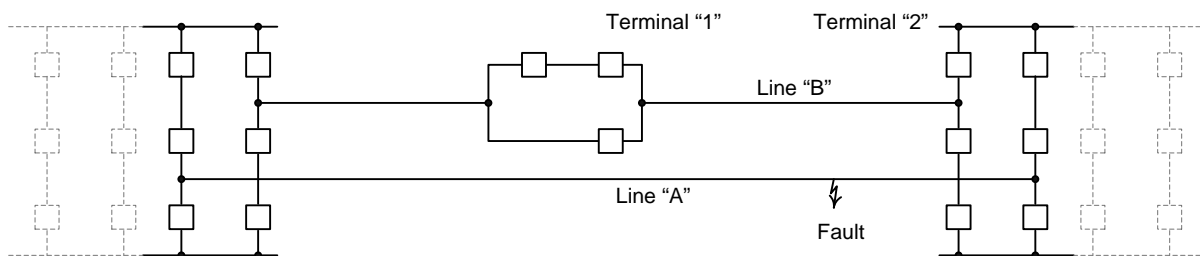
A high impedance phase to ground fault occurred on line “A.” The fault was cleared with high speed relaying. During the fault, terminal “1” of line “B” upstream from the faulted line tripped. Analysis indicated that the Primary relay at terminal “1” properly sent the permissive overreaching transfer trip (POTT) signal. However, the Primary relay at terminal “2” at the opposite end of line “B” did not properly sense the fault in the reverse direction, so it echoed the POTT signal back to terminal “1.” Upon receiving the signal, terminal “1” of line “B” tripped.

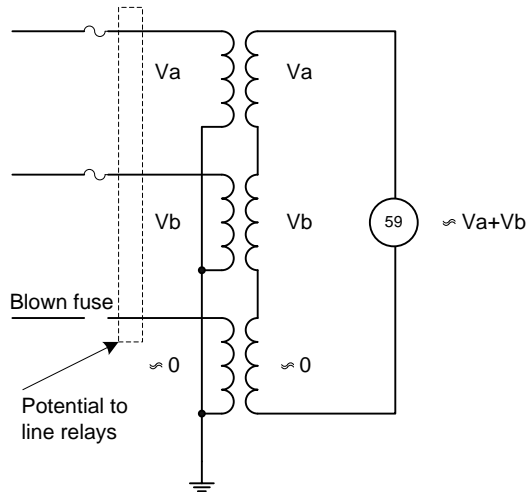
Original circuit – when a fuse blows, the overvoltage relay would see a voltage across it and alarm

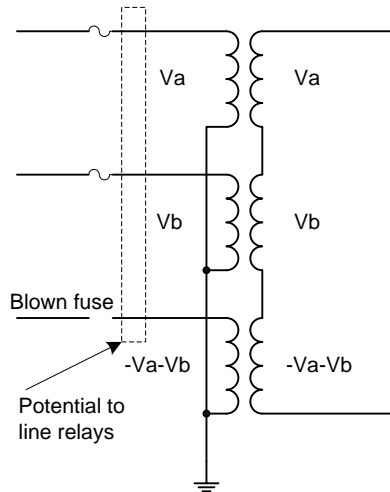
Inspection found a blown potential fuse (on the same phase as the fault) feeding the line “B” Primary relay at terminal “2.” The blown fuse should have been sensed as a loss of potential condition and caused a station alarm but this did not occur. Further analysis determined that a backfeed condition was occurring on the relay potential, keeping the relay potential at normal voltage even when the fuse was removed. The source of the backfeed was from an unneeded set of “wye - broken delta” auxiliary potential transformers (PT). The broken delta PTs had been used to supply an overvoltage relay used to detect a loss of potential condition. This relay was no longer required because the loss of potential logic was accomplished in the digital relay. When the digital relays were put in service, the overvoltage relay was removed. However, the auxiliary PTs were not

removed and the broken delta side of the auxiliary PTs was incorrectly shorted. The shorted broken delta winding was the source of the undesired backfeed. This backfeed combined with the blown PT secondary phase fuse, caused the “B” line Primary relay at terminal “2” to sense the fault improperly. Refer to the figures below showing the auxiliary PTs.

Potential circuit with aux. PTs shorted – when a fuse blows, voltage backfeeds to the line relays

The auxiliary PTs were removed from the circuit. The entity then performed random spot checks to ascertain that this design problem was an isolated incident. They later reviewed their AC schematics for all recently replaced line relaying to ensure this problem did not exist anywhere else on the system.
