Lesson Learned

Insulator Flashovers Due to Combination of Salt Spray Deposits Followed by Light Rainfall Initiating Loss of Load

Lesson Learned #: 20210801

Date Published: August 6, 2021

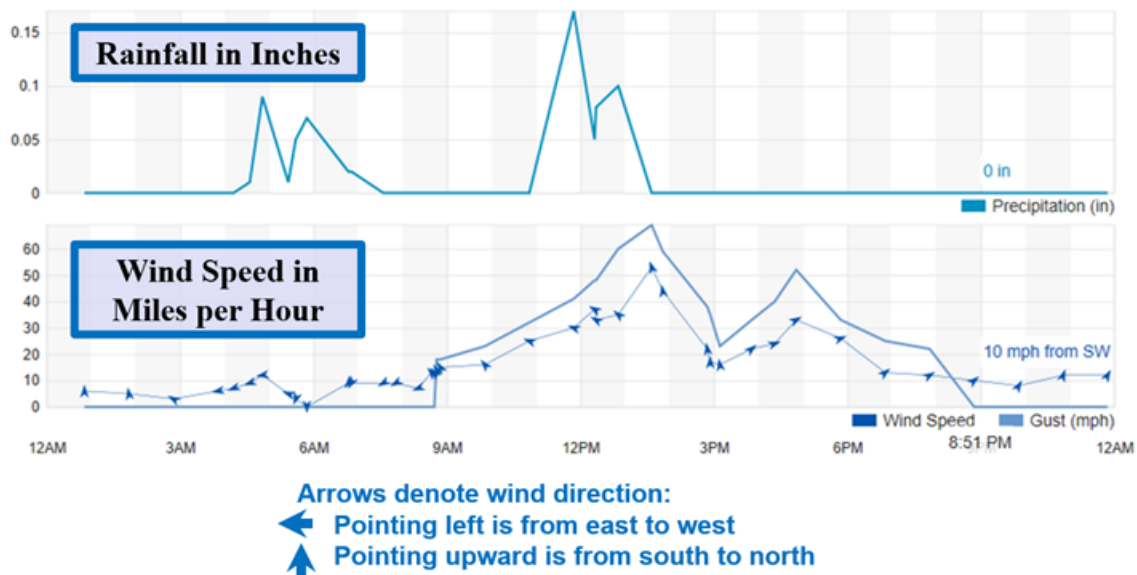
Figure 1: Rainfall, Windspeed, and Wind Direction During Tropical Storm

A tropical storm brought high winds of more than 50 miles per hour and moderate rainfall of one-half inch over the course of several hours (see [Figure 1](#)) by the meteorological data from a nearby weather station.

The rainfall ceased in the early afternoon as the winds were peaking. Around 3:00 p.m., the wind direction shifted. A second period of elevated winds ensued in the absence of any rain, although somewhat lesser than the first. The wind shift coincided with the time of high water in the saltwater channel bordering the substation, about one hour later than the time of the usual astronomical high tide on account of the storm surge. The alignment of wind direction and high water caused airborne salt spray above the churning water in the channel to be carried over the waterfront substation and deposited on surfaces therein, including insulators. Without any further rain to wash the deposits off, a thin, dry salt film remained.

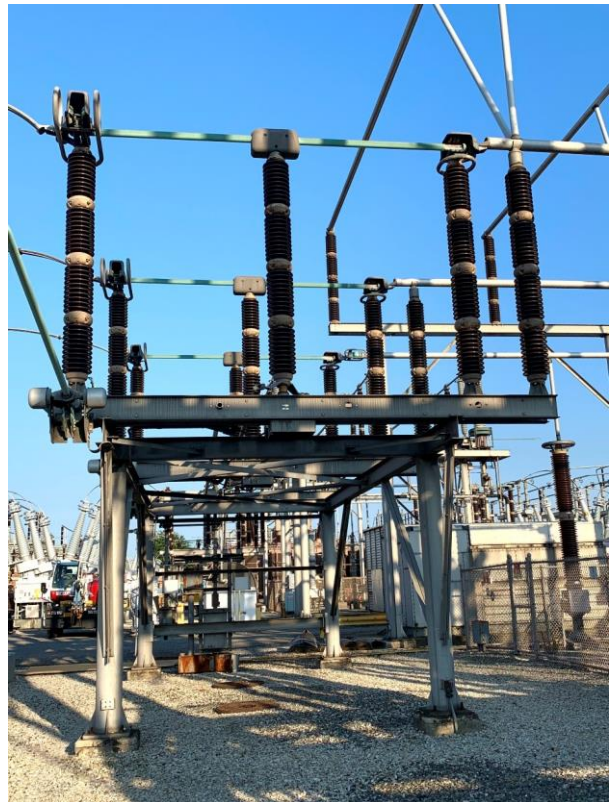
Figure 2: 345 kV Disconnect Switch w/Center-Pivot Horizontal Swing Arms

All four of the insulator columns that flashed over were double-stack vertical columns supporting 345 kV horizontal swing-arm disconnect switches. One is shown in [Figure 2](#).

The single-stack center column supports the swing arm at its pivot point. The double-stack arrangement is visible on the righthand side. One column supports the righthand jaw of the switch assembly while the immediately adjacent column supports the overhead bus work.

The wetting of the insulators during the initial minutes of rainfall caused elevated leakage currents to flow along the insulator surfaces. This is referred to as the critical wetting period. The heat generated from these currents sufficed to burn off the salt film that had been deposited by the tropical storm winds two and a half days prior. This resulted in uneven voltage gradients top-to-bottom along the columns with highly concentrated electric fields in the areas where the film had been burned off. Dry band arcing ensued in these areas. While this in itself is not an uncommon phenomenon, the fact that it was developing simultaneously on two adjacent columns within close proximity, likely at different points of elevation along the columns, significantly increased the probability that the arcing would lead to an overall top-to-bottom flashover. Uneven top-to-bottom voltage gradients on each column resulted in a voltage gradient between or across the two columns at any given height, whereas ideally there should be none. The dry band arcing on one column had the opportunity to cross over and meet up with the dry band arcing on the adjacent column.

Damage to the insulators was minimal due to the arcing being essentially external along the surfaces. As the rainfall progressed, the salt film was washed off the surfaces, allowing the equipment to be restored to service. In fact, most of the transmission facilities and all the load were restored within 33 minutes.

The substation where the faults occurred has been in service for 56 years and has never experienced simultaneous column insulator flashovers. None of the other waterfront substations of similar design in the entity's service territory have experienced this type of problem. Tempered by that long experience, the entity has opted for a measured response. Leakage current detectors are being installed on selected insulator columns so that the phenomenon can be tracked and trended over time during a variety of weather conditions. If any issues are identified, a mitigation plan will be formulated at that time.
