NORTH AMERICAN ELECTRIC
RELIABILITY CORPORATION

Hurricane Harvey Event Analysis Report

March 2018

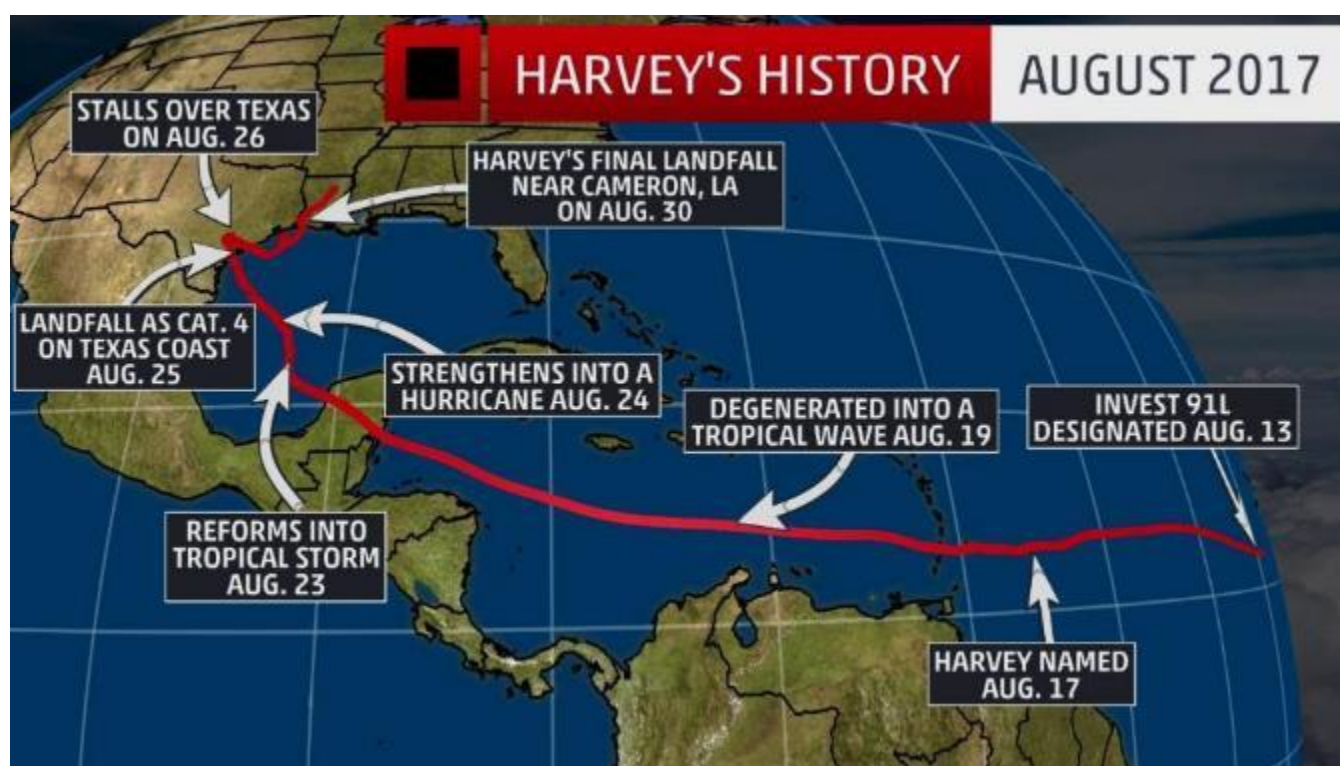
Figure 1.1: Hurricane Harvey Storm Track, August 2017

Hurricane Harvey began as a tropical wave that emerged from the African coast in early August (see [Figure 1.1](#)). The disturbance formed into Tropical Storm Harvey east of the Lesser Antilles on August 17. Those islands experienced heavy rain and gusty winds as Harvey passed through. A couple of days later, Harvey weakened to a tropical wave due to dry air and unfavorable winds in the Eastern Caribbean, and the National Hurricane Center ceased advisories on August 19.

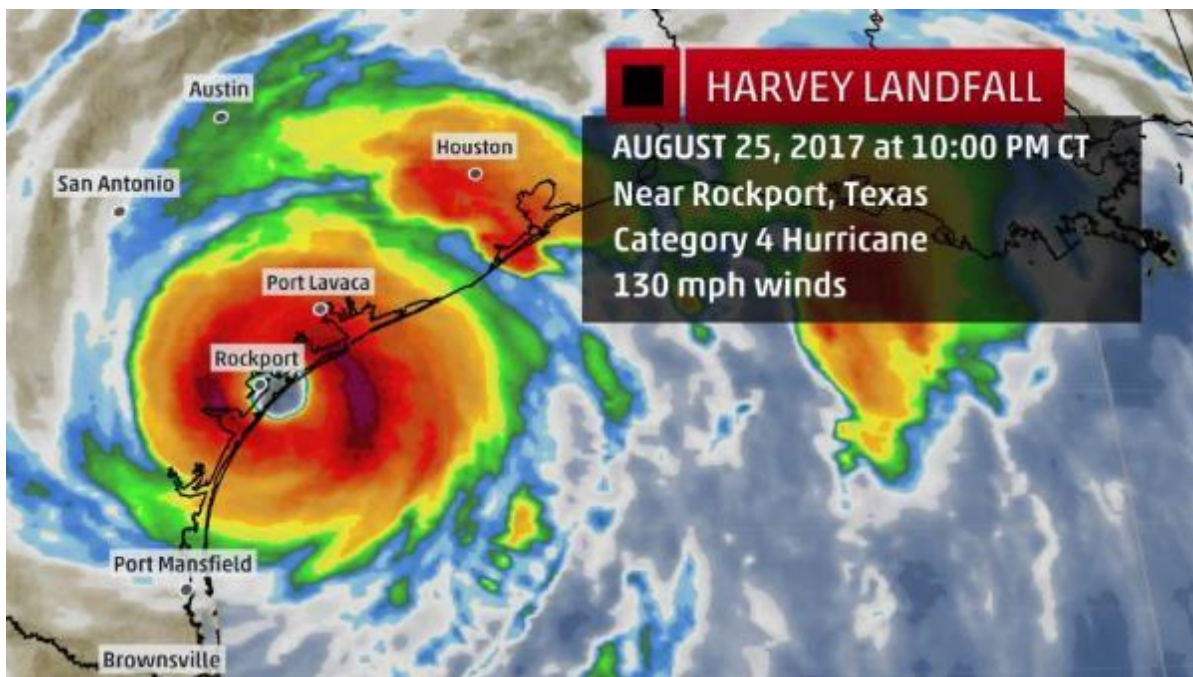
Figure 1.2: Hurricane Harvey at Landfall, August 25, 2017 at 10:00 p.m.

According to the National Oceanic and Atmospheric Administration/Atlantic Oceanographic and Meteorological Laboratory (NOAA/AOML), Harvey's minimum surface pressure of 938 millibars at landfall tied it for the 16th lowest pressure hurricane on record to make landfall in the United States. Harvey was also the strongest hurricane by pressure to make landfall in the United States since Rita in 2005 (see [Figure 1.2](#) and [Figure 1.3](#)).

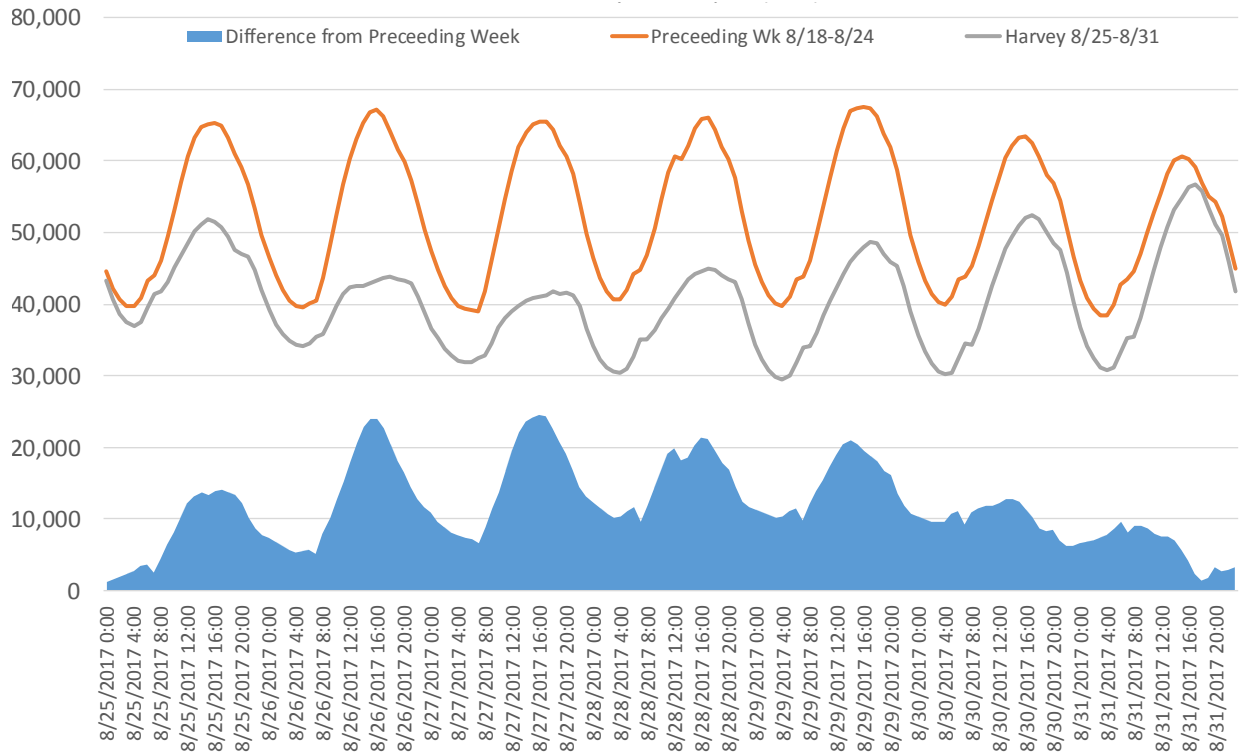
Figure 7.2: ERCOT System Load, August 25-31

ERCOT demand during the storm period was approximately 15,000–20,000 MW lower than was typically observed during August due to the cloudy and cooler temperatures as well as the number of customer outages experienced in the storm impact areas (See [Figure 7.2](#)).

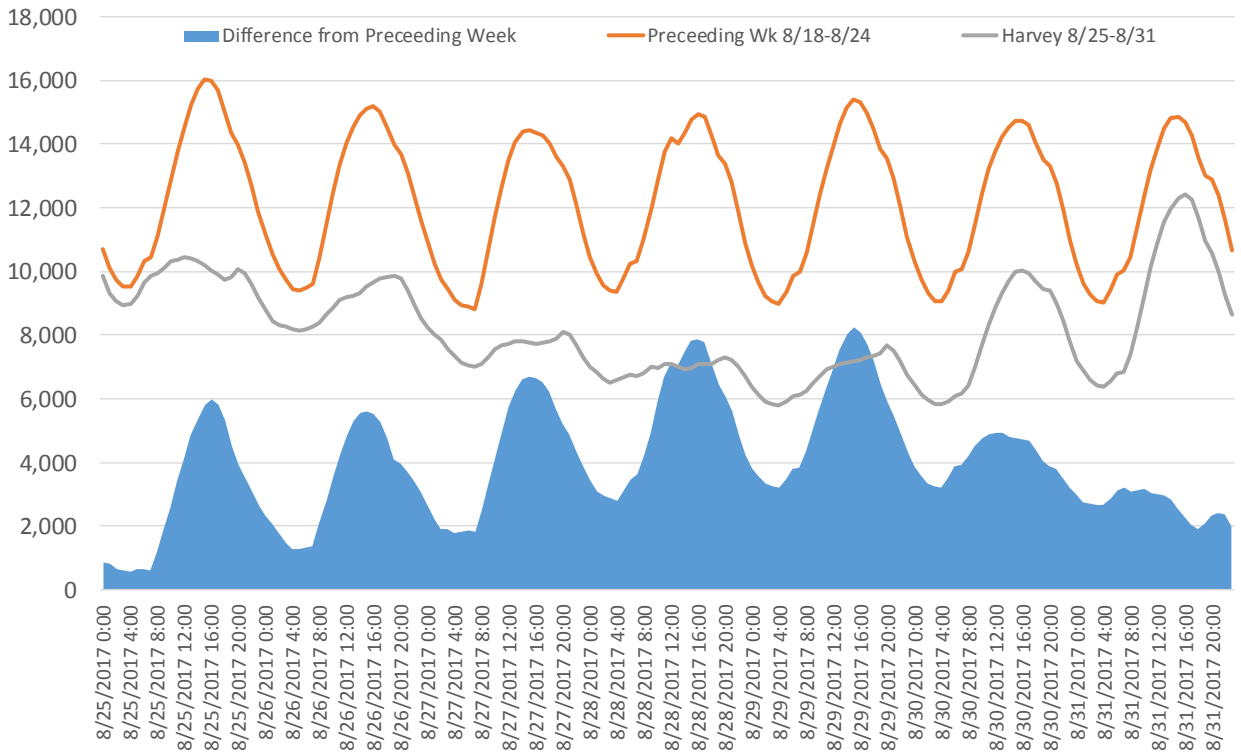
Figure 7.3: Houston Area Load, August 25-31

Demand in the Houston area was 3,000–5,000 MW lower than normal (See [Figure 7.3](#)).

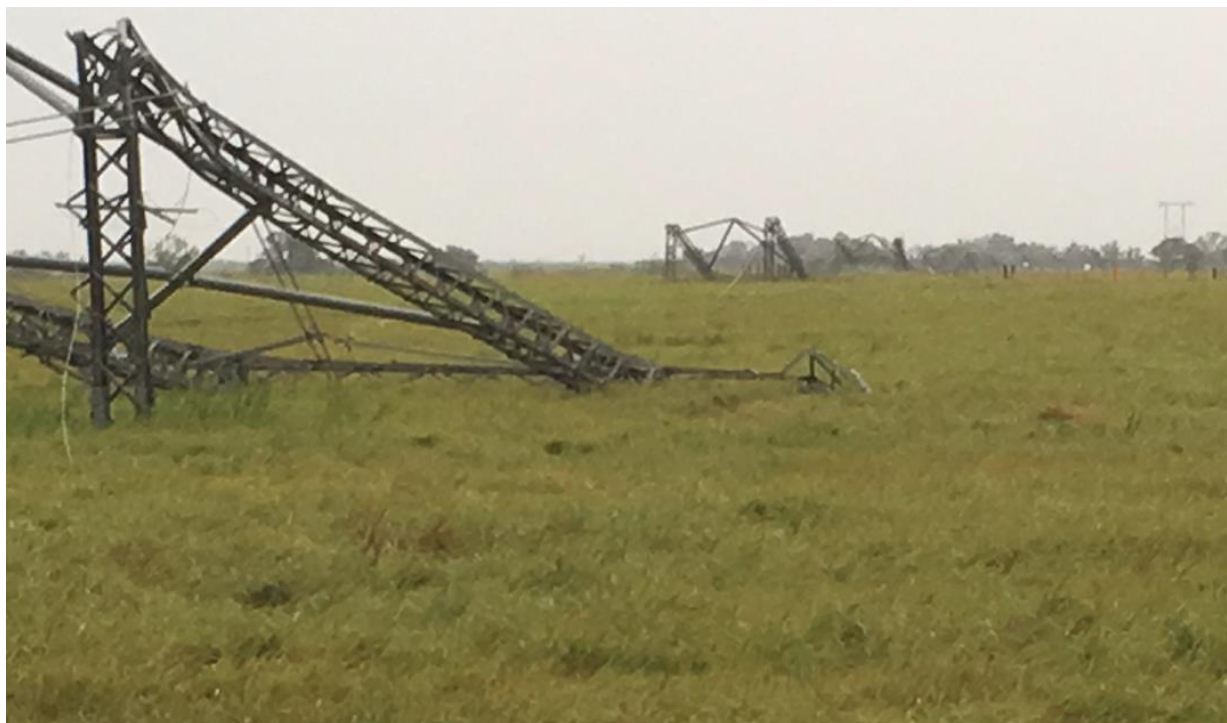
In the Corpus Christi, Port Aransas, and Victoria areas, hurricane force winds and tornados damaged over 800 transmission line structures. The vast majority of these were wood poles. High winds also damaged cooling towers at several power plants. Utilities worked with federal and state agencies to prioritize the restoration of critical transmission facilities and feeds to refineries and petro-chemical plants in particular. Over 95 percent of the transmission lines and substations were returned to service by September 8.

Figure 10.3: 345 kV line structures down

- **System resiliency:** The vast majority of damaged transmission line structures were wood poles. Utilities should review design criteria and construction methods and consider “hardening” transmission lines in hurricane zones in order to reduce or limit the damage caused by hurricane-force winds.

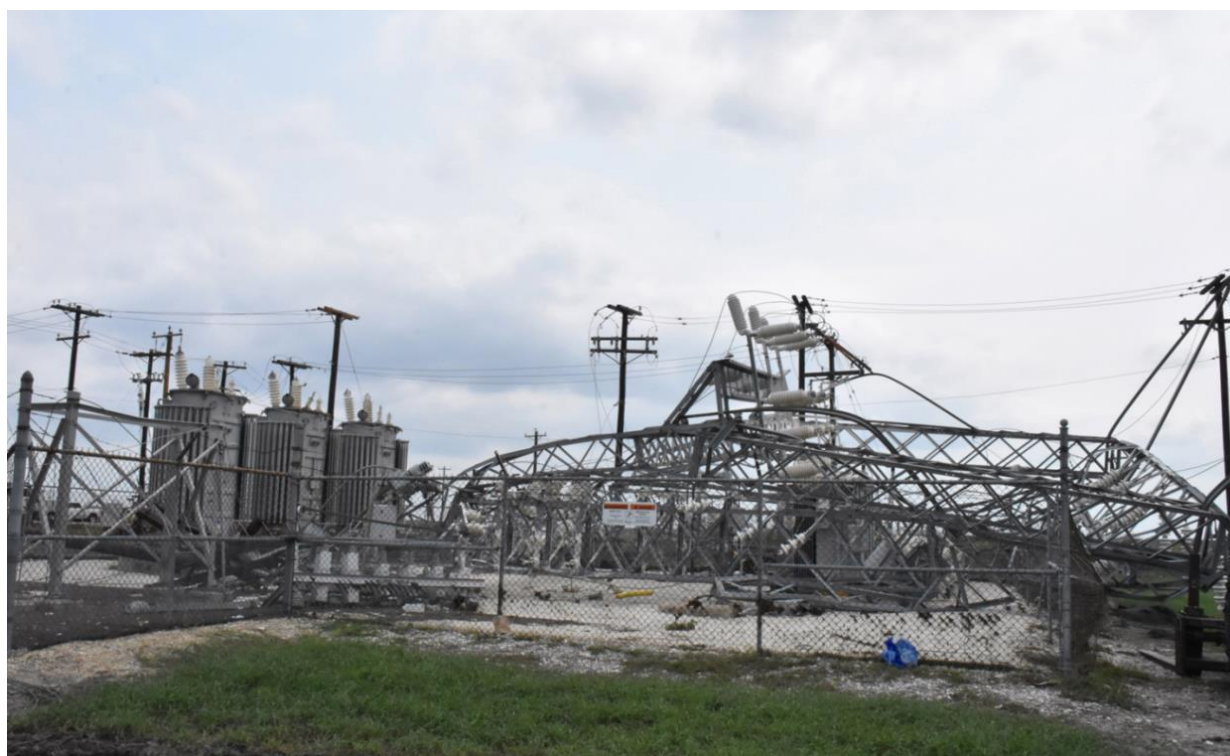
Figure 10.4: 69 kV substation structure damage

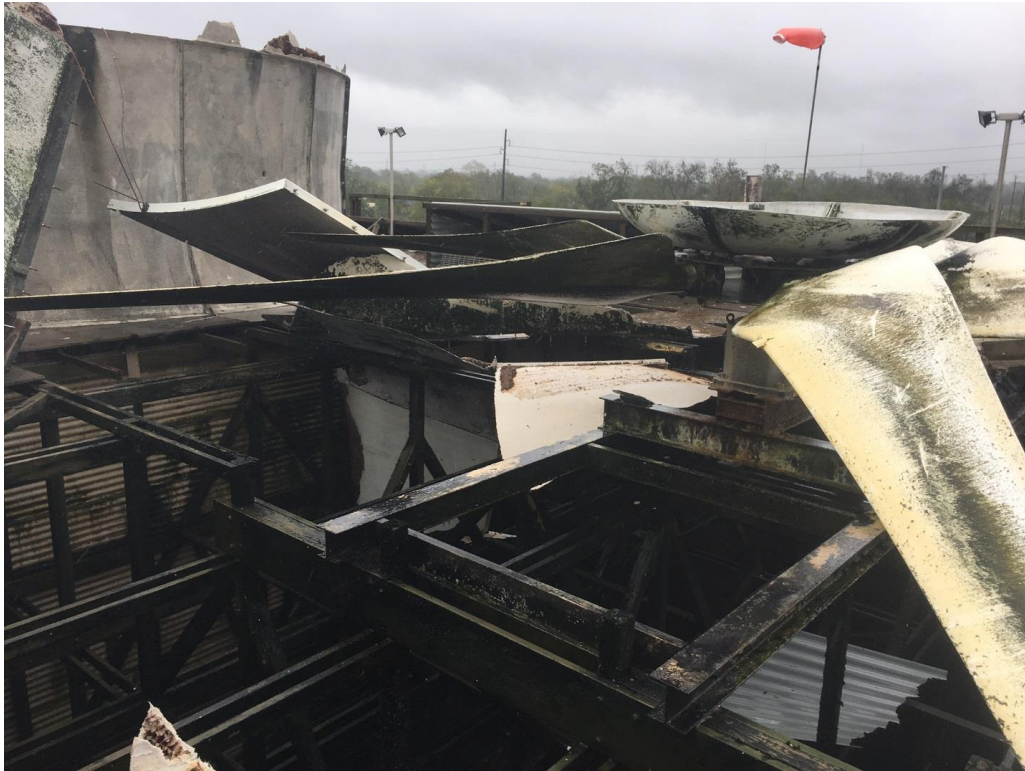
- One generation facility suffered extensive damage to its cooling tower fan deck from high winds. All the fan cylinders, most of the fan blades and much of the decking and support for decking were damaged or destroyed. Units were returned to service on November 15.
- One generation facility suffered site-wide flooding damage to waste water treatment facilities, gas turbine controls, batteries, relays and administration building. Its expected return to service is the end of May 2018.

Figure 10.5: Damaged power plant cooling tower fan deck

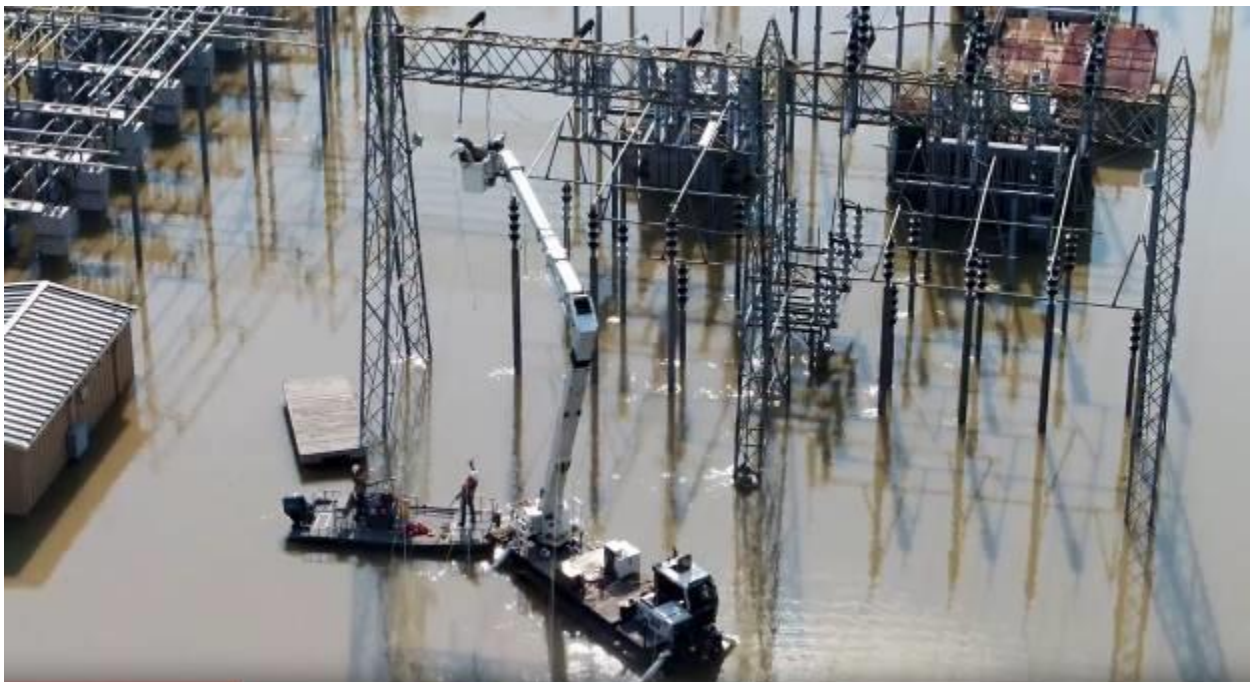
In Houston and Southeast Texas areas, the unprecedented flooding created severe challenges. Substations and power plants experienced damaged equipment due to high flood waters. Several transmission line structure foundations were washed out. Substations had to be de-energized, reconfigured, or bypassed due to flooding. A mobile substation was used in one location when the existing substation was flooded. Areas were inaccessible for extended periods, delaying restoration activities. High water vehicles and boats were used to access some areas. All transmission lines and substations were returned to service by September 13.

Figure 10.6: Flooded substation

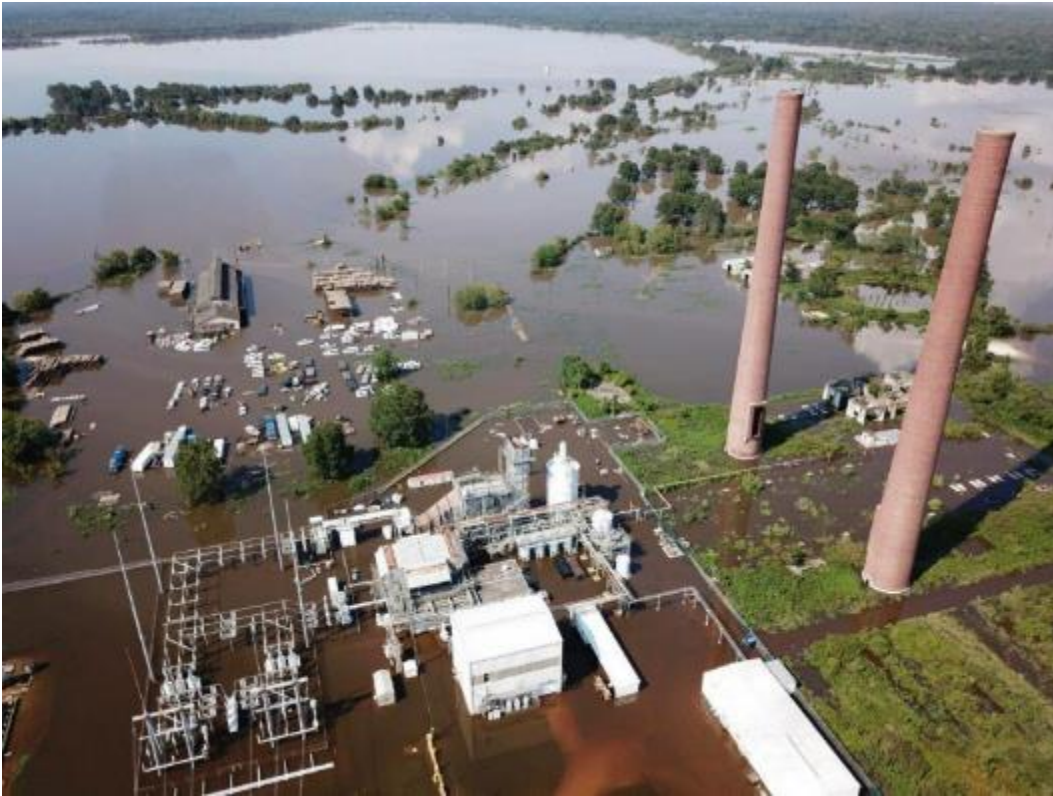
- One generation facility suffered extensive flooding of its control room, which damaged pumps, motors, protective relays, plant DCS, control valves, batteries, and other auxiliary equipment. Its expected return to service is the end of January 2018.
- One 345/138 kV autotransformer failed. Its expected return to service is the end of March 2018.
- One 345 kV line suffered heavy damage with approximately 25 miles of structures and conductor knocked down. Its expected return to service is the end of May 2018.
- One 138 kV line suffered heavy damage with over 90 structures knocked down. It was returned to service at the end of December 2017.
- In MISO, approximately 1,200 MW of generation remained out of service until mid-November 2017.

Figure 10.7: Flooded power plant

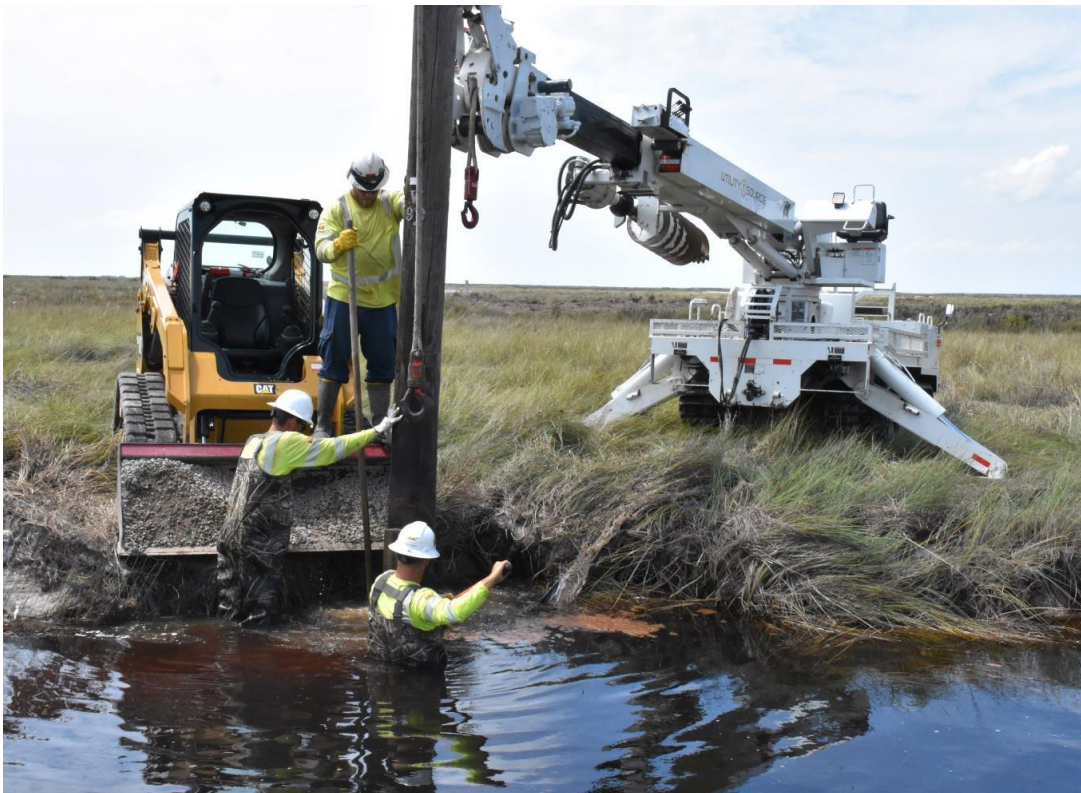
Figure 10.8: Flooding, mosquitos, as well as windy and muddy conditions created special challenges for work crews.

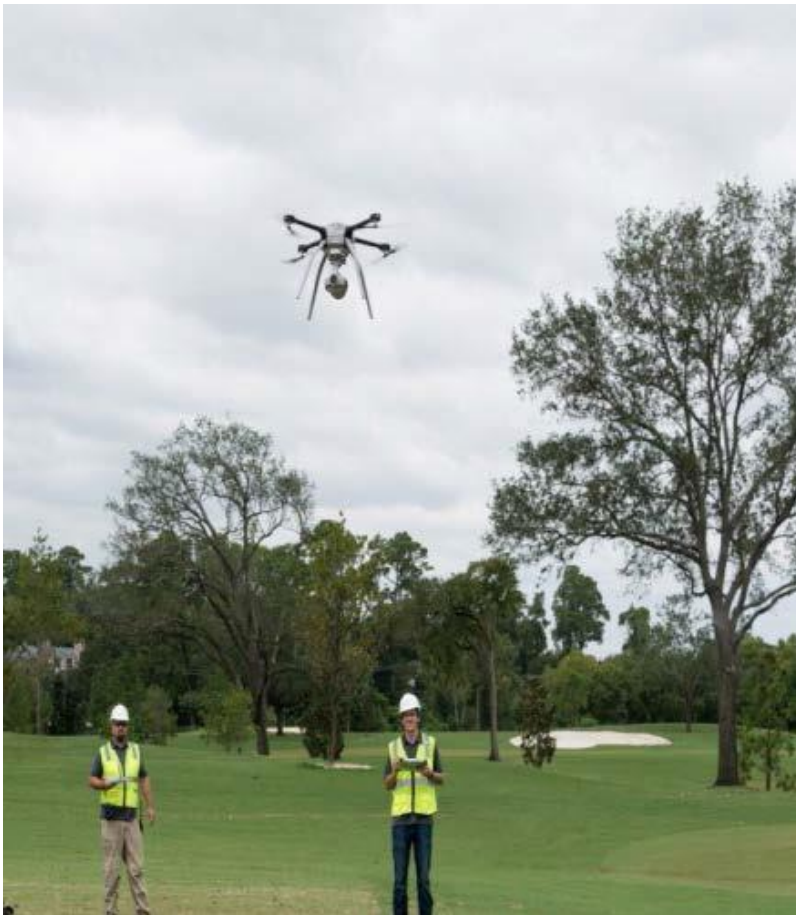
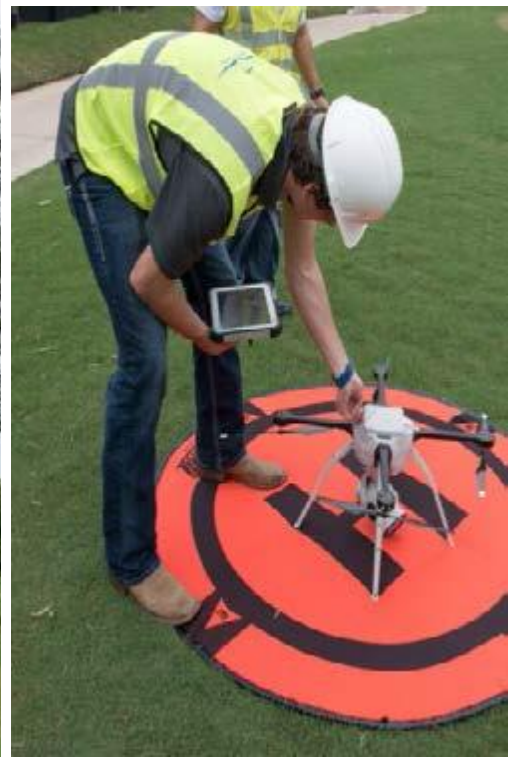
- Unmanned aerial drones were used to perform damage assessments on inaccessible transmission and distribution lines
- Amphibious vehicles and airboats were used to access flooded areas

- The use of aerial drones was effective to assess damage, evaluate work conditions, and enable real-time situational awareness. Infrared capabilities helped identify equipment that needed further inspection.

Figure 10.10: Use of drones to perform inspections.

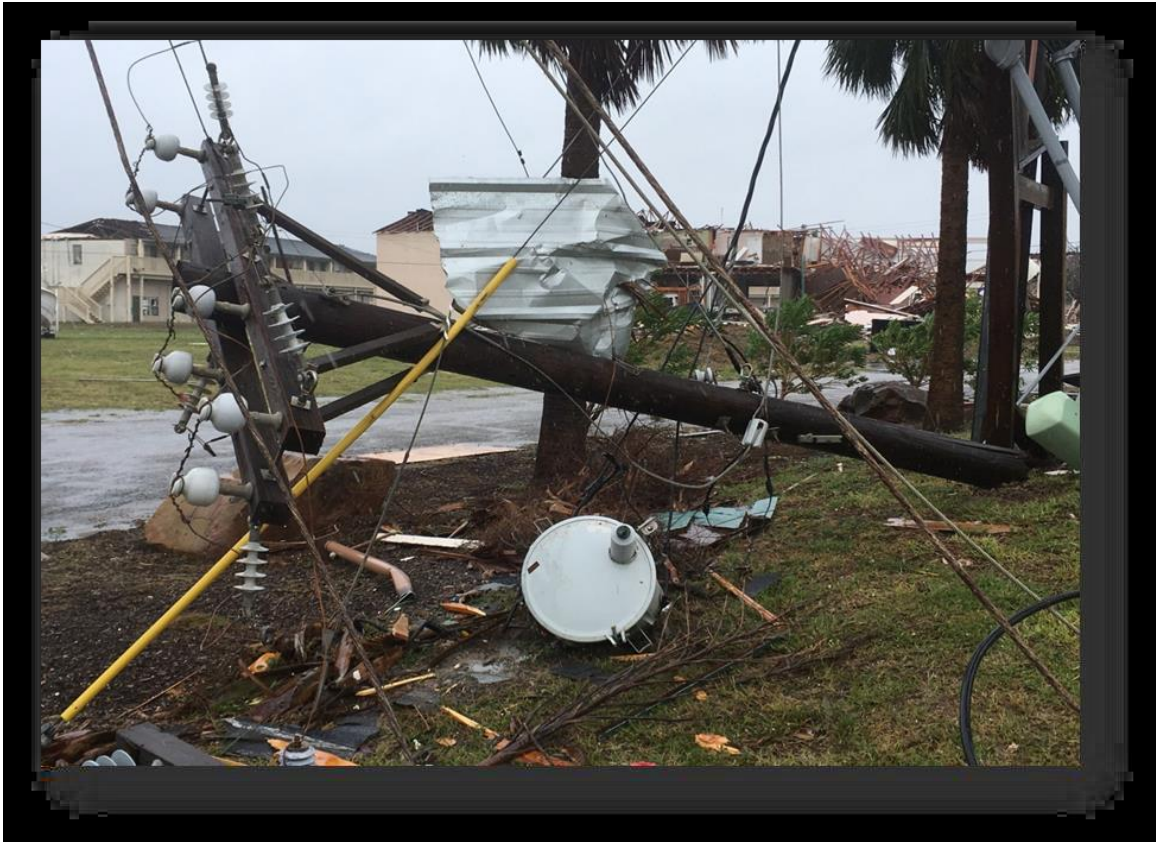
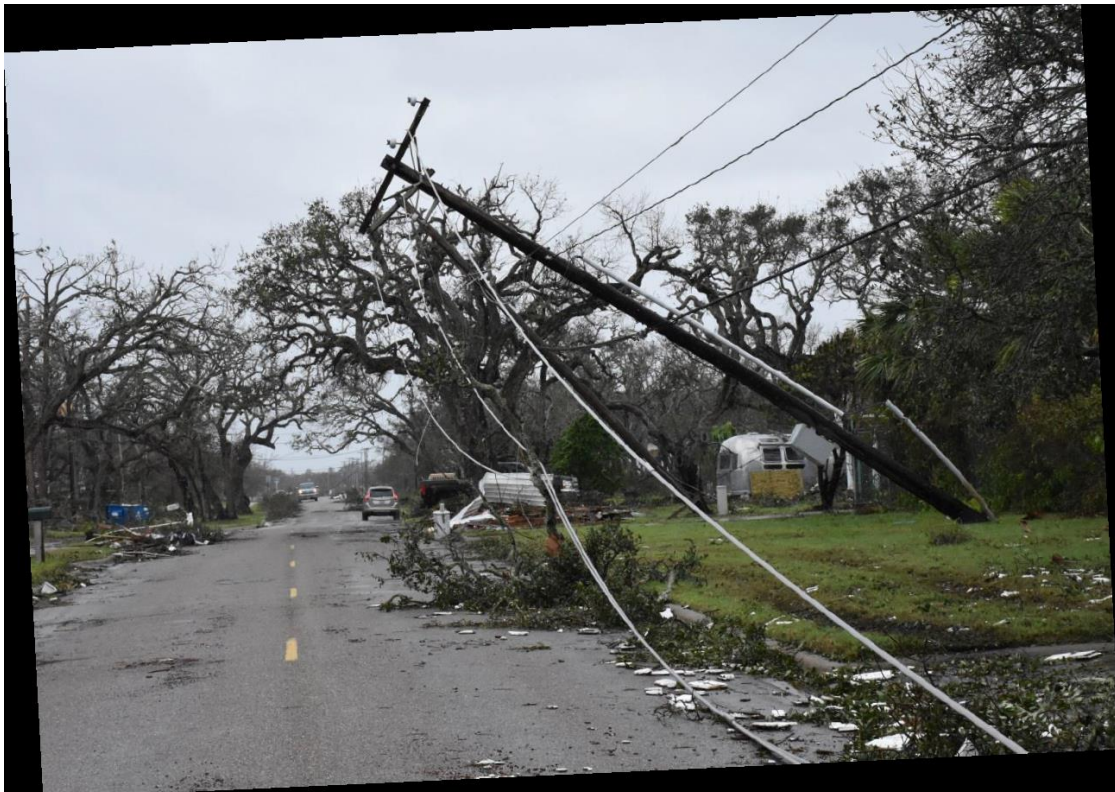
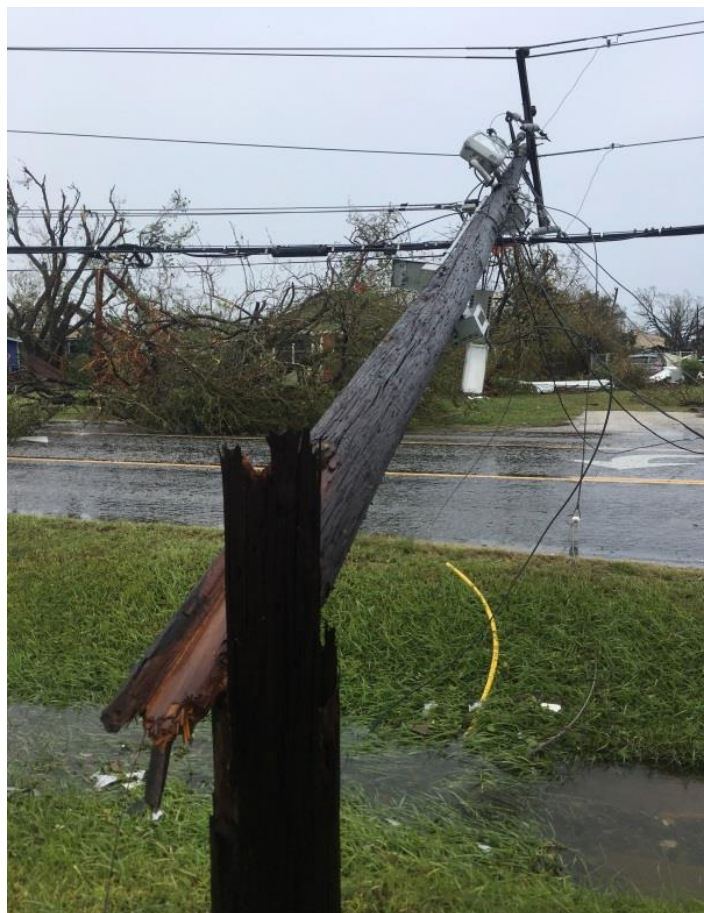
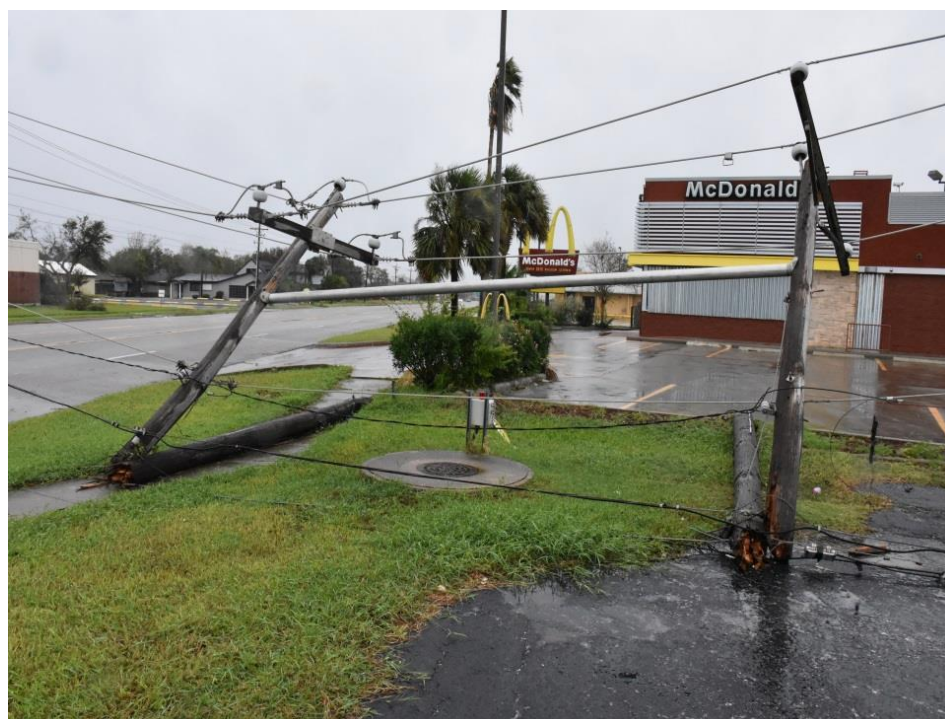
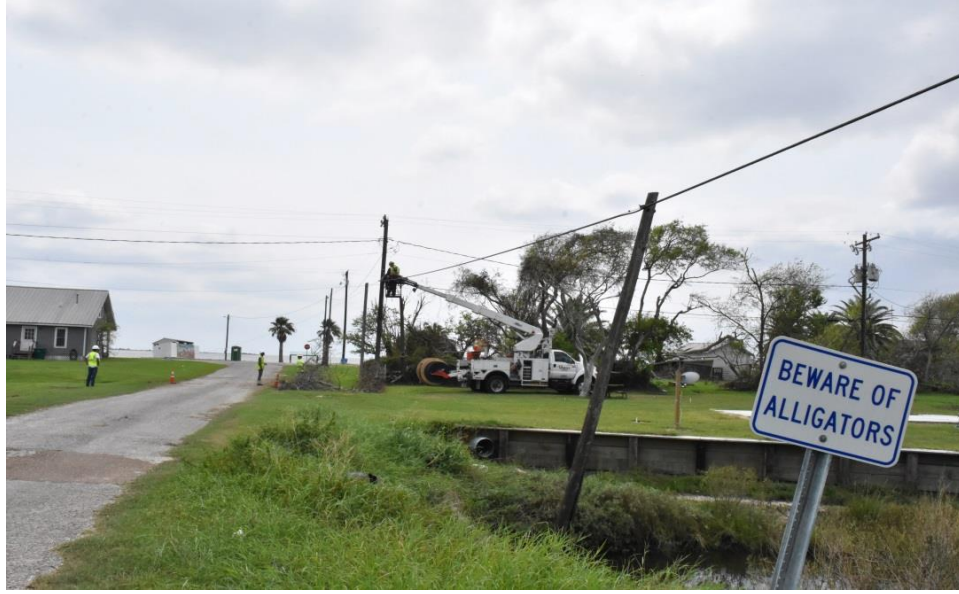
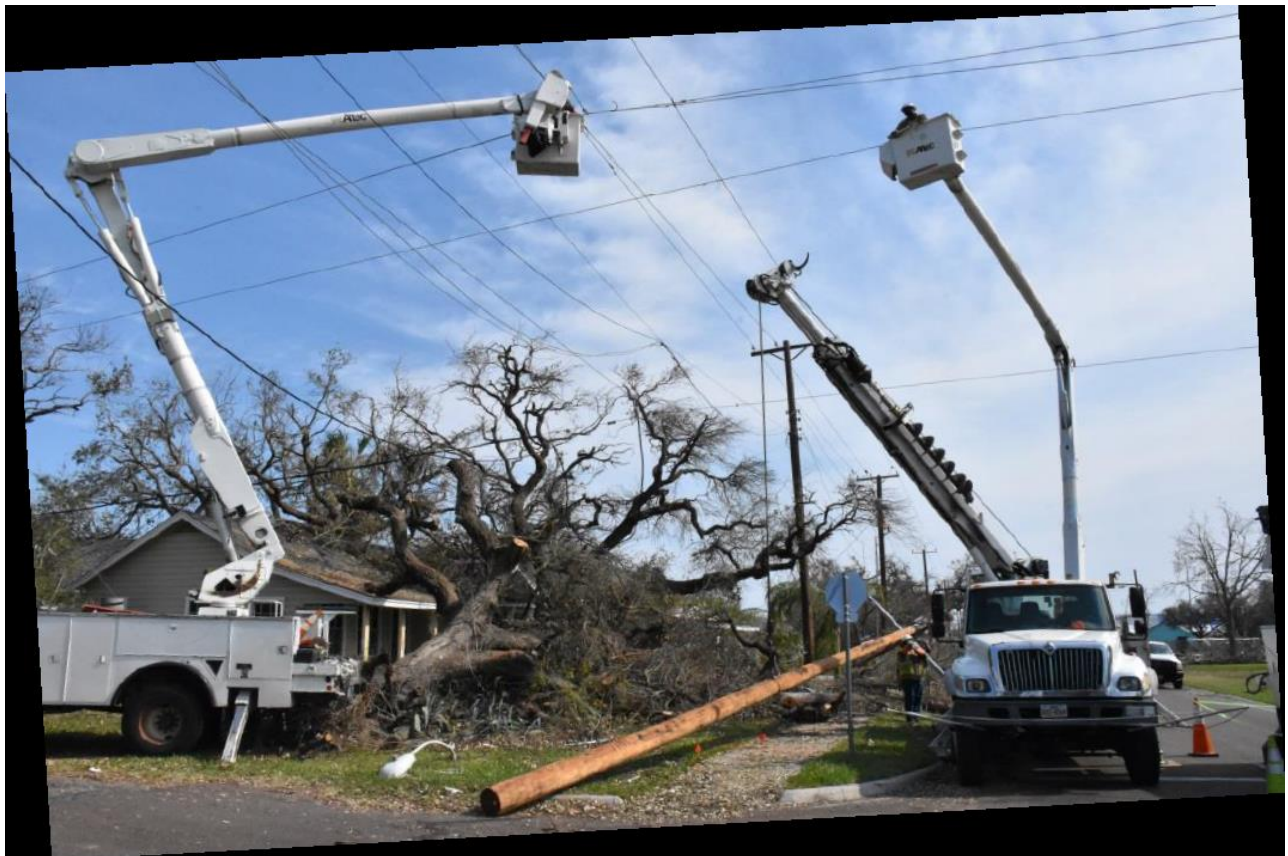
Figure 10.11: Examples of the damage sustained by the distribution system

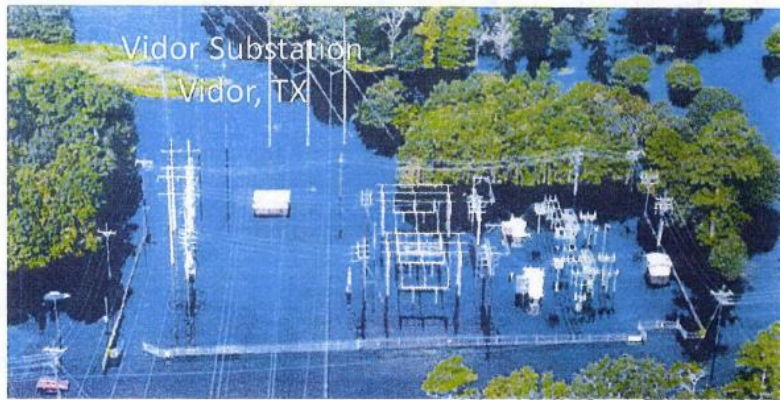
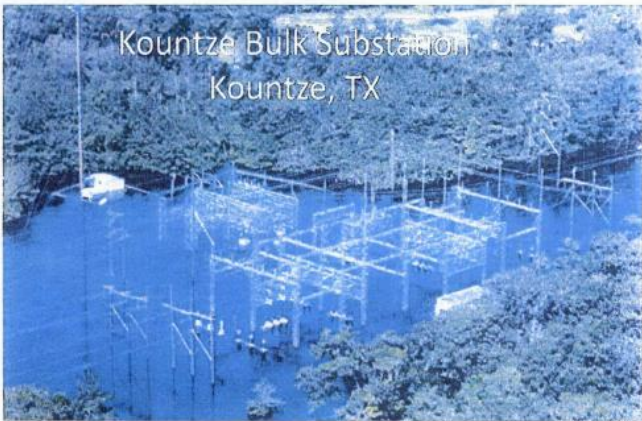
Figure 10.17: Examples of the damage sustained by the distribution system
