2022 Odessa Disturbance

Texas Event: June 4, 2022
Joint NERC and Texas RE Staff Report

December 2022

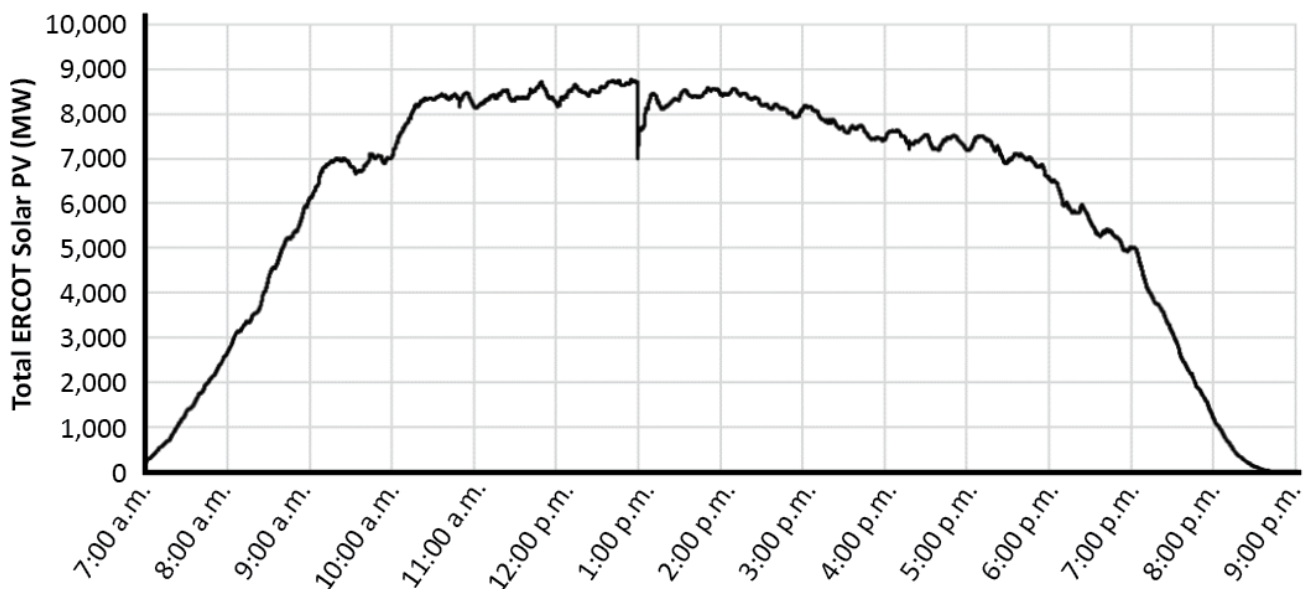
Figure I.1: ERCOT Solar PV Profile for June 4, 2022

Figure I.1 shows the total ERCOT solar PV generation profile for June 4, 2022. The disturbance occurred at 12:59:25 p.m. Central, when solar was at its peak output for the day. The disturbance is clearly visible in the total solar PV power output. The unexpected reduction and abnormal performance of solar PV resources and synchronous generation across a large geographic area of the ERCOT footprint presents significant BPS reliability concerns. Most of the affected solar PV facilities were located in the West Texas area; affected synchronous generation was located in West Texas and South Texas.

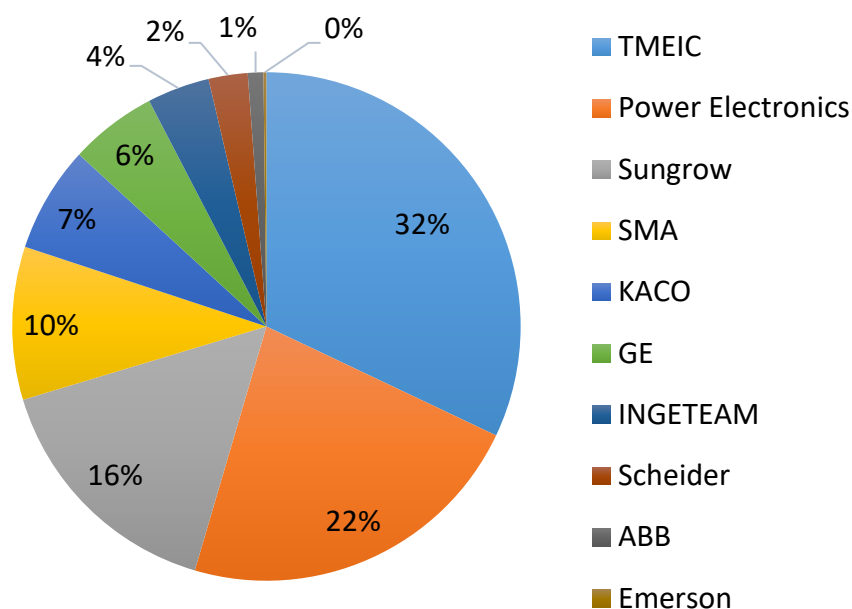
Figure I.2: Capacity Share of BPS-Connected Solar PV Inverter Manufacturers

Figure I.2 shows the share of BPS-connected solar PV resources by inverter manufacturer around the time of this disturbance. Inverter manufacturers involved in this event (and in the 2021 Odessa Disturbance) include Toshiba Mitsubishi-Electric Industrial Systems Corporation (TMEIC), Power Electronics, and KACO.¹² The majority of abnormal performance (e.g., tripping) is attributed to the two largest manufacturers by installed capacity.

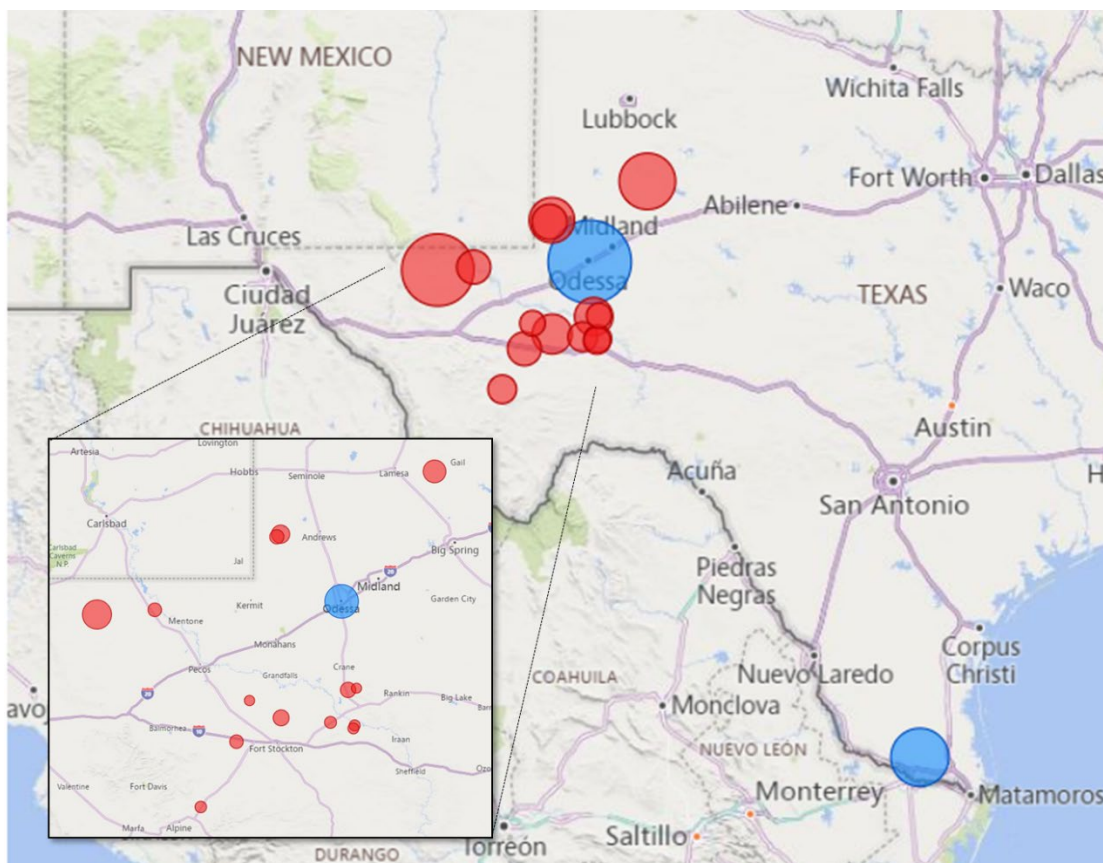
Figure I.3: Map of the Fault Location and Affected Solar PV and Synchronous Generators

The fault occurred in the Odessa, Texas, area within the ERCOT footprint. Multiple solar PV facilities were identified as exhibiting unreliable performance. All affected solar PV facilities are within or near the West Texas part of ERCOT. **Figure I.3** shows the geographic location of the fault and the affected solar PV facilities. The blue and red circles represent synchronous generators and solar PV facilities, respectively, that abnormally responded to the fault. The size of the circle illustrates the relative size of reduction.

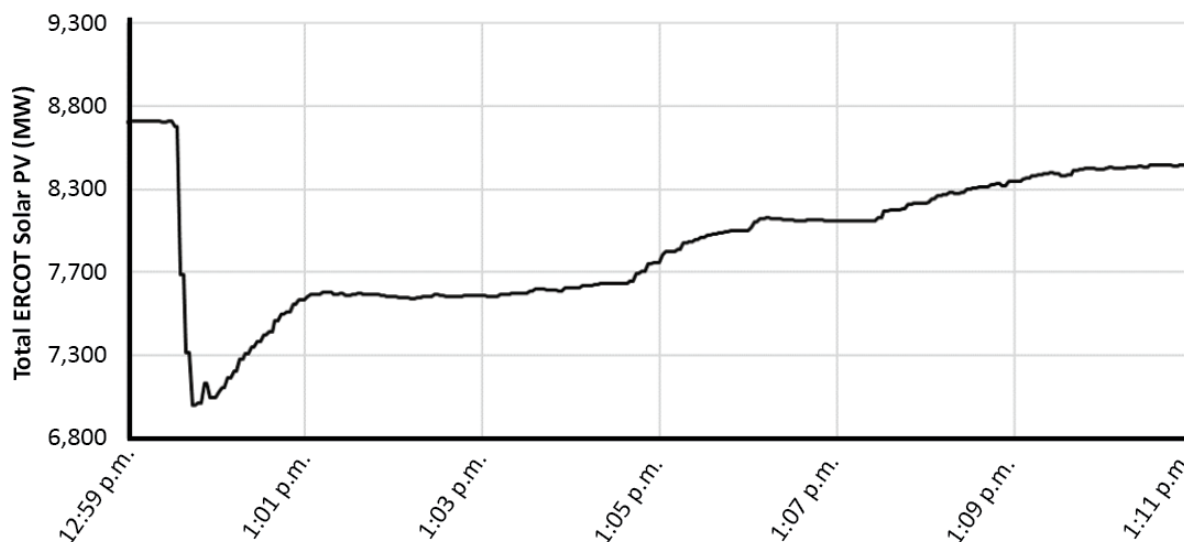
Figure I.4: ERCOT BPS-Connected Solar PV Generation during Disturbance [Source: ERCOT]

Figure I.4 shows the reduction in solar PV resources reported by ERCOT SCADA data. As with past analysis of inverter-based resource disturbances, reductions captured by SCADA likely differ from information captured with higher resolution monitoring equipment. Discrepancies may exist between this value and others reported in this disturbance report; however, the reduction in solar PV output captured by SCADA provides a relative indicator of the impact of each disturbance.

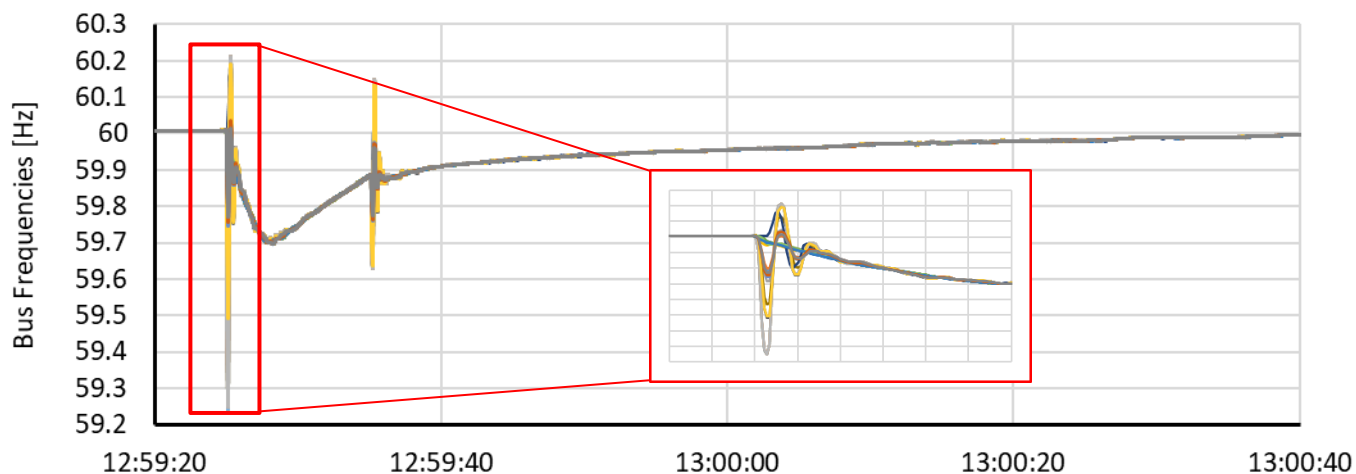
Figure I.5: ERCOT System Frequency

The loss of generation caused system frequency to fall from around 60.01 Hz to 59.70 Hz. A total of 1,116 MW of end-use loads participating in ERCOT's load resources program¹³ provide responsive reserve service that is automatically deployed in response to the frequency drop. End-use loads participating in ERCOT's load resources program are set to automatically disconnect when frequency hits 59.70 Hz. This ancillary service market product is used to stabilize system frequency for large frequency excursions to avoid frequency from reaching emergency underfrequency load shedding thresholds beginning at 59.3 Hz.

Synchronous generation levels were relatively high during this time, so system inertia and high rate-of-change-of-frequency conditions were not a concern. The time from the event start to the frequency nadir was measured at approximately three seconds.

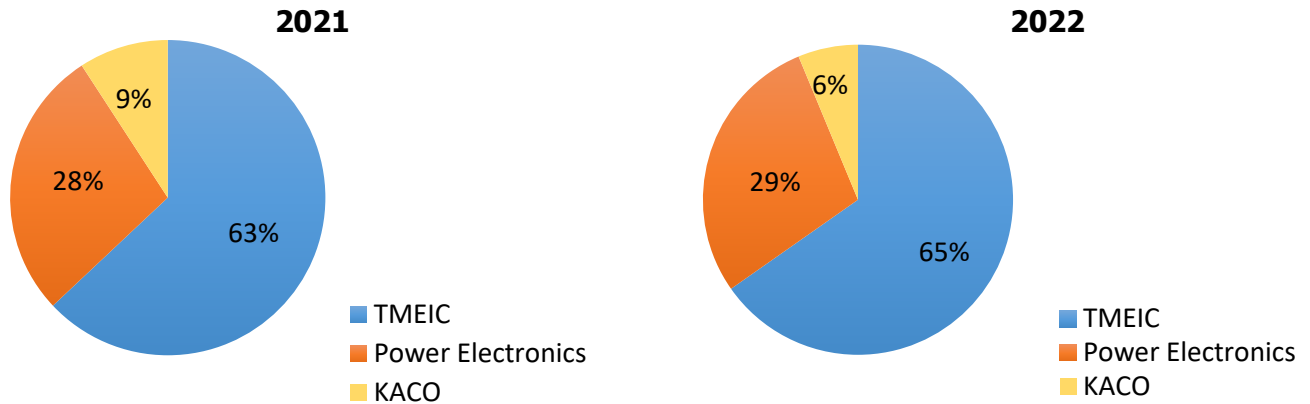
Figure 1.2: Inverter Manufacturers Involved in Odessa Disturbances in 2021 and 2022

Figure 1.2 shows the share of solar PV inverter equipment manufacturers involved in the 2021 and 2022 Odessa disturbances. Only three manufacturers were involved in both events, showing systemic performance issues for those manufacturers. KACO is no longer in the business of manufacturing large-scale inverters. TMEIC and Power Electronics are actively involved in the production of inverters for large-scale solar PV power plants across all Interconnections, and they are the two largest equipment manufacturers by market share in the Texas Interconnection.

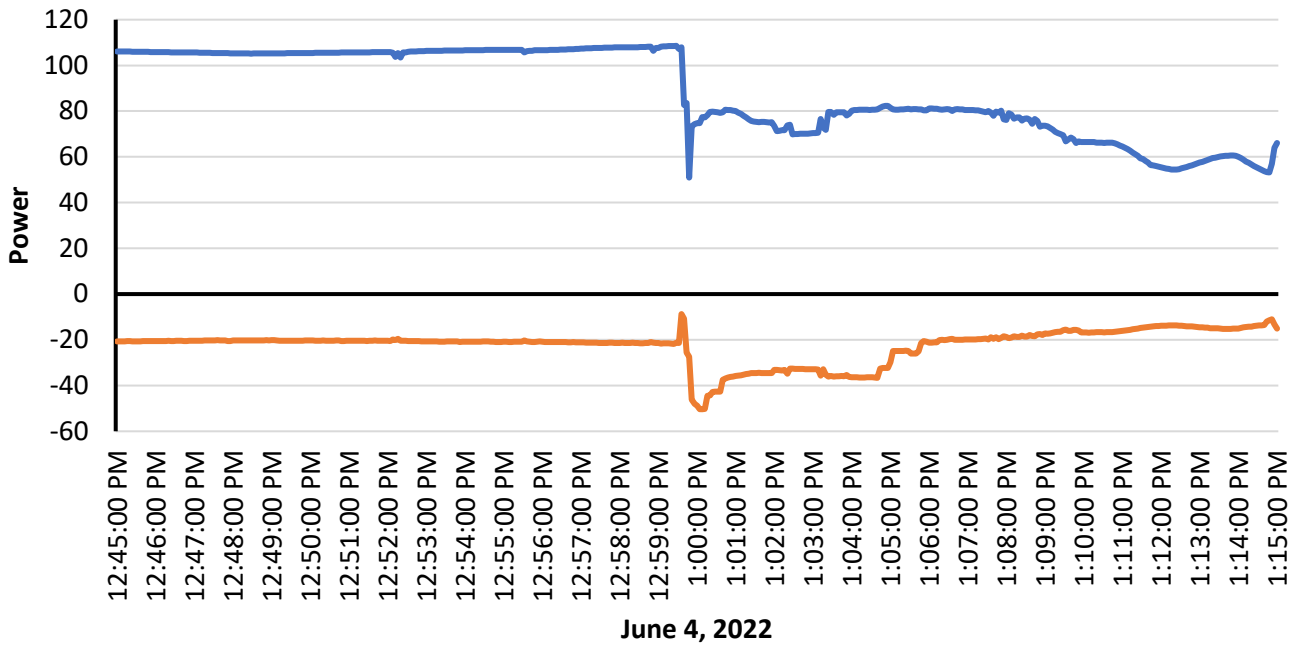
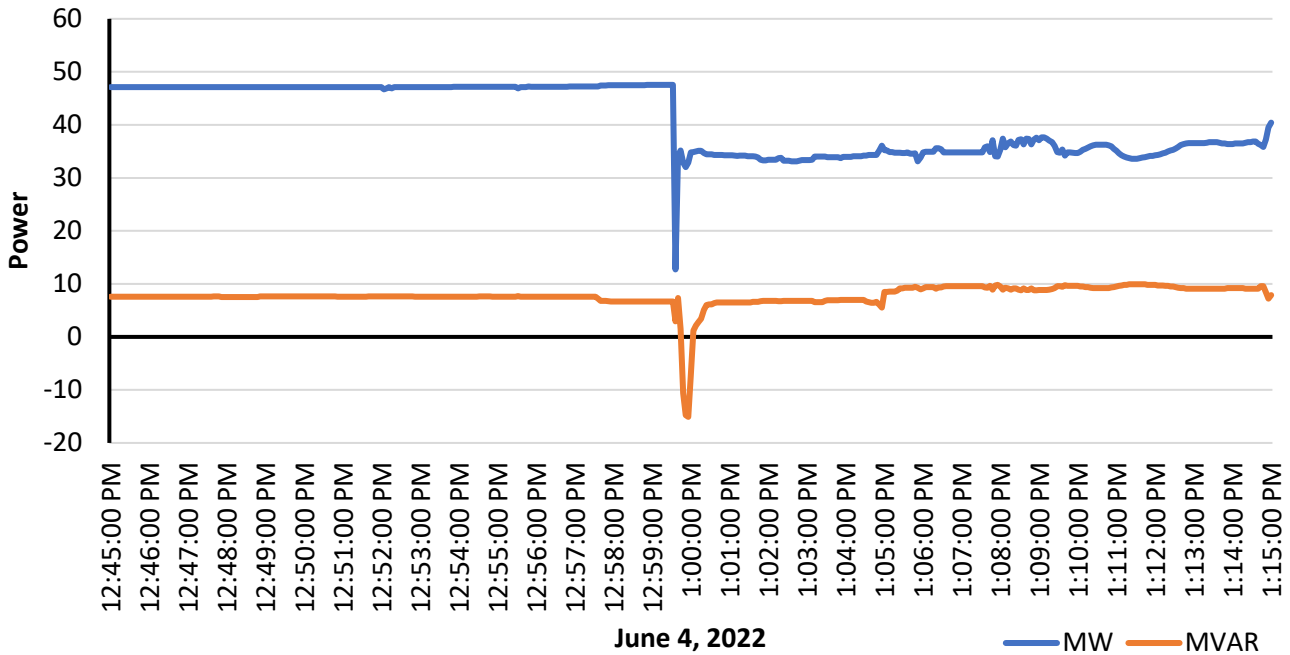
The inverters initially indicated that tripping was caused by overfrequency settings at 60.6 Hz for 600 seconds, which the grid did not experience. Upon further inspection, the GO determined that field technicians updating inverter human-machine interface (HMI) software inadvertently changed the fault code table/register. This resulted in incorrectly mapped fault codes; therefore, the actual cause of inverter tripping at this facility is unknown.

NERC, Texas RE, and ERCOT stressed during follow-up discussions with the GO that inverter protection settings should be based on equipment ratings. The GO has worked with the equipment manufacturer service provider (Siemens) to develop and implement expanded frequency and voltage ride-through settings based on equipment tolerances.
