April and May 2018 Fault Induced Solar Photovoltaic Resource Interruption Disturbances Report

Southern California Events: April 20, 2018 and
May 11, 2018

Joint NERC and WECC Staff Report

January 2019

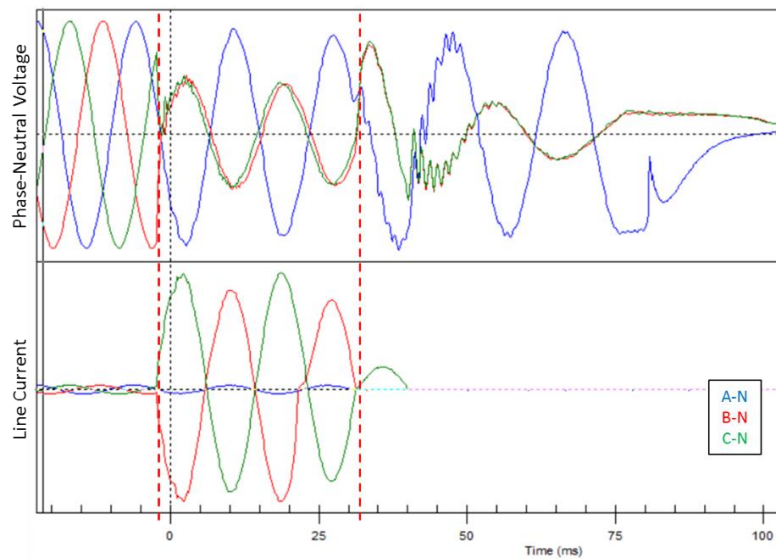
Figure 1.3: DFR Data from Local End of Faulted 500 kV Circuit [Source: SCE]

[Figures 1.3](#) and [1.4](#) show DFR point-on-wave data from the local and remote ends of the faulted transmission circuit, respectively. Red dotted vertical lines show an estimate of the fault inception and fault clearing times. The DFRs monitor line voltages via capacitance-coupled voltage transformers (CCVTs) that are on the line (within the zone of protection). When the line clears, the CCVTs will monitor any LC resonance that exists on the line as it rings down to a steady-state. The faulted line is also mixed 500 kV underground/overhead configuration with relatively lopsided resistance-inductance-capacitance (RLC) line parameters and unbalanced line shunt reactors to compensate for high capacitive charging from the underground portion of the line. Since the line is 500 kV, there is significant charging from the underground portion that led to the unusual shunt compensation; this was likely the cause of the abnormal resonant RLC response shown in the DFR records when the line was opened at both terminals.

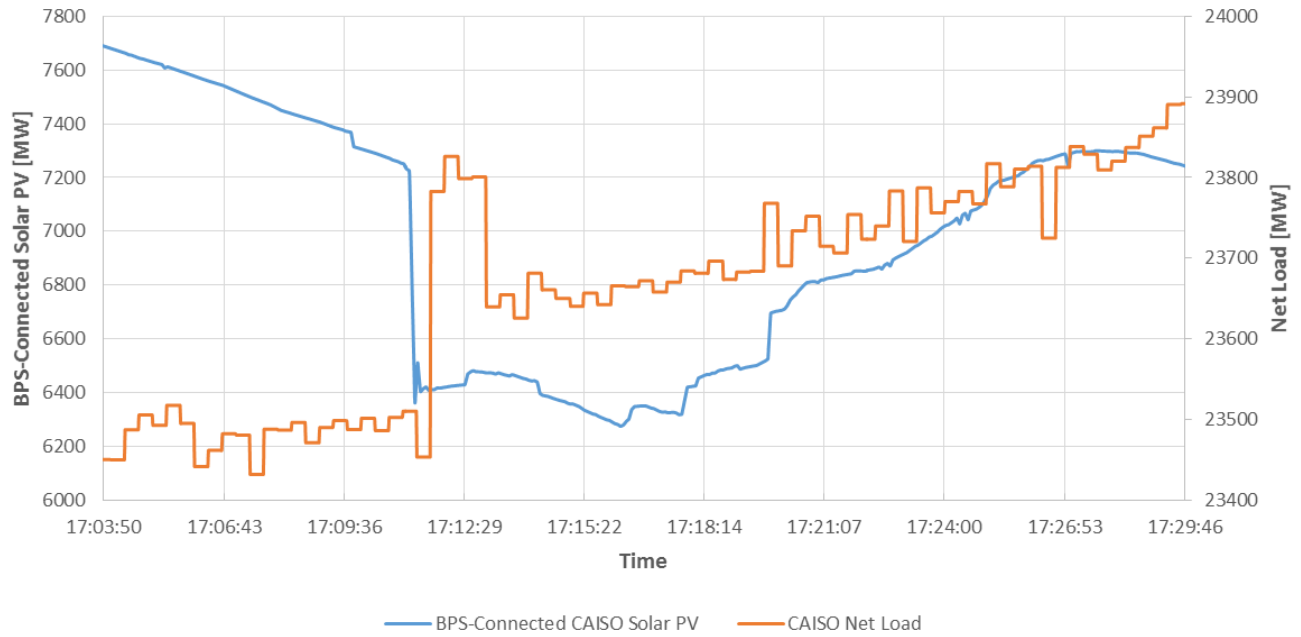
Figure 1.5: CAISO BPS-Connected Solar PV and Net Load during Angeles Forest Disturbance [Source: CAISO]

The disturbance affected⁸ generation in CAISO (SCE and Pacific Gas & Electric (PG&E)) and the Los Angeles Department of Water and Power (LADWP) footprints. **Figures 1.5** through **1.8** show CAISO,⁹ SCE, PG&E, and LADWP BPS-connected solar PV responses during the grid disturbance.¹⁰ No noticeable impact to BPS-connected solar PV was observed in either San Diego Gas & Electric (SDG&E) or Imperial Irrigation District (IID) footprints. The 500 kV transmission line fault resulted in a reduction of BPS-connected solar PV output by 860 MW in CAISO and 17 MW in LADWP.

The Angeles Forest disturbance was the first disturbance NERC has analyzed where a discernible response of net load increase can be observed. This is attributed to DER tripping or reduction based on engineering judgment and discussion with local utilities. [Figure 1.5](#) also shows the CAISO net load response during the Angeles Forest disturbance. There is a clear change in net load calculation, and a value of 130 MW is deemed to be involved with DER tripping and reduction. [Chapter 2](#) provides a more comprehensive analysis of the challenges of identifying DER behavior for these types of disturbances.

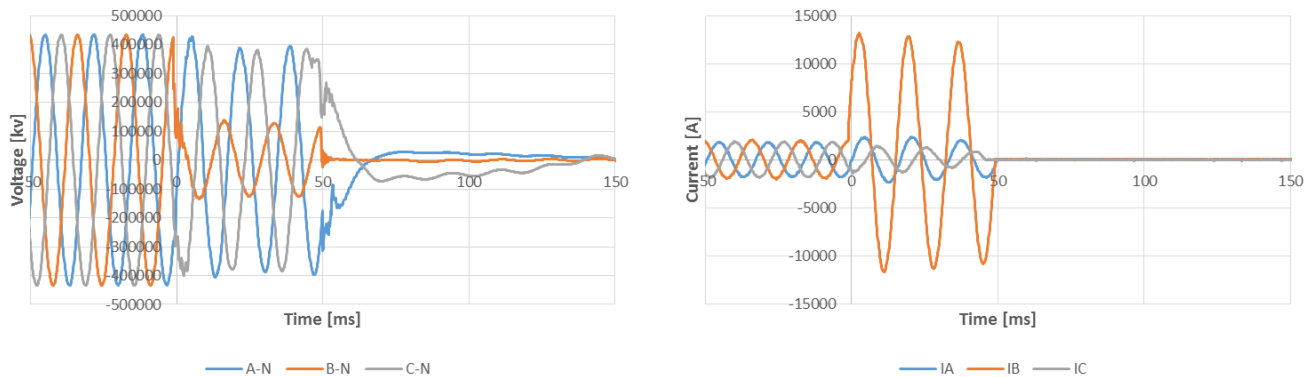
Figure 1.11: DFR Voltage and Current at One End of Faulted Circuit [Source: SCE]

On May 11, 2018, at 15:20:14 PDT, a fault occurred on a short 500 kV transmission circuit in the SCE footprint near Palmdale, California, and was subsequently coined the “Palmdale Roost” disturbance since the fault was due to bird nesting materials causing a flashover. The B-phase-to-ground (B-N) fault was normally cleared in three cycles.

Figures 1.11 and 1.12 show DFR records of line-to-line voltages and line currents at both ends of the faulted circuit.

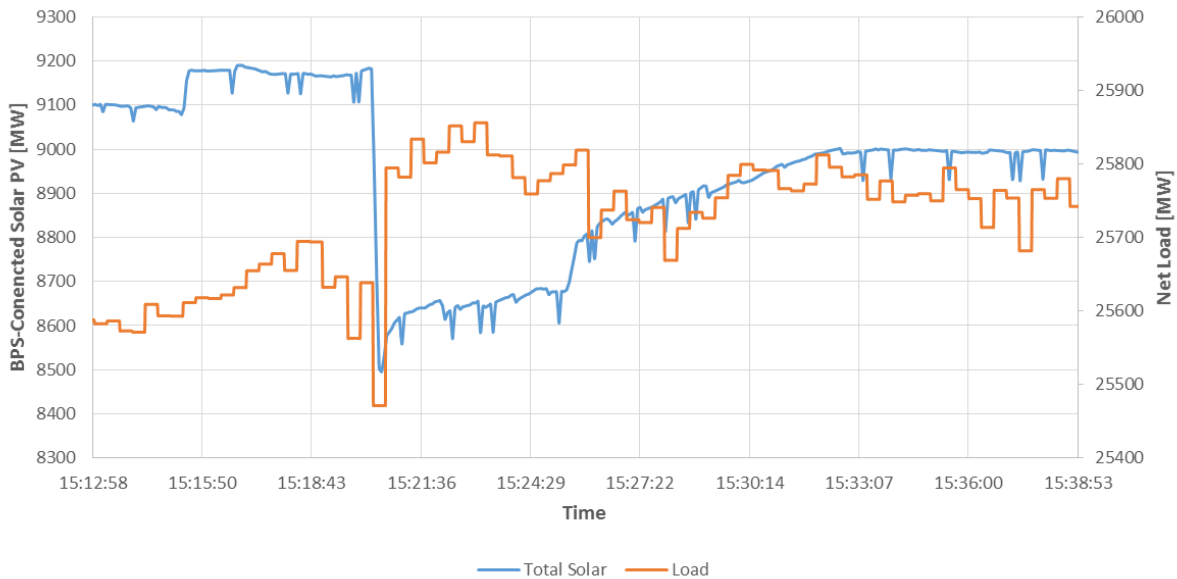
Figure 1.13: CAISO BPS-Connected Solar PV and Net Load during Palmdale Roost Disturbance [Source: SCE]

This disturbance affected¹¹ generation in CAISO (SCE and PG&E), LADWP, and IID footprints. **Figures 1.13** through **1.17** show CAISO, SCE, PG&E, LADWP, and IID BPS-connected solar PV responses during the grid disturbance.¹² No noticeable impact to BPS-connected solar PV was observed in SDG&E. The 500 kV transmission line fault resulted in a reduction of BPS-connected solar PV output by 630 MW in CAISO, 48 MW in LADWP footprint, and 33 MW in IID.

The Palmdale Roost disturbance, similar to the Angeles Forest disturbance, included a discernible response of net load increase that is attributed to DER tripping or reduction. **Figure 1.13** shows CAISO net load response during the Angeles Forest disturbance. There is a clear change in net load calculation, and a value of 100 MW is deemed to be involved with DER tripping and reduction.

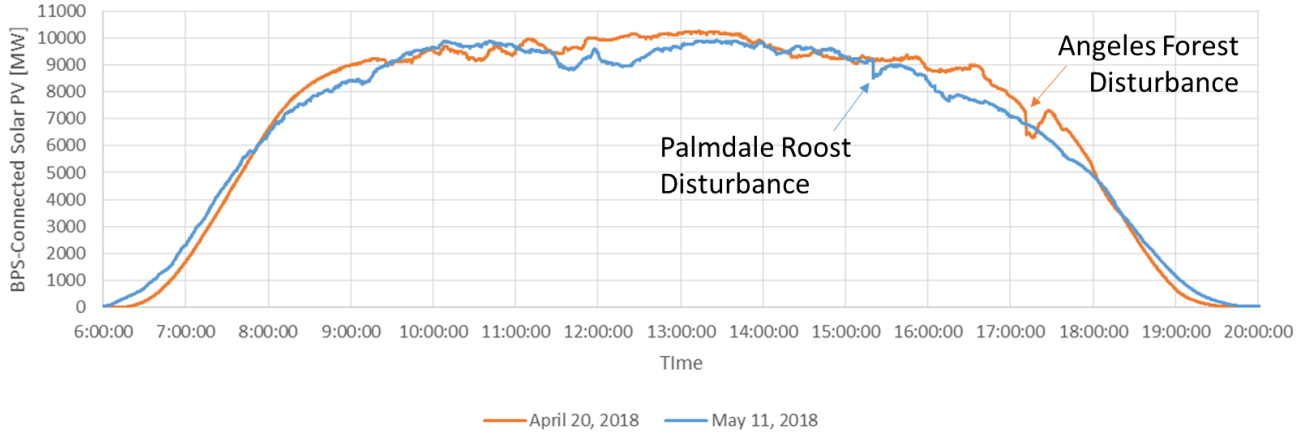
Figure 1.20: CAISO Solar Profiles on Days of Disturbances [Source: CAISO]

Figure 1.20 shows the solar power output profiles for April 20, 2018, and May 11, 2018. The changes in BPS-connected solar PV caused by the Angeles Forest and Palmdale Roost disturbances are indicated. The Palmdale Roost disturbance (May 11) occurred at the end of the daily solar PV peak period while the Angeles Forest Disturbance occurred during the daily solar PV ramp down.

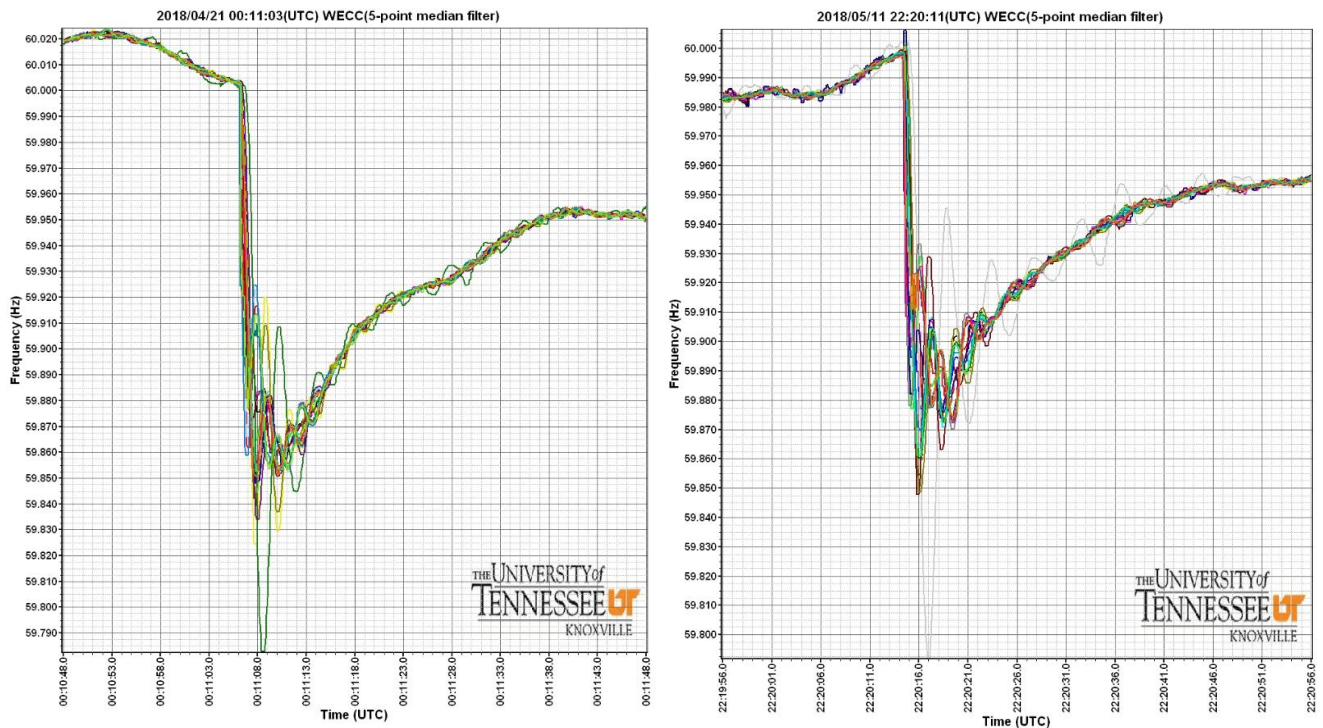
Figure 1.21: System Frequency during Both Disturbances [Source: FNET]

System frequency exhibited similar performance in both the Angeles Forest disturbance and the Palmdale Roost disturbance. Predisturbance frequency was around 60.0 Hz in both events, and approximate system (median) frequency fell to around 59.86 Hz and 59.88 Hz, respectively. System frequency recovered and settled near 59.95 Hz within 30 seconds. Figure 1.21 shows frequency measurements from across the WI for the April 20, 2018, (left) and May 11, 2018, (right) disturbances.

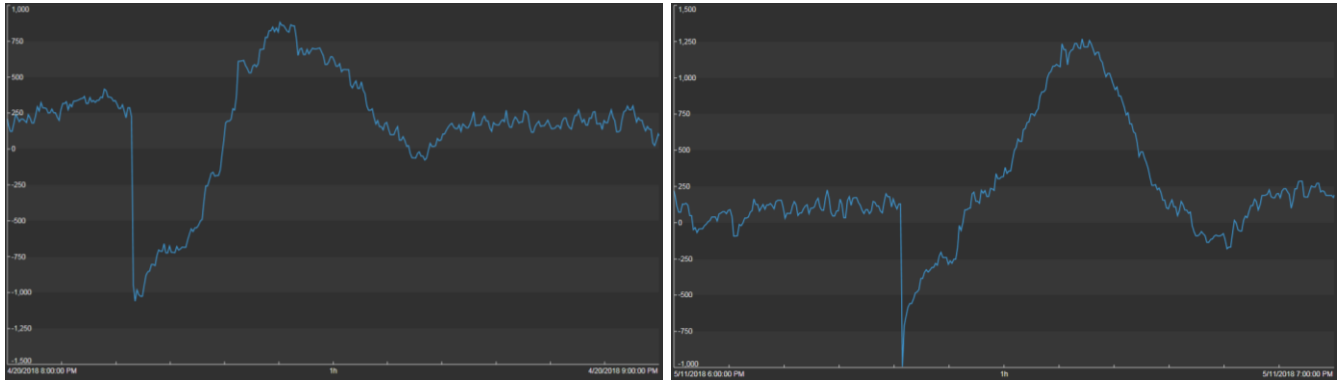
Figure 1.22: CAISO ACE during Angeles Forest and Palmdale Roost Disturbances

Figure 1.22 shows the CAISO area control error (ACE) for the Angeles Forest disturbance (left) and the Palmdale Roost disturbance (right). ACE is analyzed to ensure that the estimated resource loss size matches reasonably well with the change in ACE at the time of the disturbance. Since these types of disturbances involving solar PV and momentary cessation that can have large fluctuations in active power injection occur across a wide area, the additional data point helps ensure resource loss numbers are reasonable.

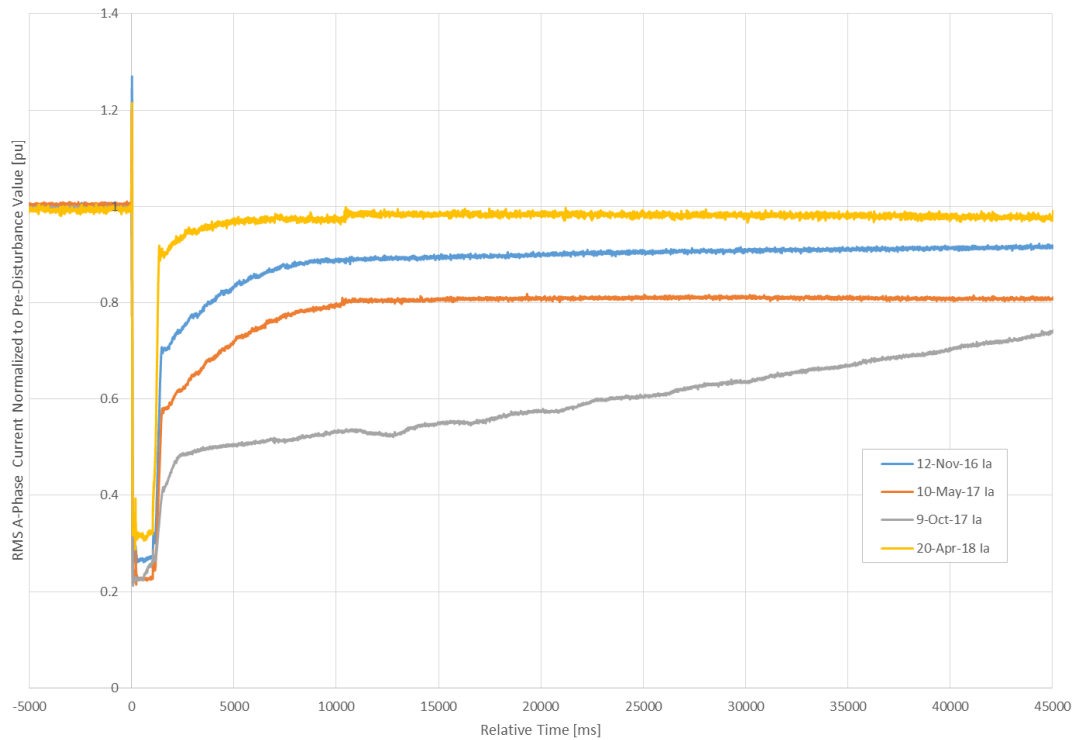
Figure 2.2: Improved Recovery from Momentary Cessation

Some plants have made changes based on the recommendations following the Blue Cut Fire and Canyon 2 Fire disturbances. [Figure 2.2](#) shows an example of a solar PV plant that has observed multiple nearby fault events over the last couple years. The plant responds slightly differently to each event; however, the dynamic response to the Angeles Forest disturbance (April 20, 2018) shows improved recovery back to predisturbance output in a relatively quick time frame compared to the prior events. While the delay upon recovery from momentary cessation is still one second (well beyond the time recommended in the NERC Alert following the Canyon 2 Fire disturbance), the interaction between inverter response and the plant-level controller appears to have been mitigated. The GO has made changes to the plant-level controller such that restoration from momentary cessation is not impeded by plant-level controller ramp rates. It appears those corrections have resulted in improved performance returning to predisturbance output. The GO is awaiting approval from their respective PC prior to eliminating momentary cessation (as recommended in the NERC Alert).

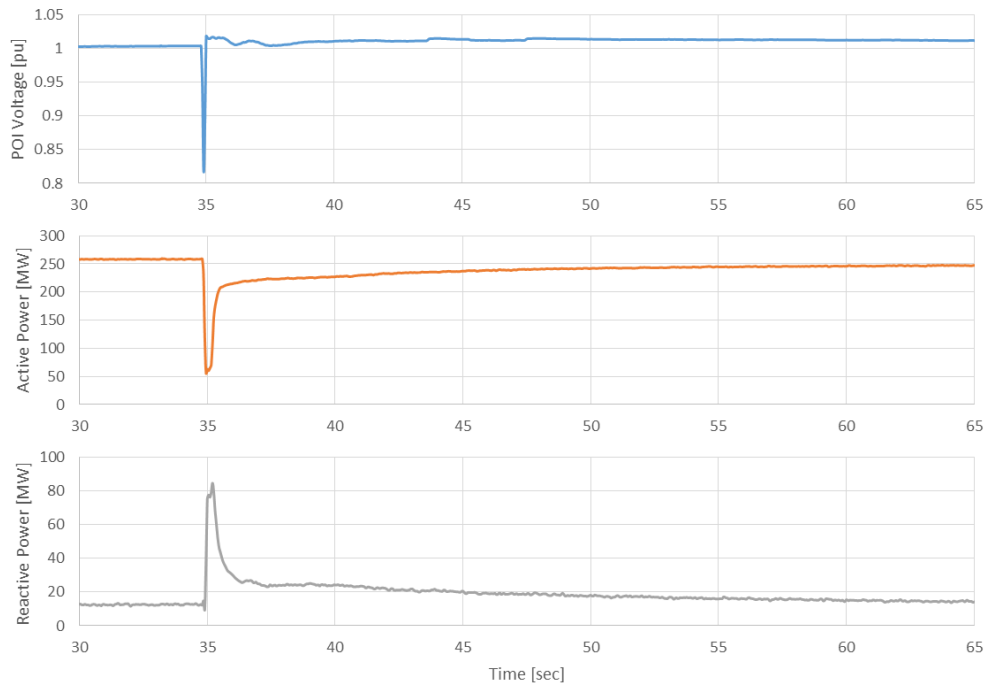
Figure 2.3: Data Collected Related to Momentary Cessation

A couple of plants analyzed using DFR data at the POI during the Angeles Forest disturbance exhibited effective fault ride-through performance, including injection of reactive current during on-fault and post-fault conditions. [Figure 2.3](#) shows the voltage, active power, and reactive power at the POI of one large solar PV facility. When the fault occurs, active power drops quickly and reactive power increases. This is caused by the drop in voltage at the time of the fault. Once the fault clears, in approximately three cycles, the active power ramps back up very quickly, and reactive power settles. Post-fault voltage recovery at the POI is very good.

The response of this solar PV resource was cross-checked with the data submitted in response to the NERC Alert, which also stated that momentary cessation is not used, that reactive current injection is used during fault conditions, and that a mixture of active and reactive current is used once voltage returns to within the continuous operating range.

Recommendation #2: GOs, in coordination with their inverter manufacturer(s), should implement the recommended changes to inverter settings and performance as outlined in the NERC Alert following the Canyon 2 Fire disturbance.

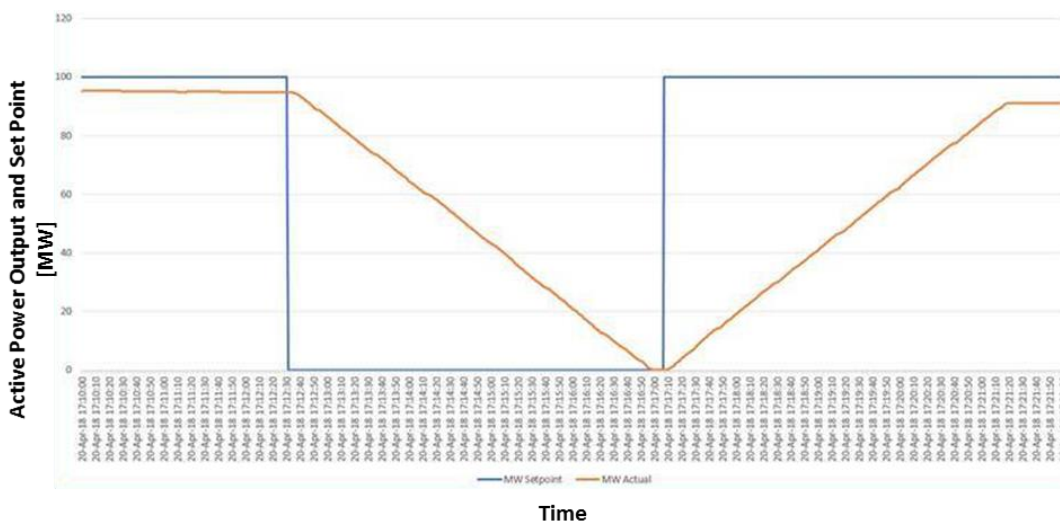
Figure 2.5: Active Power Output and Set Point at Curtailed Solar PV Facility

One solar PV facility reported that the reduction in active power output observed at their facility was caused by a curtailment command received from CAISO’s Automated Dispatch System (ADS). Upon reviewing the active power output and power set point data (See Figure 2.5), it was determined that the curtailment occurred after the fault condition by a couple minutes (assuming aligned time synchronization). Therefore, it was determined that the curtailment command did not contribute to the reduction in solar PV output during the time of the disturbance. However, it did appear strange that the set point command drops from 100 percent to zero percent immediately and remains there for approximately five minutes and then returns to 100 percent. Further, it is unclear what caused the curtailment from the BA and if that was related to the post-fault operating conditions observed by the BA. Therefore, it is recommended that BAs ensure their dispatch and curtailment commands are coordinated appropriately and are particularly able to handle these conditions where a substantial amount of solar PV resources reduce power output for periods of 5–10 minutes. There appears to be some anomalous behavior with automatic generation control (AGC) that has occurred in multiple events immediately after the fault and solar PV reduction conditions.

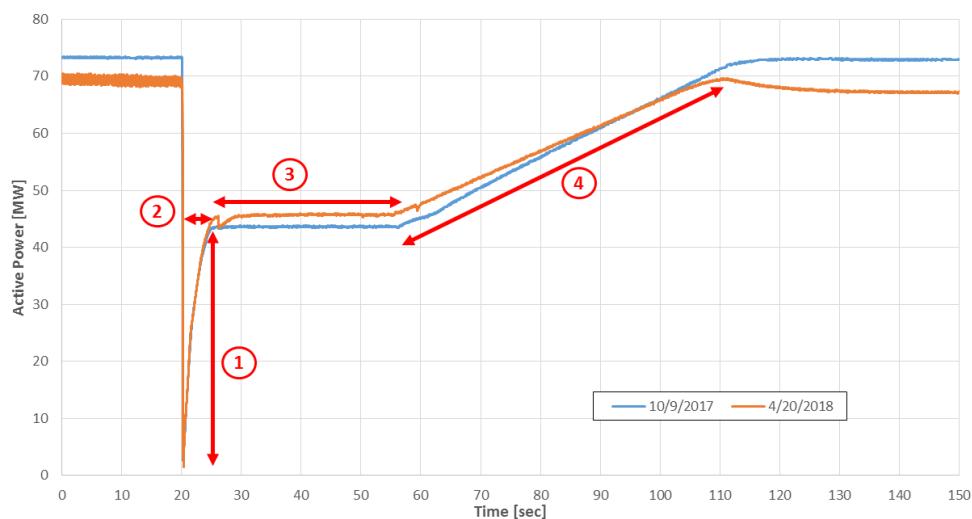
Figure 2.6: Partial Tripping and Momentary Cessation during Past Disturbances

Figure 2.6 illustrates a plant where 60 percent of the inverters entered momentary cessation while the remaining 40 percent tripped. The response to the Angeles Forest disturbance (April 20, 2018) was compared against the response to the Canyon 2 disturbance (October 9, 2017), and it was observed that the plant exhibited very similar behavior in both events. **Figure 2.6** is annotated to illustrate what is happening at the facility during the disturbance, including the following:

3. An approximate 35-second delay then occurs where active power output levels off with the fraction of inverters that recovered from momentary cessation. After 35 seconds or so, the tripped inverters have completed their automatic reset and begin returning to service. These inverters do not have any intentional time delay (e.g., five minutes) before attempting to restore output.

4. The tripped inverters then resume current injection back to predisturbance output based on the ramp rates programmed into the plant-level controller.

Recommendation #4: The NERC Inverter-Based Resource Performance Task Force (IRPTF) should review existing NERC Reliability Standards and provide some technical perspectives and guidance as to how partial tripping or partial momentary cessation could be handled. This was highlighted in the NERC IRPTF Standard Authorization Request (SAR) submitted regarding PRC-024-2 and may be applicable to other NERC Reliability Standards as well.

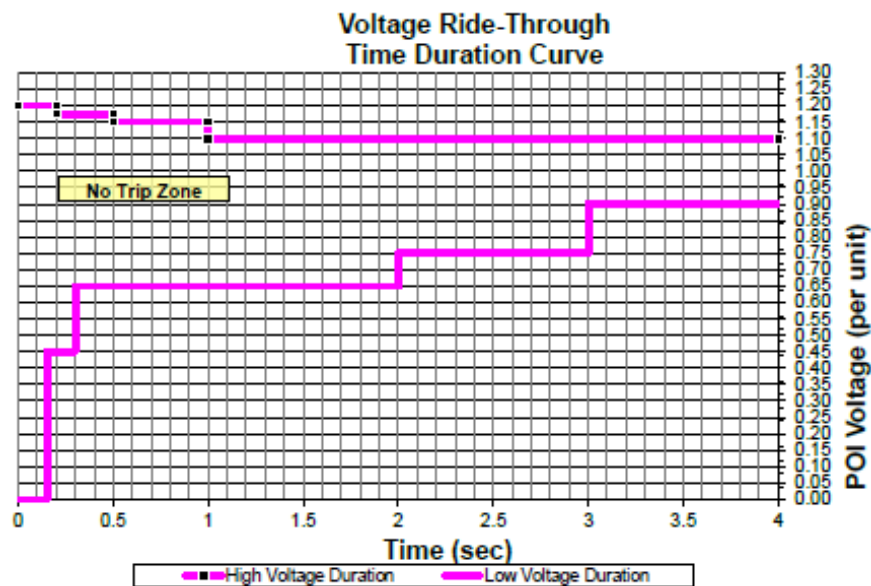
Figure 2.9: PRC-024-2 Voltage Curve

It should be reinforced and clarified that PRC-024-2 Requirement R2 states that generator voltage protective relaying (including protective functions within control systems that directly trip or provide tripping signals to the generator based on voltage inputs) shall be set to “not trip the applicable generating units as a result of a voltage excursion (at the point of interconnection) caused by an event on the transmission system external to the generating plant that remains within the “no trip zone” of PRC-024 Attachment 2.”¹⁹ The “Voltage Ride-Through Time Duration Curve” in Attachment 2 (shown in [Figure 2.9](#)) also refers to the “POI Voltage (per unit)” on the vertical axis.

It is the responsibility of the GO to determine, either through stability studies or engineering calculations, what the appropriate inverter trip settings should be such that they will not trip for voltages at the POI that are within the “No Trip” zone of PRC-024-2. As described above, it appears to be a very common situation that the POI and inverter terminal conditions are significantly different during grid disturbances. Therefore, it is not suitable to simply program the PRC-024-2 voltage curve directly into the inverter protective settings. This leads to a susceptibility for inverter tripping during transient voltage excursions at the time of faults.

Recommendation #5: GOs should be performing analyses for each installation to correctly set inverter protective functions such that all inverters within a facility will not trip for any voltages seen at the POI within the “No Trip” zone of Attachment 2 of PRC-024-2. Setting the inverter protection settings to match the PRC-024-2 curve is not a recommended practice as it does not consider the vastly different voltage conditions that may be experienced at the inverter terminals relative to the POI voltage (as has been observed in multiple disturbances analyses).

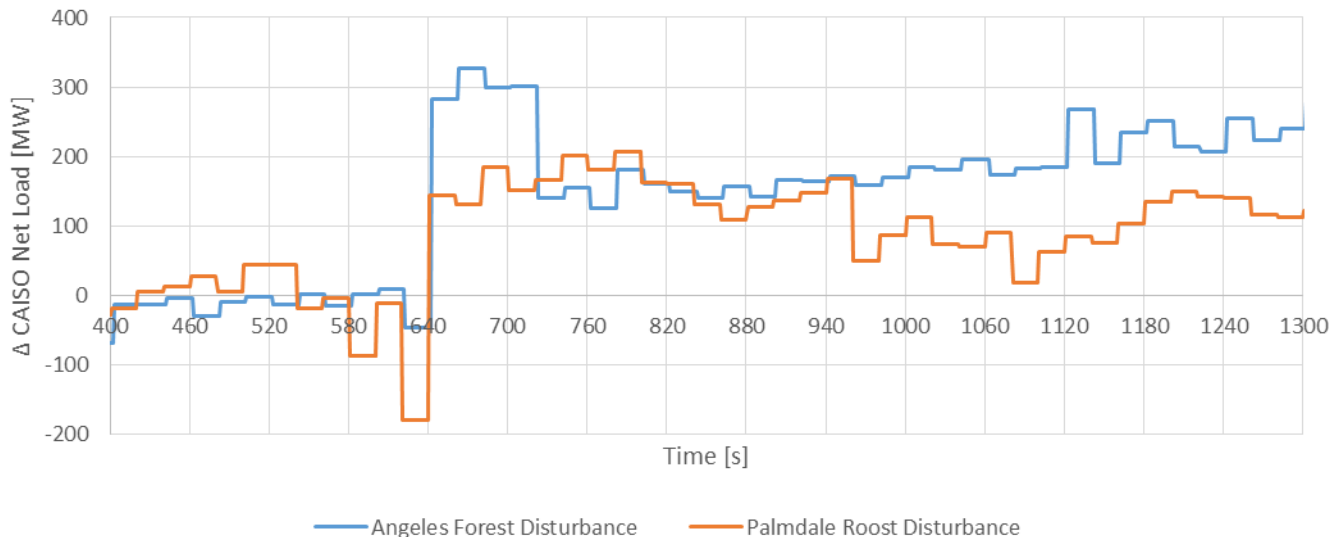
Figure 2.11: CAISO Net Load during Angeles Forest and Palmdale Roost Disturbance [Source: CAISO]

A noticeable increase in net load was identified in both the Angeles Forest and Palmdale Roost disturbances, signifying a response from behind-the-meter (BTM) solar PV DERs. [Figure 2.11](#) shows the CAISO net load for both disturbances. This plot illustrates the challenge in identifying an exact amount of DERs by using BA net load quantities. While a noticeable change in net load is observed, the exact value of DER tripping is difficult to define. Based on the plots below, the ERO determined that approximately 130 MW of DERs were involved in the Angeles Forest disturbance, and approximately 100 MW of DERs were involved in the Palmdale Roost disturbance. However, these are estimated values only.

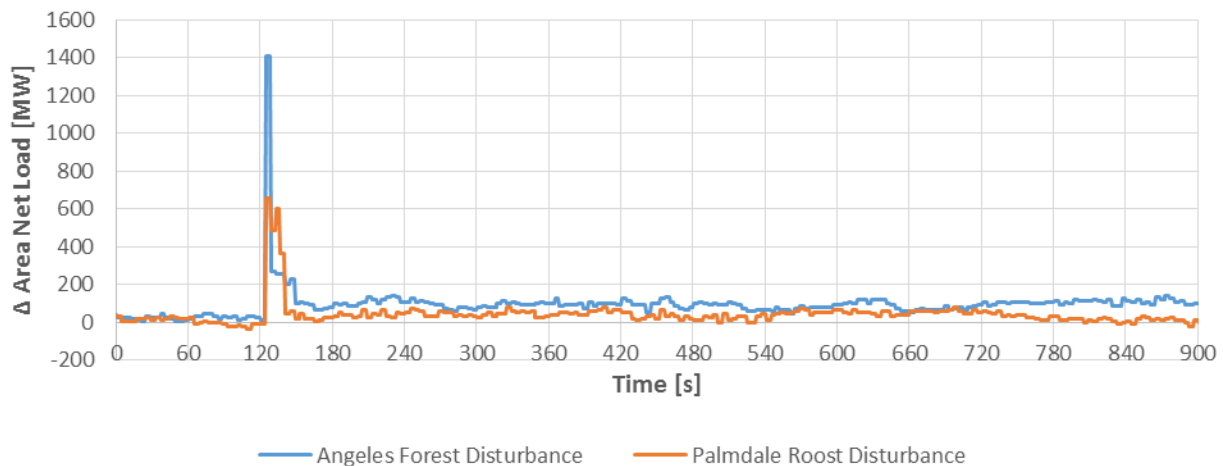
Figure 2.12: SCE Area Net Load Response [Source: SCE]

SCE also gathered its net load data around the time of the disturbances, as shown in [Figure 2.12](#). This plot, upon first glance, shows a significant amount of DER response within the first few seconds following the event. However, SCE explained that using the area-wide net load plot can lead to false interpretation of DER response during grid events for the following reasons:

- As with all energy management systems (EMS), the remote terminal units (RTUs) reporting data to the EMS are not time-synchronized. Delays in the incoming data during the disturbance can result in temporary spikes. Fast changes in metered generation (e.g., generator tripping or active power reduction) before refreshed values of intertie flow can cause the calculated load point to change rapidly around fault events. Once the refreshed values are received, the spikes balance out.

For the reasons described above, the spikes in net load were accounted for as calculation errors and variations in system losses and intertie flow changes. The temporary increase within the first tens of seconds after the fault event should not be completely attributed to DER tripping or active power reduction when using area-wide net load SCADA points.

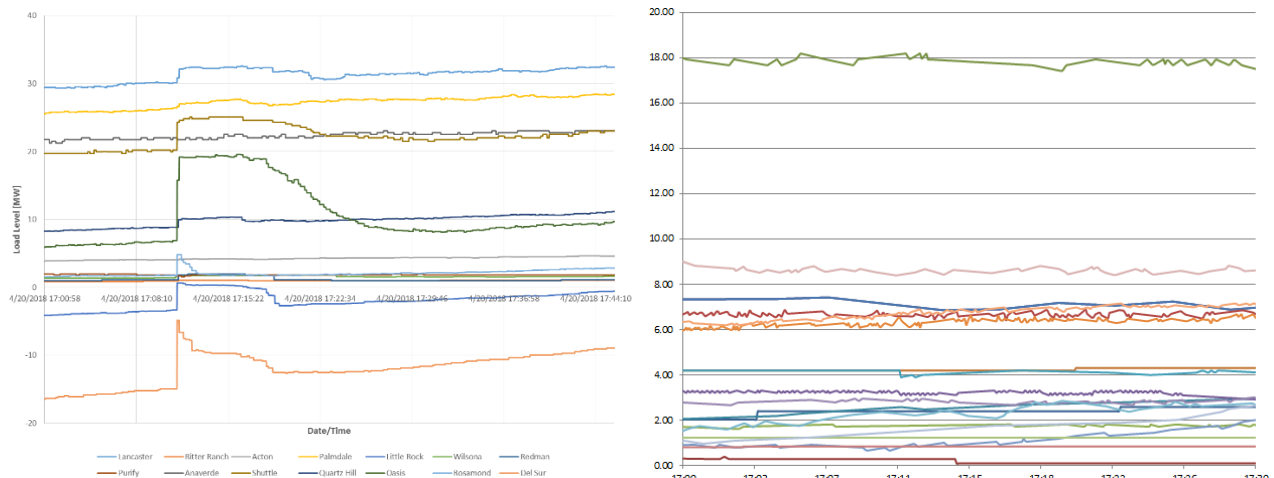
Figure 2.13: SCE (left) and PG&E (right) Individual Load SCADA Points

SCE found that the best method to analyze DER response is to monitor the T-D transformer bank flows directly by using SCADA measurements rather than using the calculated area net load value. This is beneficial because it removes the time synchronization issues that occur in the method discussed above. [Figure 2.13](#) (left) shows direct measurements of T-D bank flows in the area around the fault. The significant upward spike does not occur in these measurements as it did in the area-wide calculation. However, it is clear that multiple T-D transformer banks did increase net loading immediately after the fault. These net load increases lasted on the order of five to seven

minutes, correlating with the reset times for DER tripping as described in IEEE Std. 1547.²² After that time, the net loading returned back to its original load level (accounting for decrease in solar irradiance during solar PV ramp down in the early evening) in all cases. This method of accounting for DER response is much more accurate and provides a clearer picture of how DERs respond to BPS faults. However, this method is time intensive and difficult to aggregate all individual T-D transformer banks to ascertain a total DER reduction value.

For the Angeles Forest disturbance, PG&E also provided individual T-D transformer net load SCADA points across their footprint. **Figure 2.13** (right) also shows that net load remained relatively constant during the disturbance; hence, DERs in the PG&E footprint were likely not involved.

Tripping or momentary cessation of DERs was involved in the Angeles Forest and Palmdale Roost disturbances. This is based on anecdotal evidence and analysis of area net load and individual T-D transformer load SCADA points. Increase in net load on the order of 130 MW and 100 MW in the CAISO footprint was observed for the Angeles Forest and Palmdale Roost disturbances, respectively. These are estimated values of DER response since the exact values are not ascertainable. DER response was identified in the SCE footprint; DERs in the PG&E footprint were not affected.

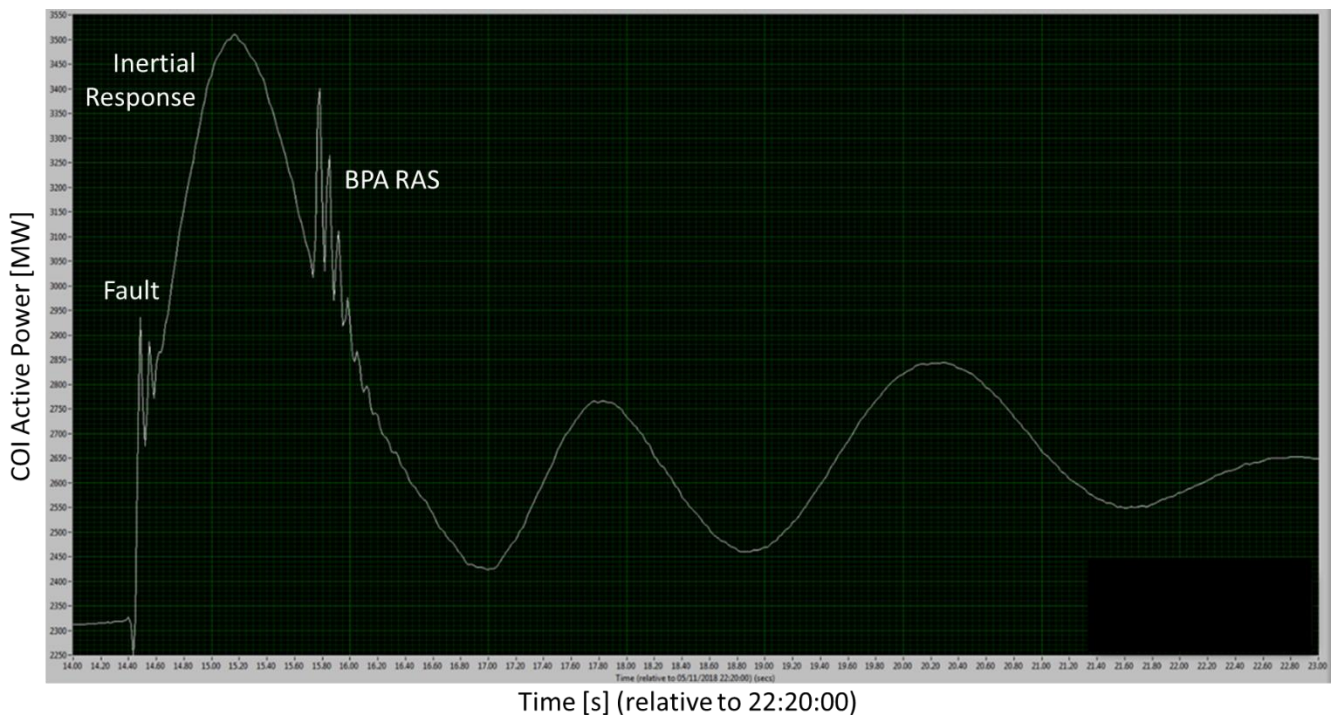
Figure 2.14: COI Active Power Pickup during Palmdale Roost Disturbance [Source: BPA]

The Palmdale Roost disturbance was unique in that the PDCI RAS and another BPA RAS were also involved in the disturbance. When the fault occurred in the Southern California area, about 25 miles from the receiving end of the PDCI inverter terminal, voltage fell low enough at the terminal for it to very briefly block firing of the thyristors in the power electronic controls. DC blocking is used to avoid commutation failure on the PDCI, particularly for low voltages at the inverter end. When the fault was detected, the PDCI responded as designed for a temporary fault on the ac side by ceasing thyristor firing and thus blocking current flow; this action occurs within cycles of detecting the low voltage. Once voltage returned to above acceptable levels, the PDCI resumed thyristor firing and returned to predisturbance power flow within approximately 200 ms. The brief blocking of the PDCI, along with the momentary cessation and tripping of solar PV resources in Southern California, caused a moderate pickup of power along the COI. **Figure 2.14** shows COI power flow, which is a collection of three ac transmission circuits. Power flow rapidly increased from about 2300 MW to 2900 MW within about one electrical cycle. After fault clearing, the PDCI began recovering active power flow, large synchronous machine inertia in the Pacific Northwest inherently responded, and COI flow reached a maximum flow of around 3500 MW.

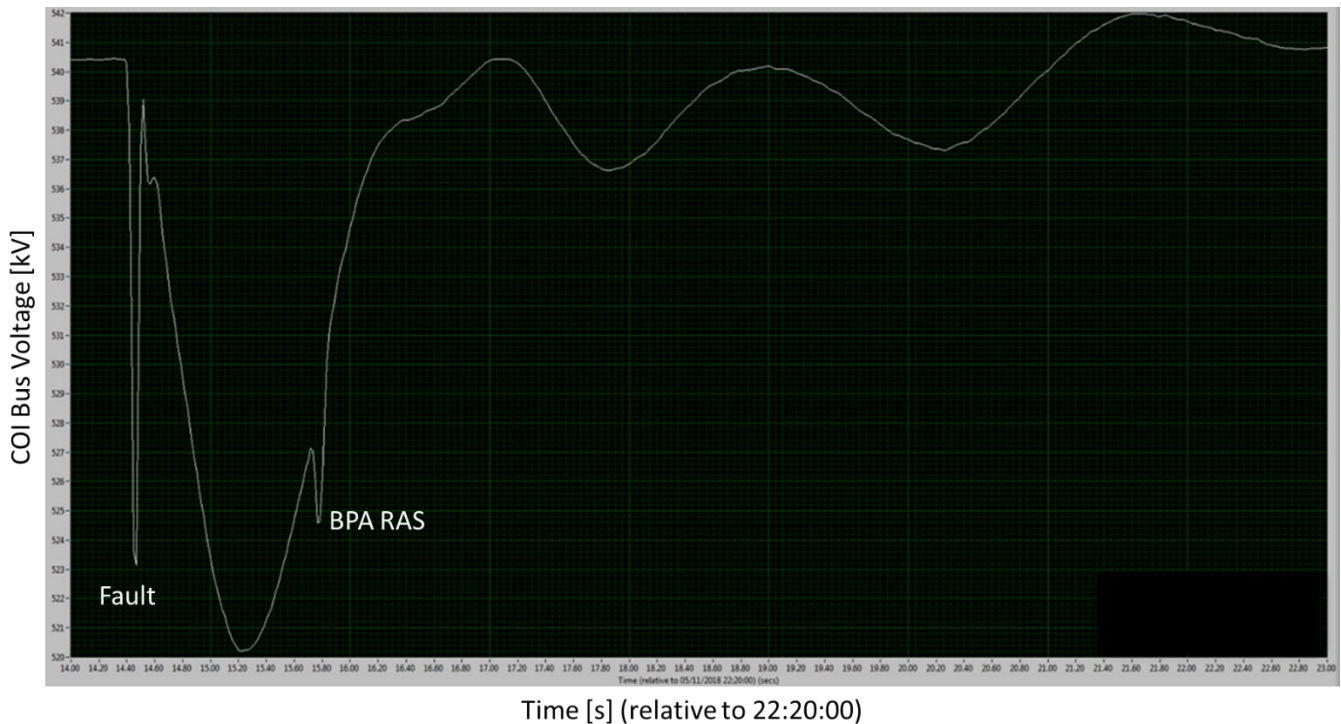
Figure 2.15: COI Bus Voltage during Palmdale Roost Disturbance [Source: BPA]

An increase in power flow across large areas of the WI can cause fluctuations in BPS voltages. Buses along the COI are inherently prone to larger fluctuations in voltage since they are in the midpoint of these large power changes. Therefore, the BPA RAS is designed to autonomously act to maintain transient voltage stability and support these large power swings. **Figure 2.15** shows a COI 500 kV bus voltage during the disturbance. Bus voltage was initially around 540 kV prior to the disturbance. Immediately after the fault and a large power fluctuation, COI voltage dropped on the initial swing to a value of 520 kV. Voltages fell below a predetermined threshold value for a sufficient period of time such that the BPA RAS initiated removal of shunt reactors that were in-service and insertion of series capacitors along the COI corridor. These actions of the BPA RAS operated as designed, and are not related to blocking of the PDCI (other than the impacts of the additional change in COI flow due to PDCI blocking). The PDCI also has a gen drop associated with its tripping, but the gen drop was not armed due to low power transfer levels and gen drop is not initiated for temporary blocking conditions.

The PDCI experienced temporary blocking to avoid commutation failure during the Palmdale Roost fault near the inverter terminal of the PDCI. The large change in power flows across the WI initiated the BPA RAS due to detected drop in voltage along the COI. Both of these actions operated as designed to support BPS reliability. However, the impacts of these actions along with BPS solar PV use of momentary cessation has likely not been sufficiently studied by TPs and PCs.
